ALBERTA TRANSPORTATION GRMP (CON0022164) PEACE REGION (PEACE RIVER DISTRICT) INSTRUMENTATION MONITORING RESULTS – SPRING 2022

SITE PH072: HWY 744:04, JUDAH HILL (SUNSHINE SLIDE)

TABLE PH072-1 SPRING 2022 – HWY 744:04 JUDAH HILL (SUNSHINE SLIDE) SLOPE INCLINOMETER INSTRUMENTATION READING SUMMARY

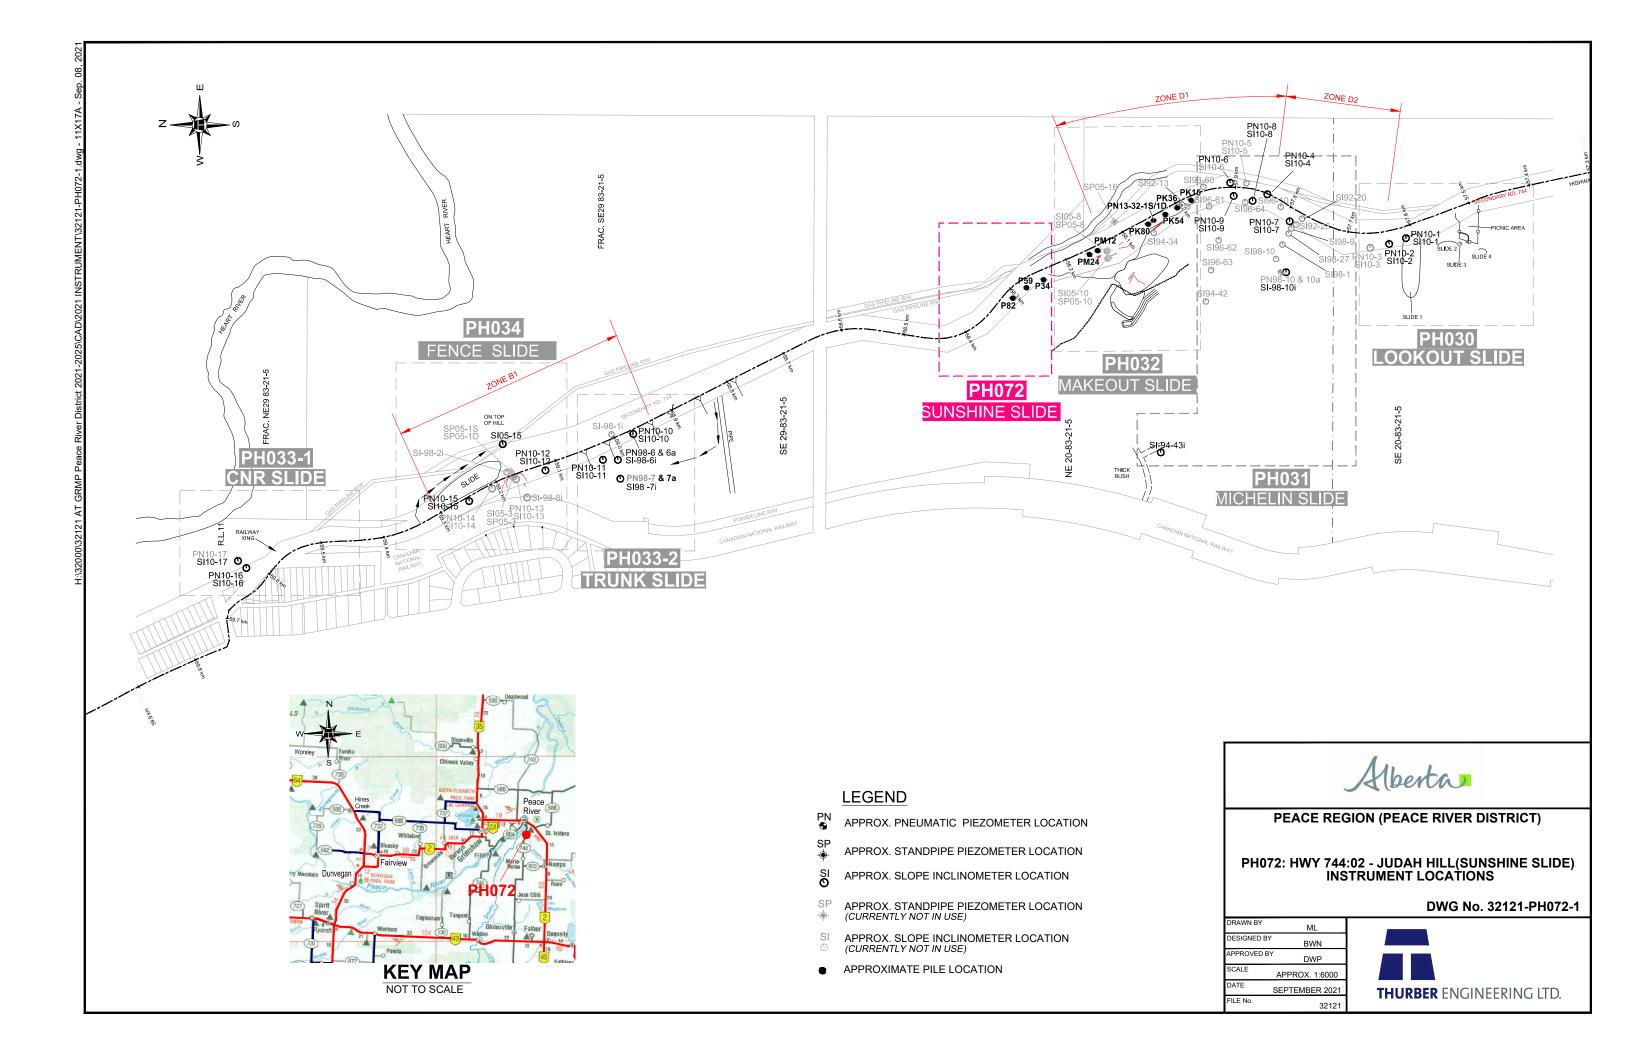
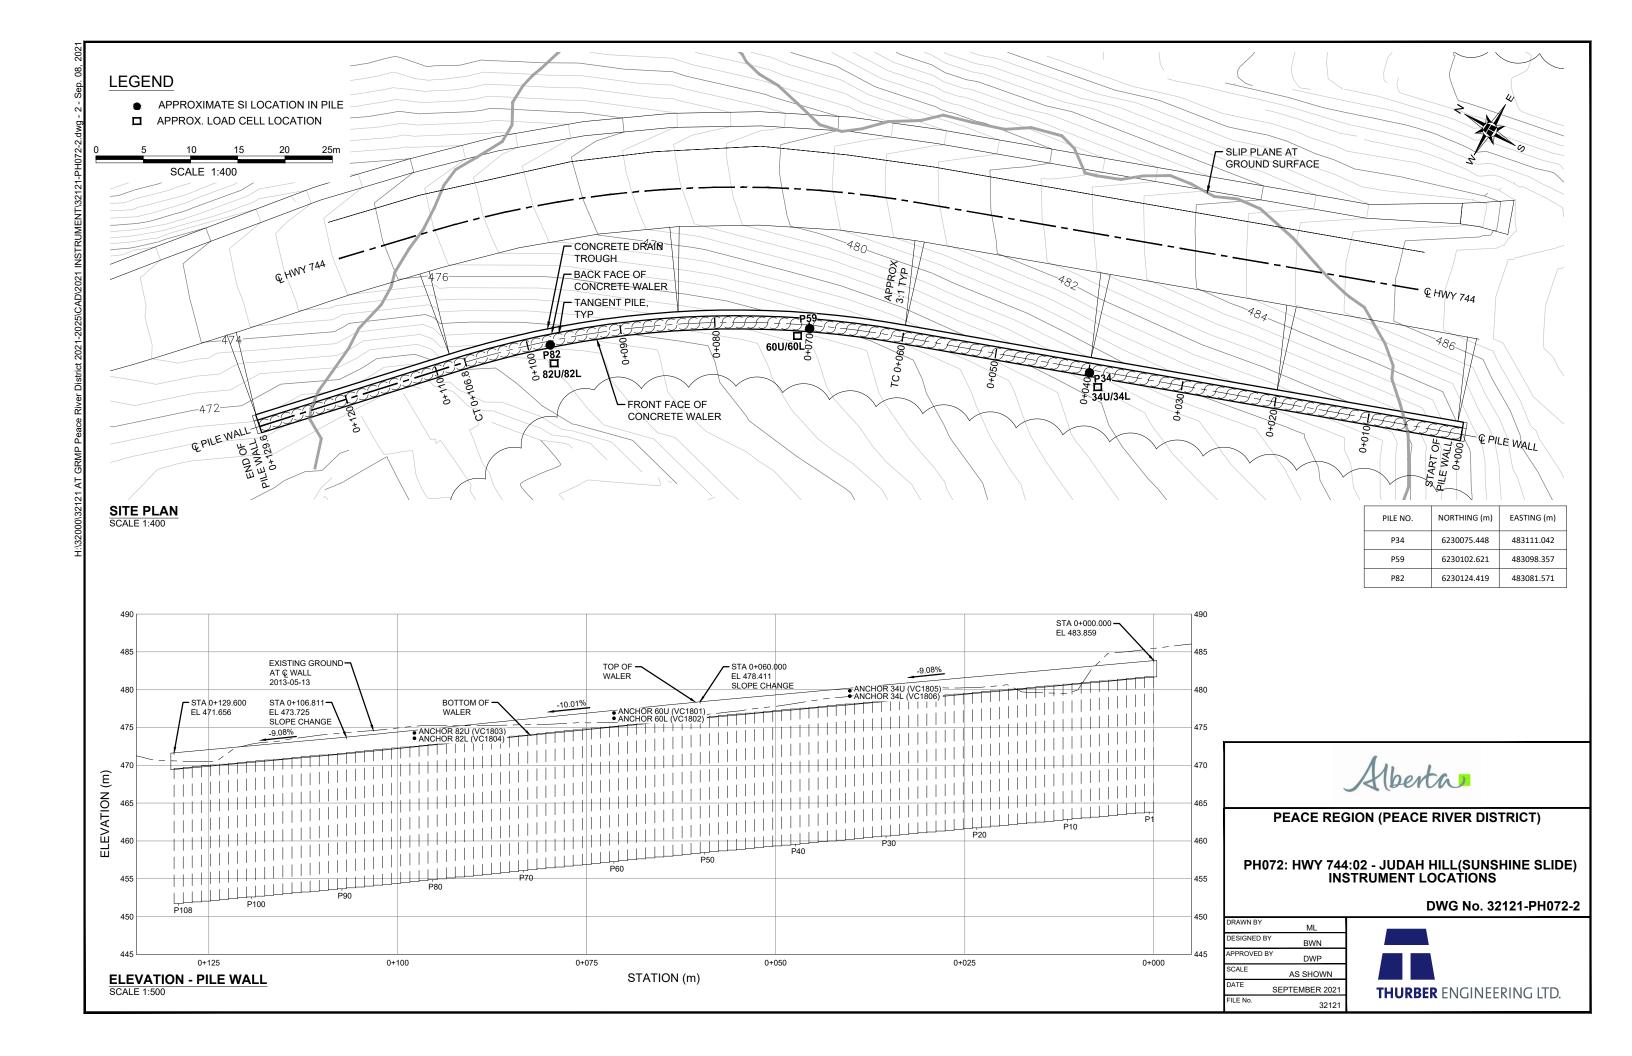
PH072 Sunshine (Post Construction), Inclinometer Pile 34

Thurber Engineering Ltd Deflection (mm) Deflection (mm) -50 0__ 25 50 __0 -25 0 12.5 25 __0 -25 -12.5 **LEGEND** Initial 4 Jul 2015 Waler Waler 21 Jul 2015 2 2 21 Oct 2015 Pile Pile 10 Dec 2015 4 Jun 2016 4 16 Sep 2016 8 Jun 2017 29 Sep 2017 6 6 Clay (Fill) with Asphalt Clay (Fill) with Asphalt 13 Jun 2018 26 Sep 2018 8 8 27 Jun 2019 Clay Soft Clay Soft Depth 30 Sep 2019 Depth (m) ₁₀ (m) 10 11 Jun 2020 10 13 Oct 2020 Clay (Till) Very Stiff Clay (Till) Very Stiff 10 Jul 2021 12 12 12 14 Jun 2022* Clay Very Hard Clay Very Hard 14 14 14 14 Silt Silt 16 16 16 16
