ALBERTA TRANSPORTATION GEOHAZARD ASSESSMENT PROGRAM PART A: FILE REVIEW

PEACE REGION – PEACE-HIGH LEVEL

PH31 JUDAH HILL – MICHELIN SLIDE

Legal Location:	NE¼20-083-21 W5M
Nearest Landmark:	1.8 km south of the CN Rail crossing on Hwy 744
Highway Control Section:	Hwy 744:04
Date of Initial Observation:	1984
Date of Last Inspection:	2008
Last Inspected By:	Thurber Engineering Ltd.
Instrumentation Installed:	10 inclinometers At least 2 pneumatic piezometers
Instrumentation Operational:	2 inclinometers 2 pneumatic piezometers
Risk Assessment: (as of last inspection)	PF = 9 CF = 4 Risk = 36

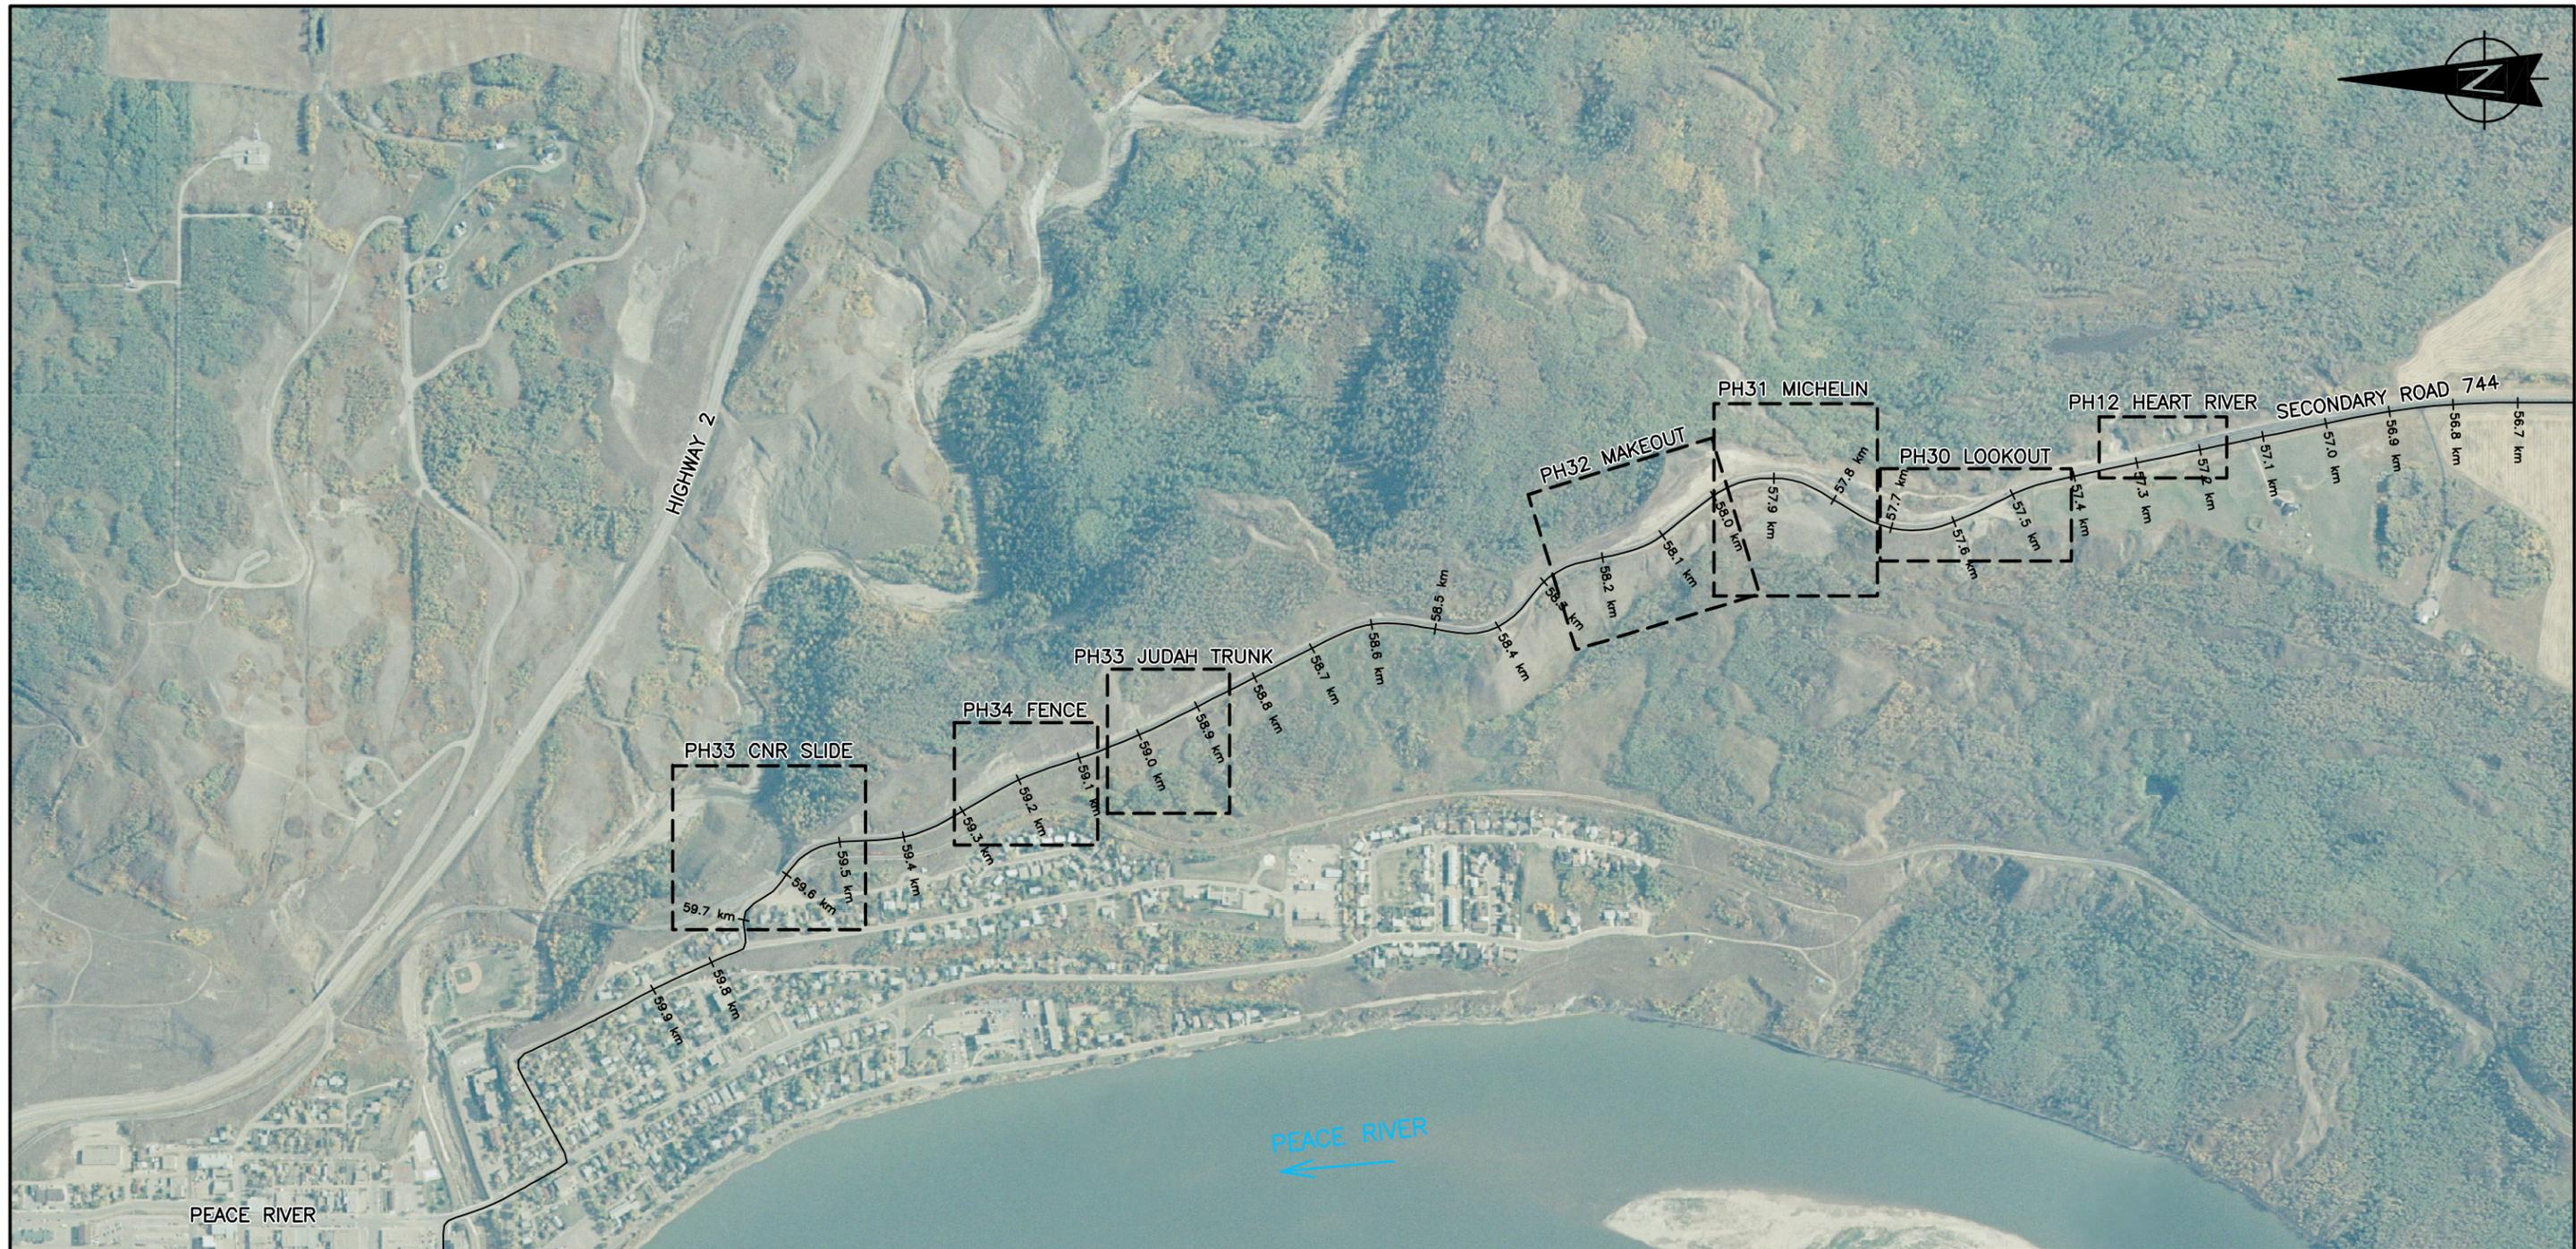
10m LONG CRACK IN N-BOUND LANE < 25mm WIDE

CRACK OPEN UP TO 70 mm VERTICAL OFFSET INCREASED TO 18 cm

CRACKING IN RE-GRADED AREA

SLIDE RE-GRADED AS PART OF MAKEOUT REPAIRS

NEW TRANSVERSE CRACK

CRACK TYP. 10 mm WIPE
