Site Number	Location	Name	Hwy	km
PH043	HWY 986:01 C1 33.357	Daishowa Retaining Wall	986:01	Km 33.4
Legal Description:		UTM Co-ordinates		
9-7-85-20 W5		11U E 491412.57	N	6246098.92

Current Monitoring:	8-June-2025	Previous Monitoring	20-May-2024
Instruments Read By:	Mr. Niraj Regmi, G.I.T and Mr. Godfred Etiendem, of Thurber

**ALBERTA TRANSPORTATION AND ECONOMIC CORRIDORS GRMP (CON0022164)
PEACE REGION (PEACE RIVER DISTRICT)
INSTRUMENTATION MONITORING RESULTS**

**SITE PH043-1: HWY 986:01, DAISHOWA EAST HILL PILE WALL
SITE PH043-2: HWY 986:01, DAISHOWA EAST HILL SITE B**

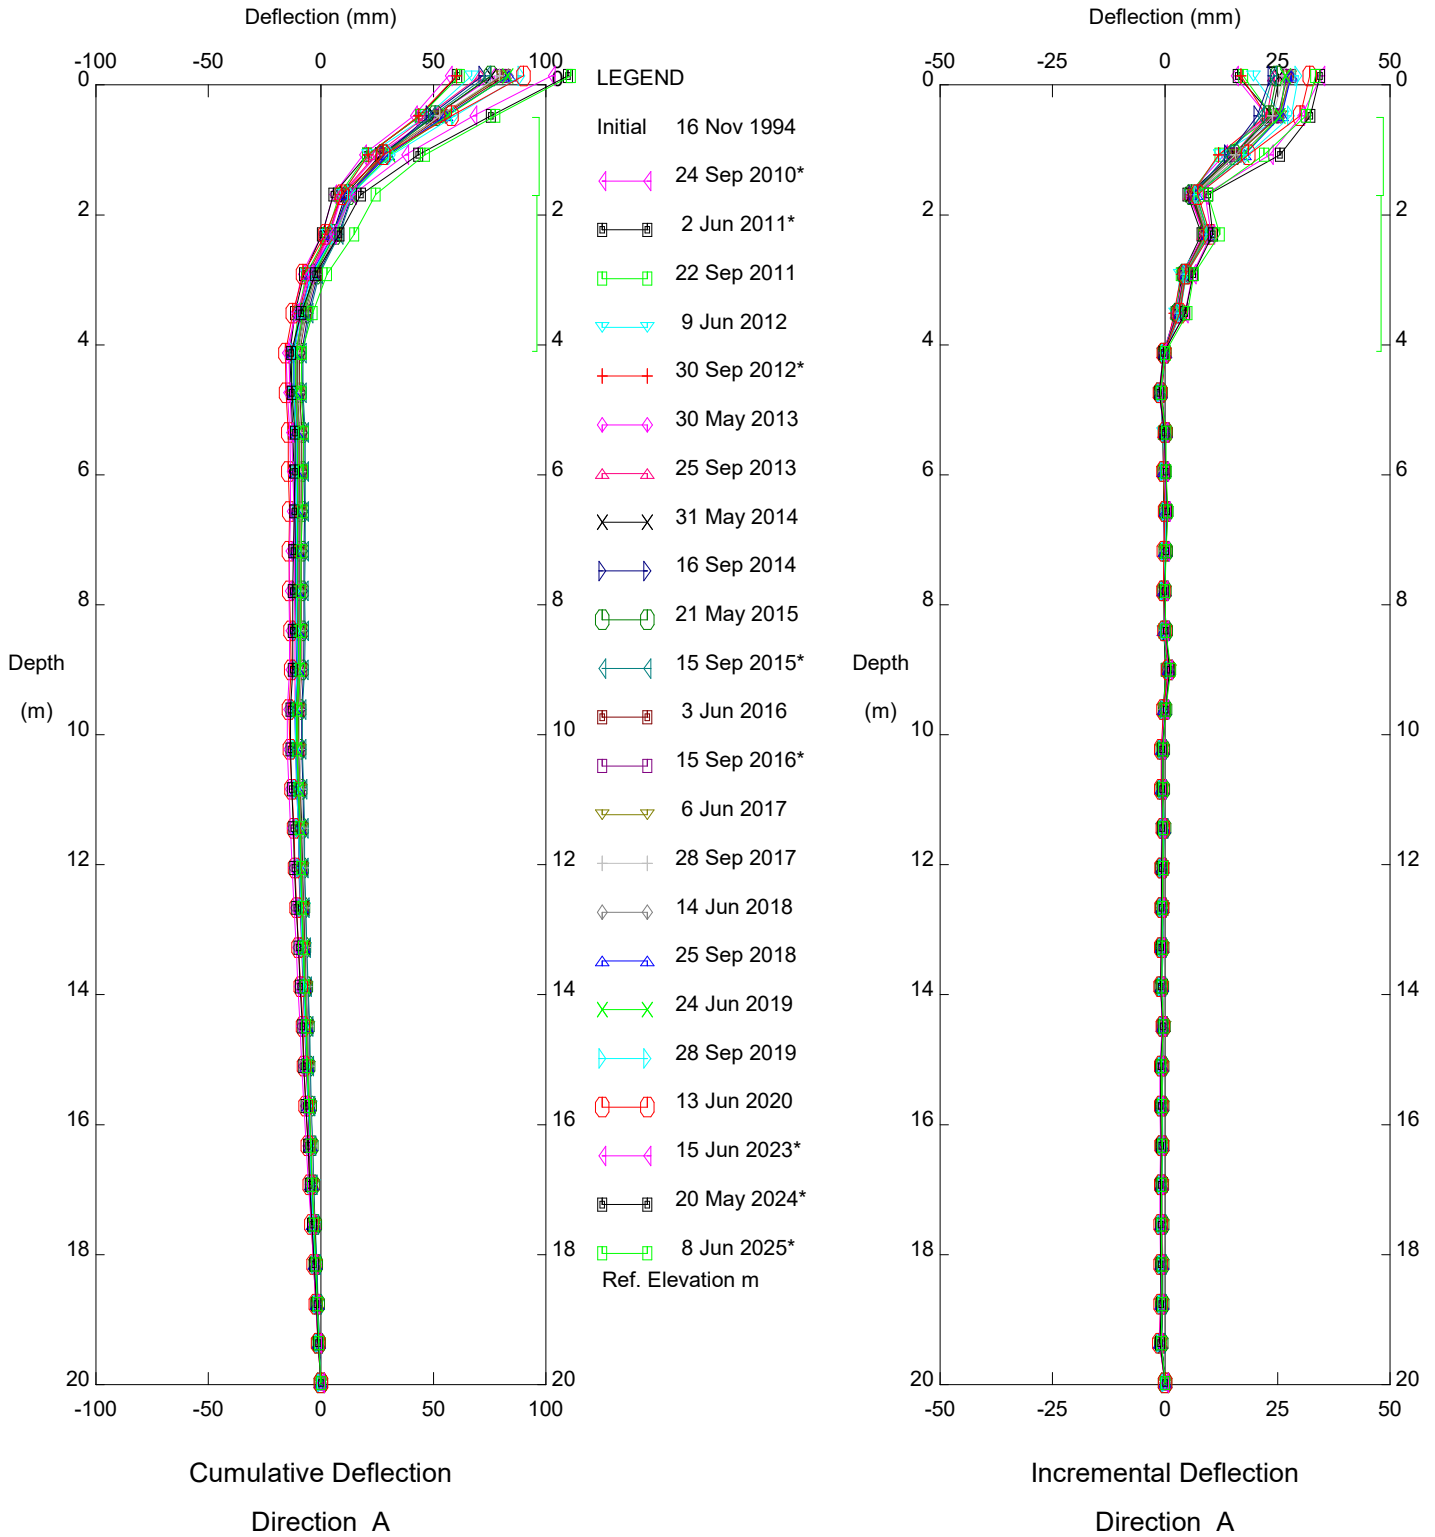
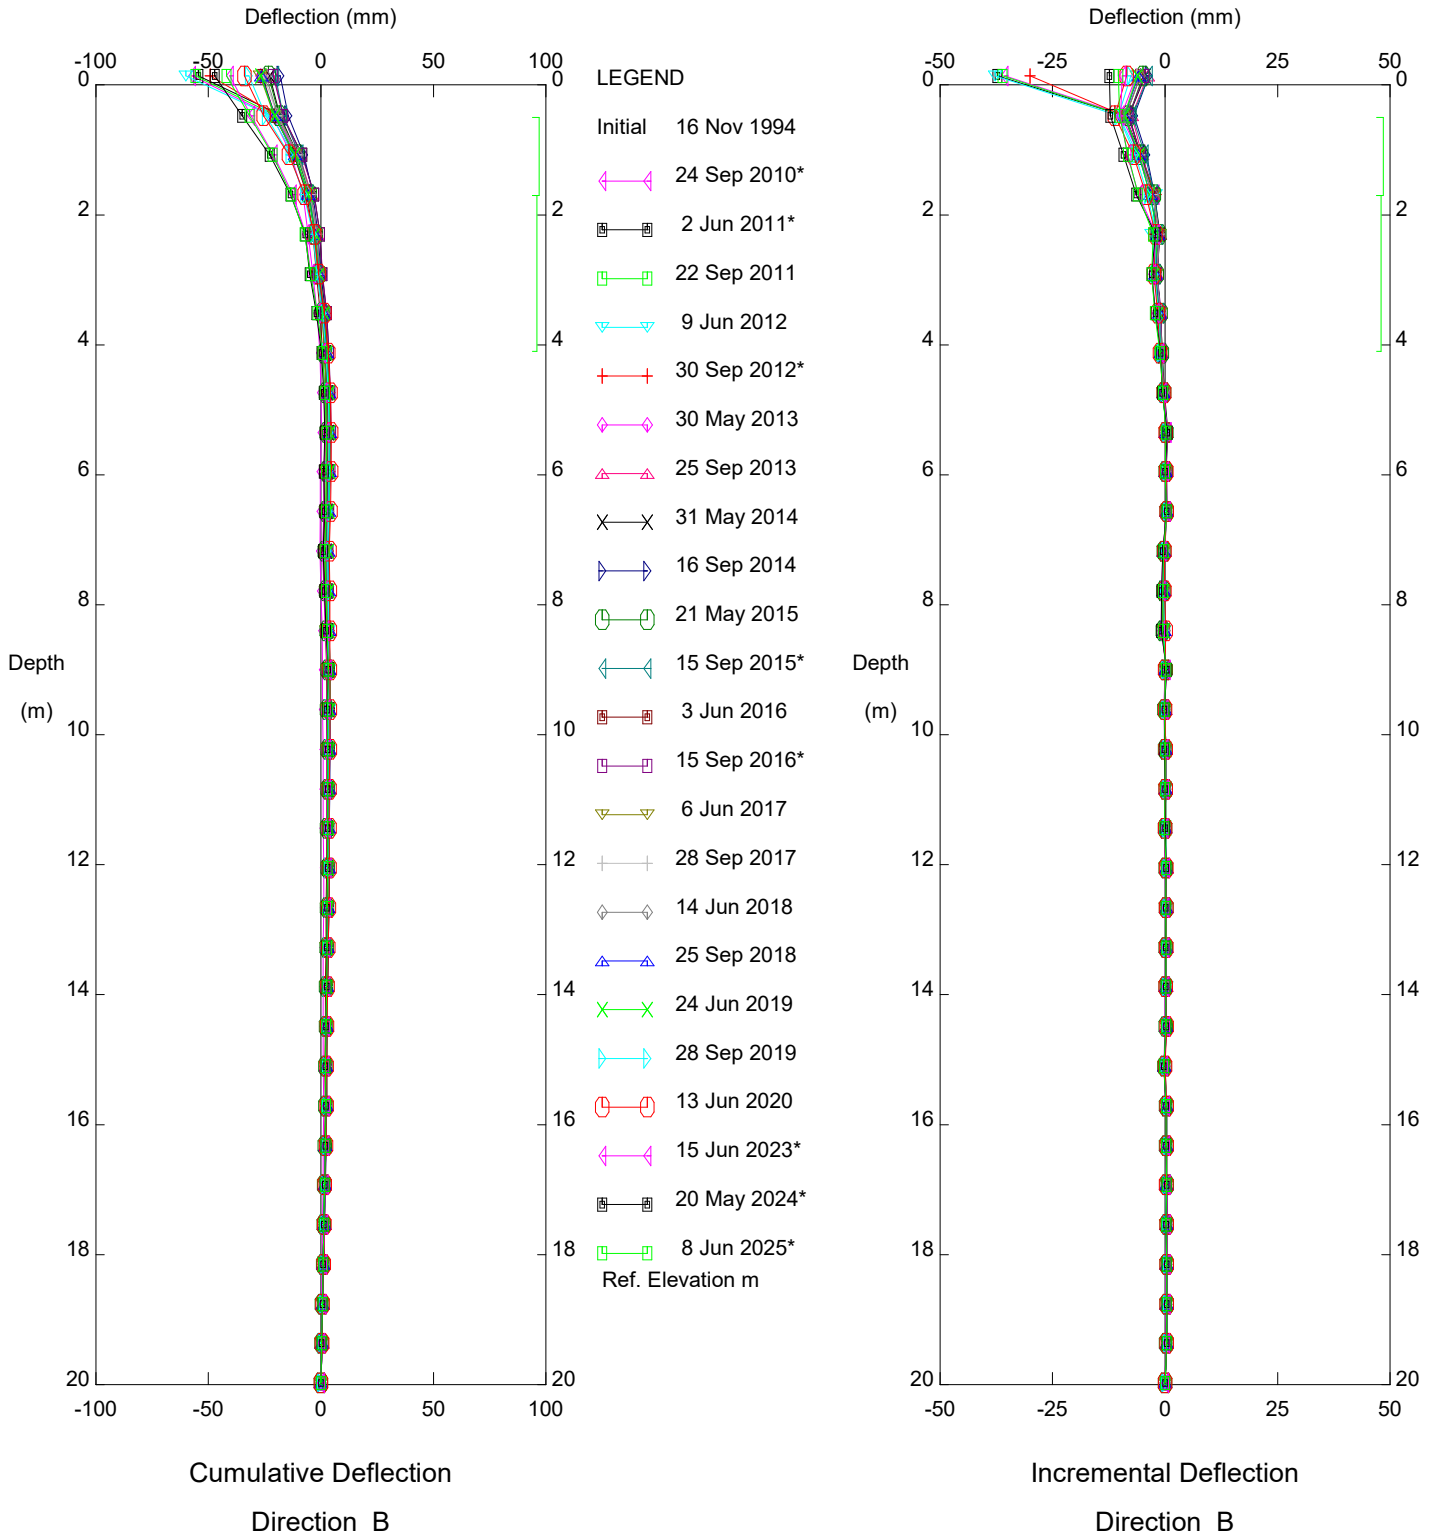
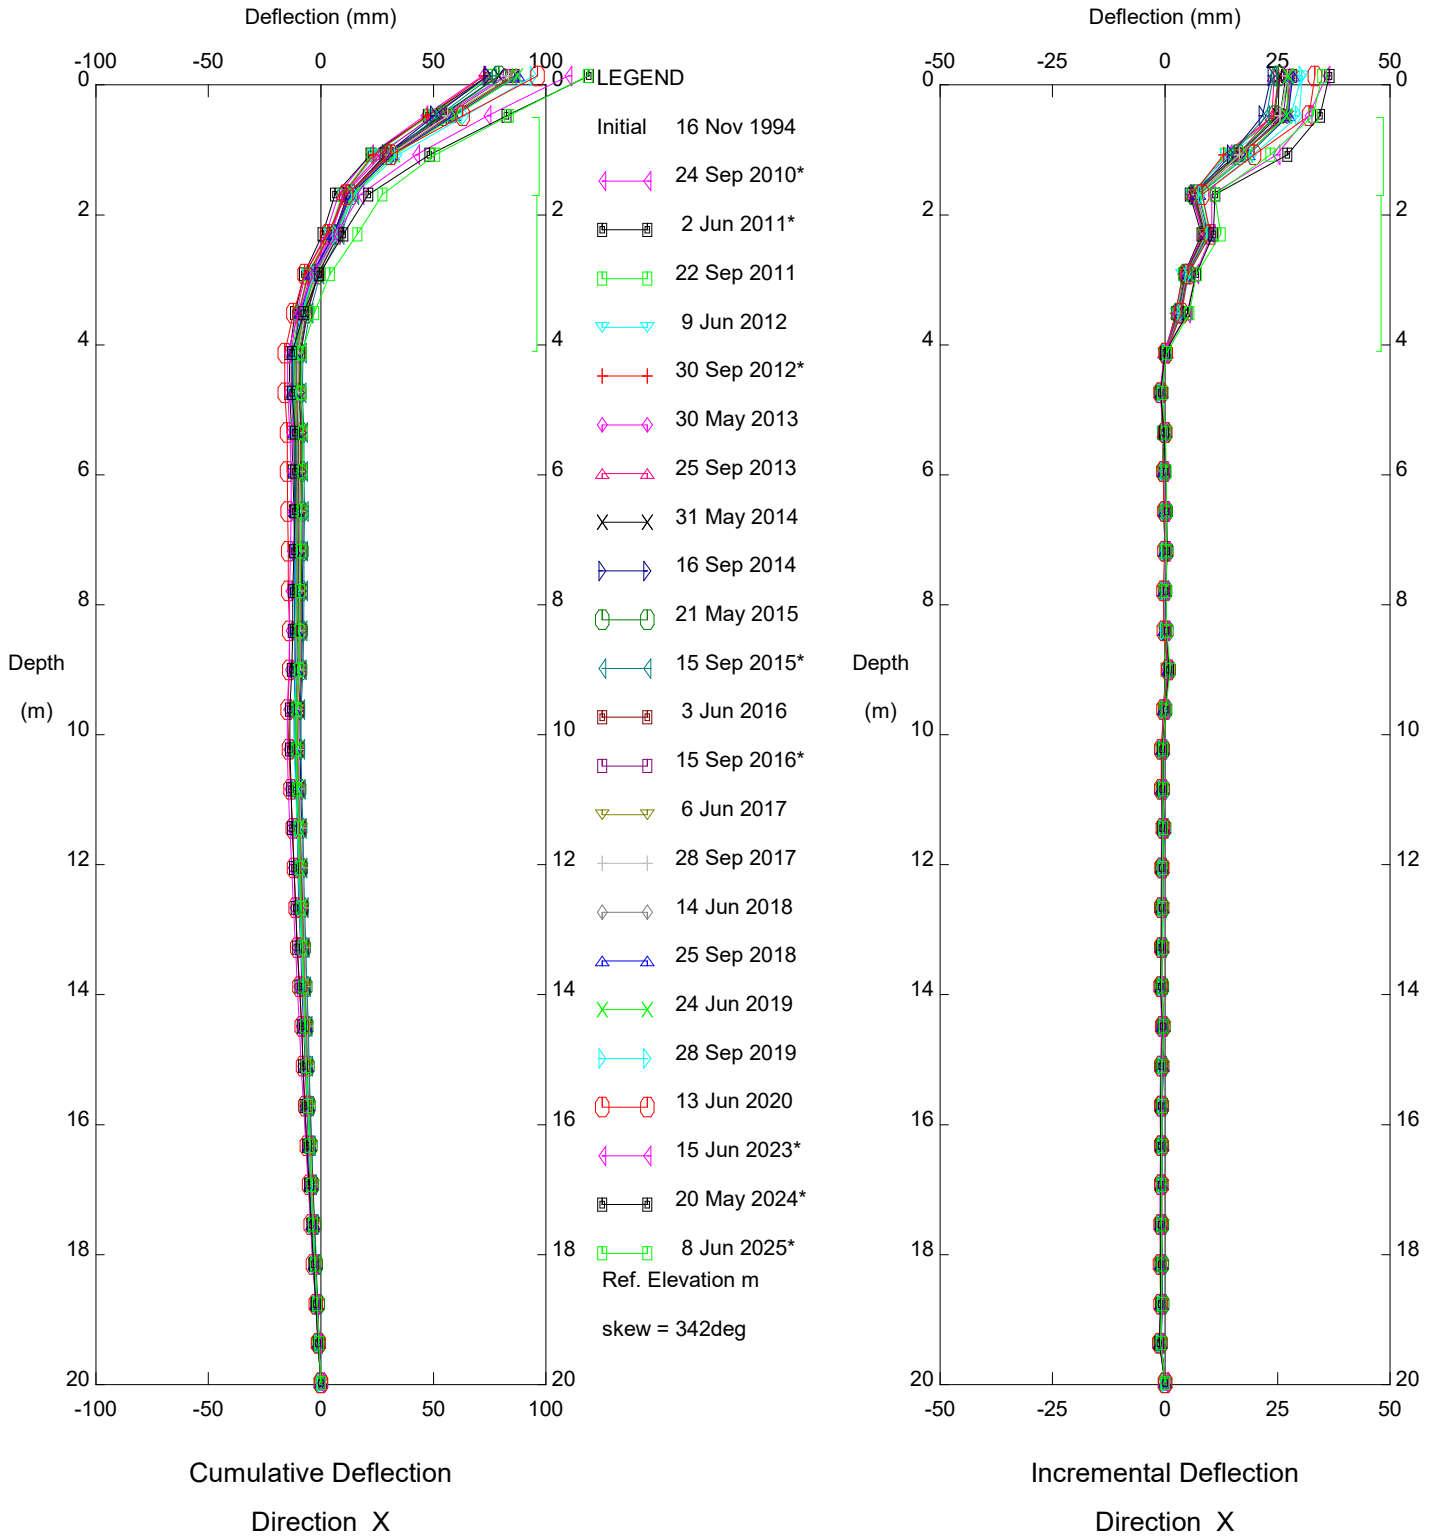
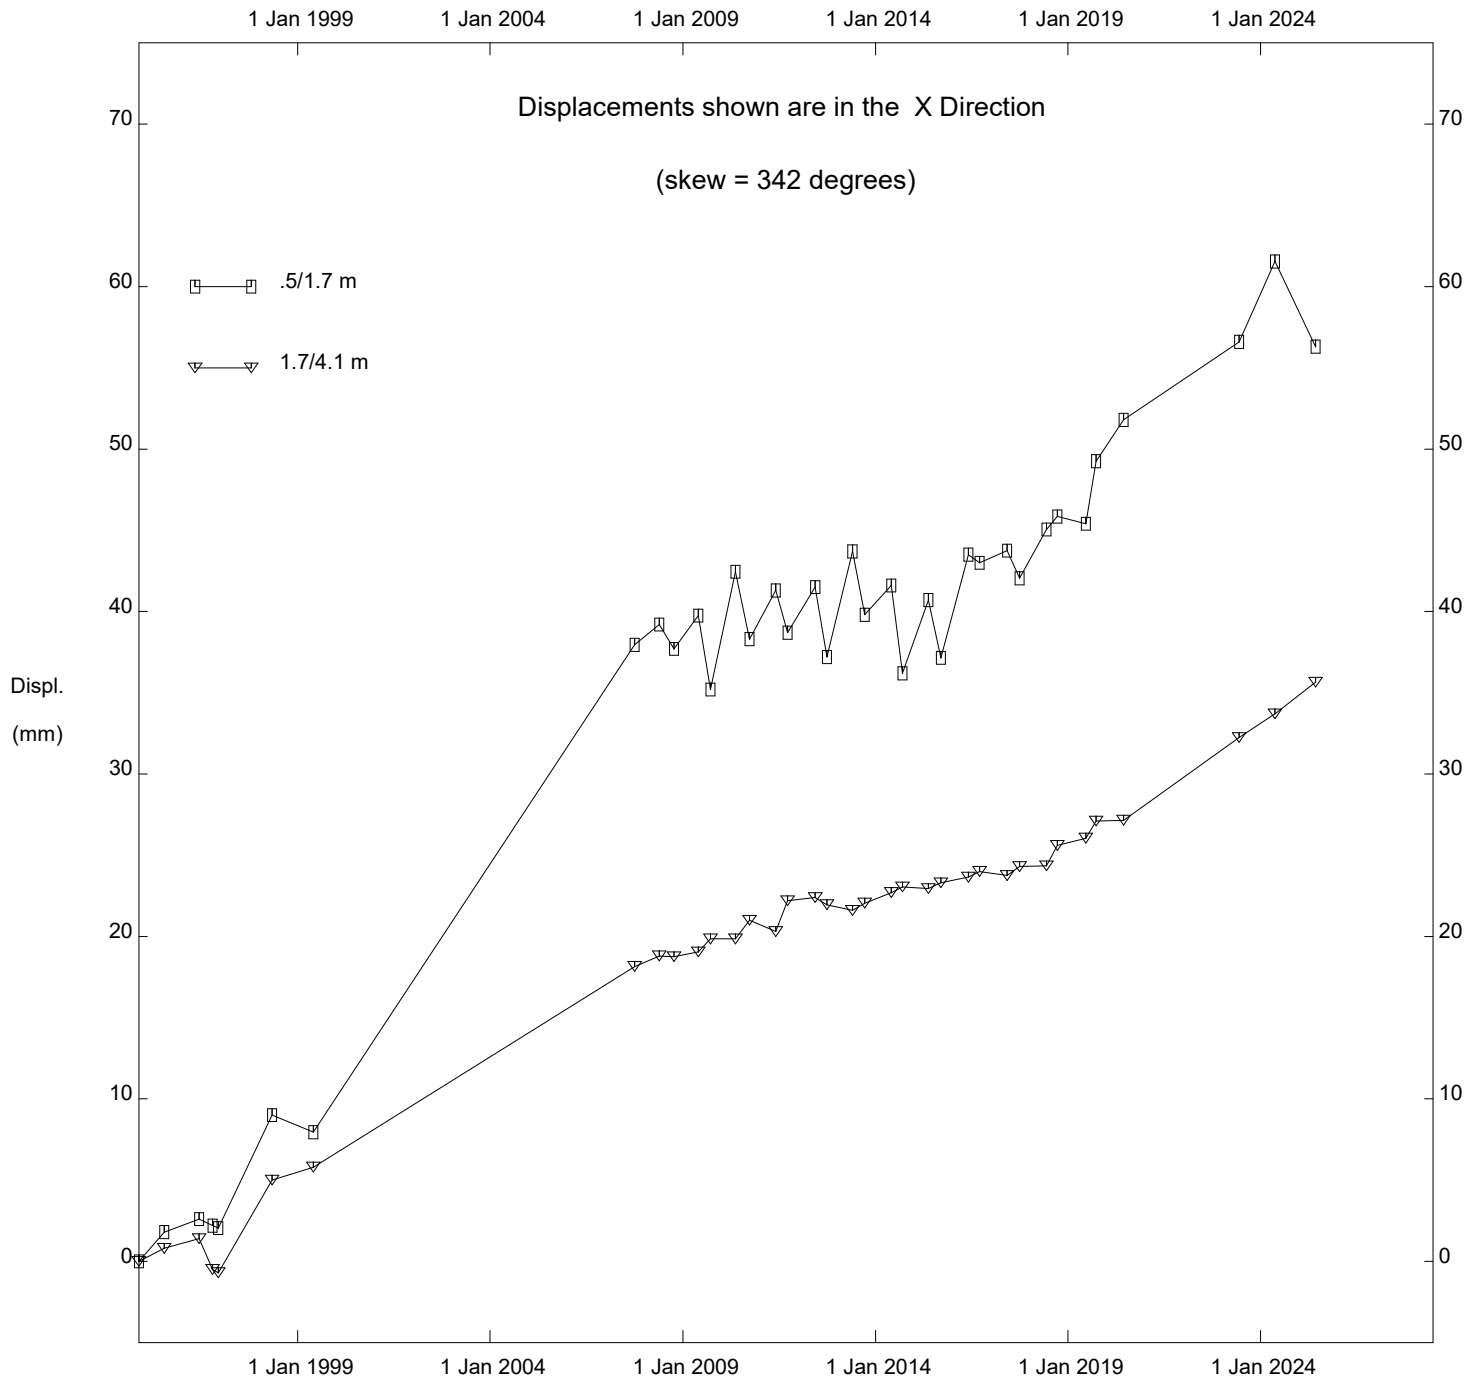
HWY 986:01 - STA. 13+540, Inclinometer SI-5

Discussion	
Zones of New Movement:	None
Interpretation of Monitoring Results:	<p>Pile Wall Site (PH043-1)</p> <p>Slope inclinometers SI-4, SI-5 and SI-6 are located east of the wall and are considered to be outside the main slide block. All three SI's have shown a relatively consistent movement trend and pattern.</p> <p>SI-4 has two distinct movement zones. Since the spring of 2024 SI-4 has shown a rate of movement of 3.0 mm/yr over 2.6 m to 6.3 m depth, which is consistent with a long term rate of movement of 2.7 mm/yr since 2012. SI-4 also showed a rate of movement of 1.2 mm/yr over 6.3 m to 8.1 m depth, which is consistent with the long-term rate of movement of 1.1 mm/yr at that depth.</p> <p>SI-5 has two movement zones. Since the spring of 2024 Si-5 has shown a rate of movement of -4.5 mm/yr over 0.5 m to 1.7 m depth and 1.9 mm/yr over 1.7 to 4.1 m depth. The upper movement zone may be impacted by surface activities and movements fluctuate by 5 to 8 mm within a year while showing an overall increase in movement by about 2.2 mm/yr since 2014. The lower zone rate of movement is consistent with long-term rate of movement of 1.6 mm/yr.</p> <p>SI-6 showed no discernible movement over 0.1 m to 5.0 m depth which is consistent with a fluctuating movement pattern since about 2017. SI-6 also shows a rate of movement of 9.1 mm/yr over 5.0 m to 6.8 m depth. This rate</p>
