Site Number	Location	Name	Hwy	km
PH071	Hwy 986:01 C1 28.474	Daishowa West Hill	986:01	Km 28.5
Legal Description:		UTM Co-ordinates		
8-9-85-21 W5		11U E 485023	N	6245526

Current Monitoring:	8-Jun-2025	Previous Monitoring	19-Sep-2024
Instruments Read By:	Mr. Niraj Regmi, G.I.T and Mr. Godfred Etiendem, of Thurber

**ALBERTA TRANSPORTATION AND ECONOMIC CORRIDORS GRMP (CON0022164)
PEACE REGION (PEACE RIVER DISTRICT)
INSTRUMENTATION MONITORING RESULTS**

SITE PH071: HWY 986:01, DAISHOWA WEST HILL

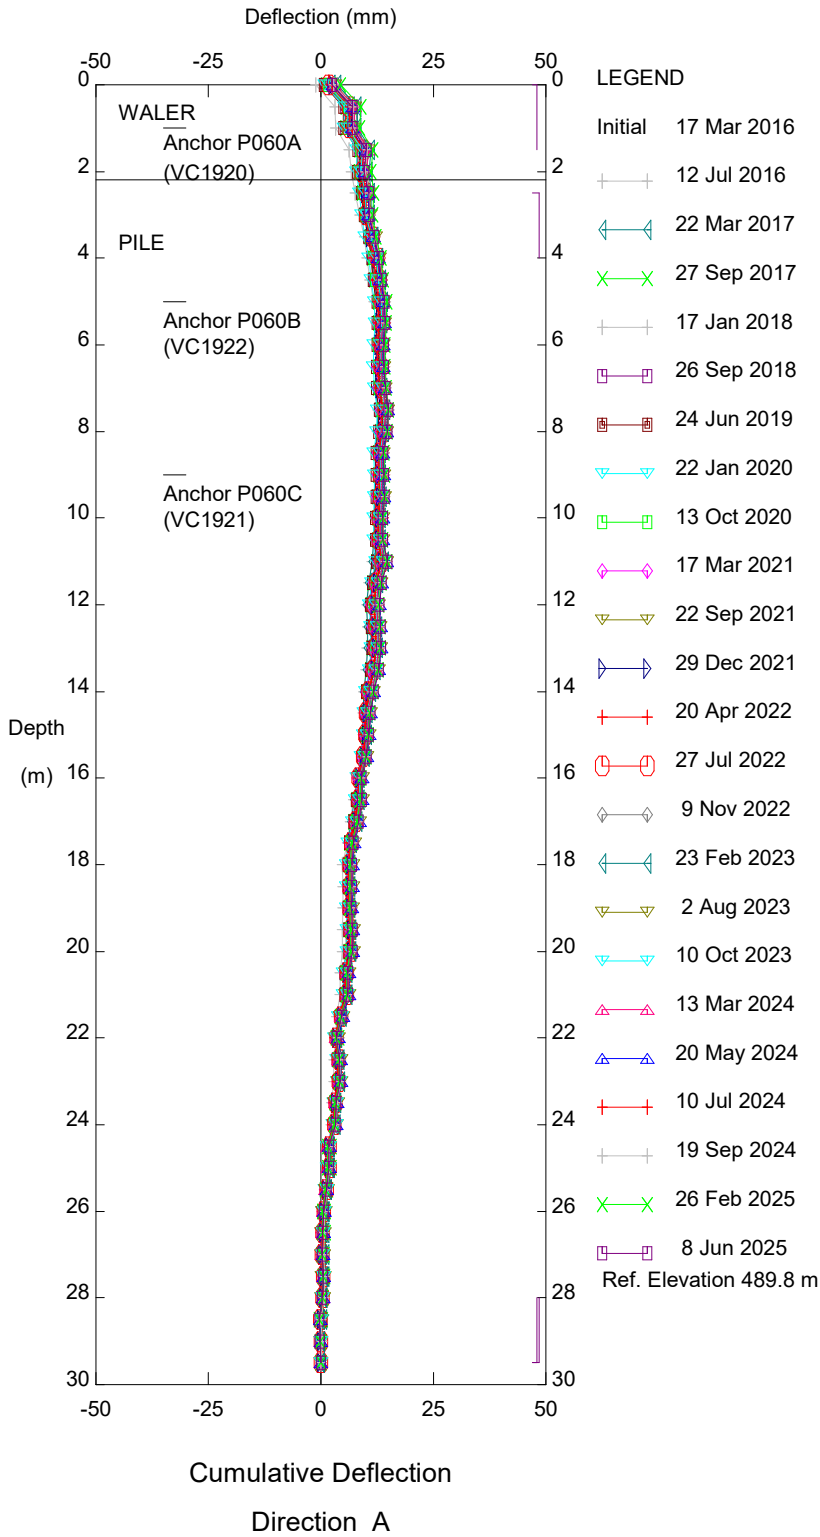
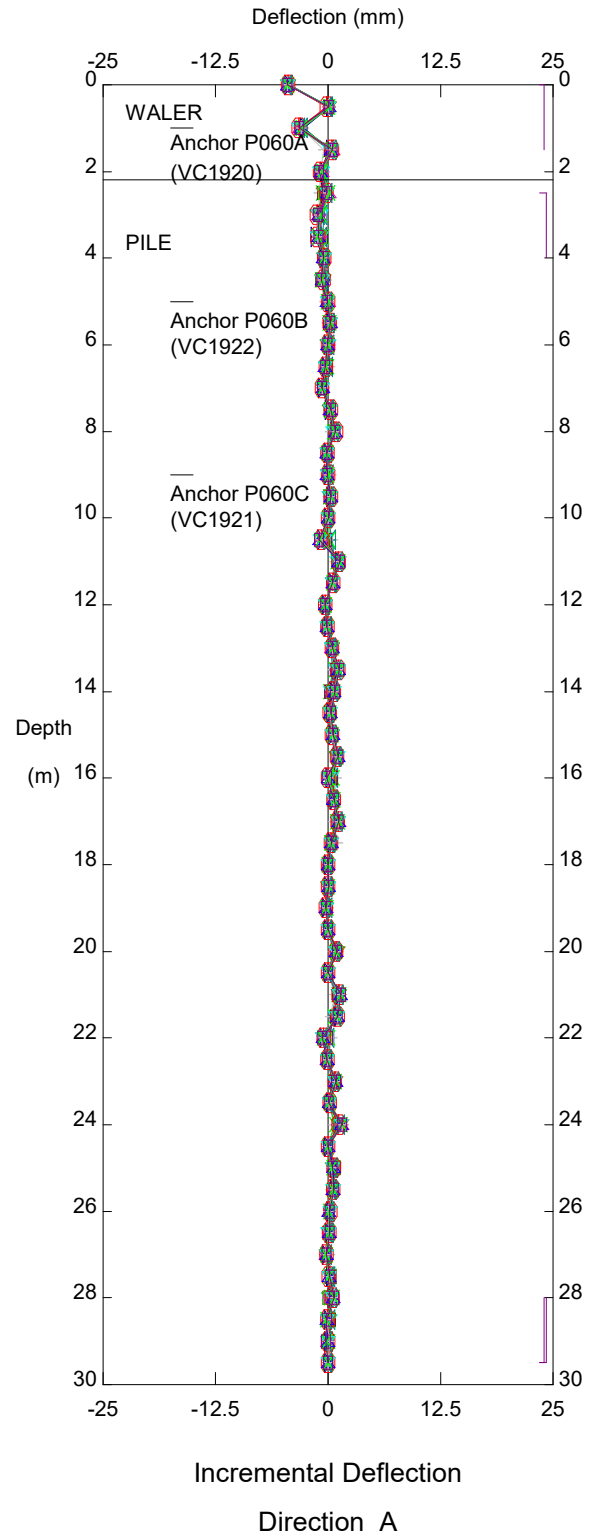
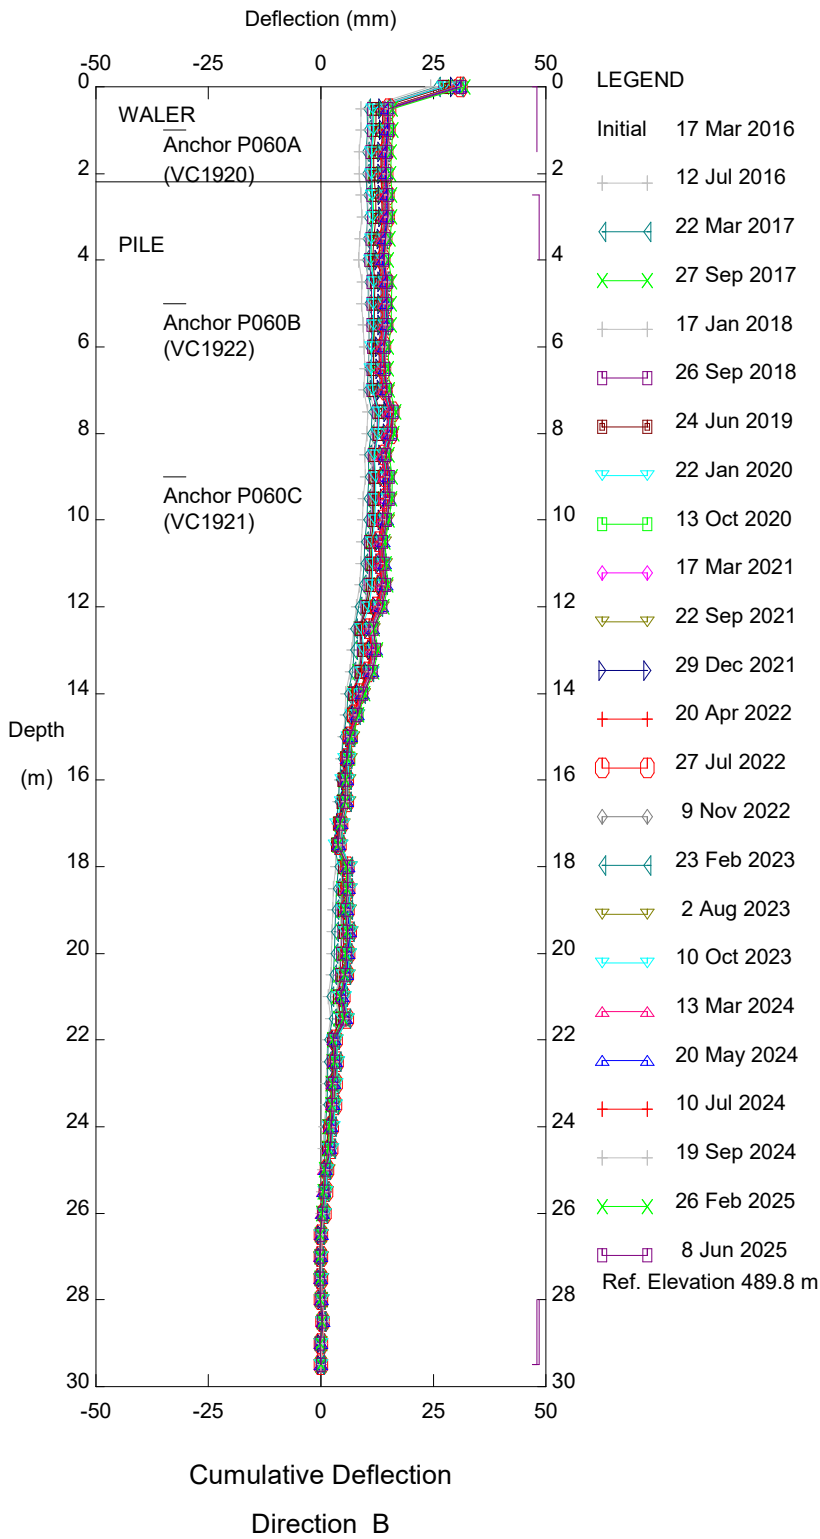
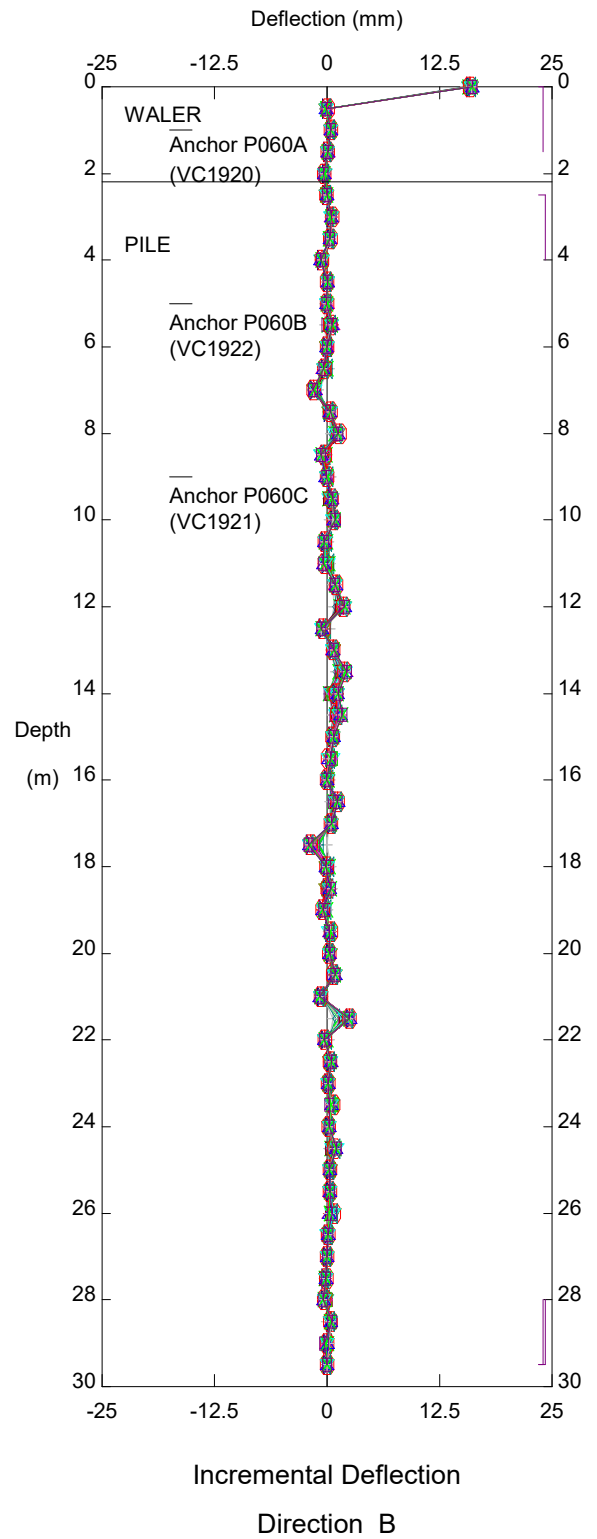
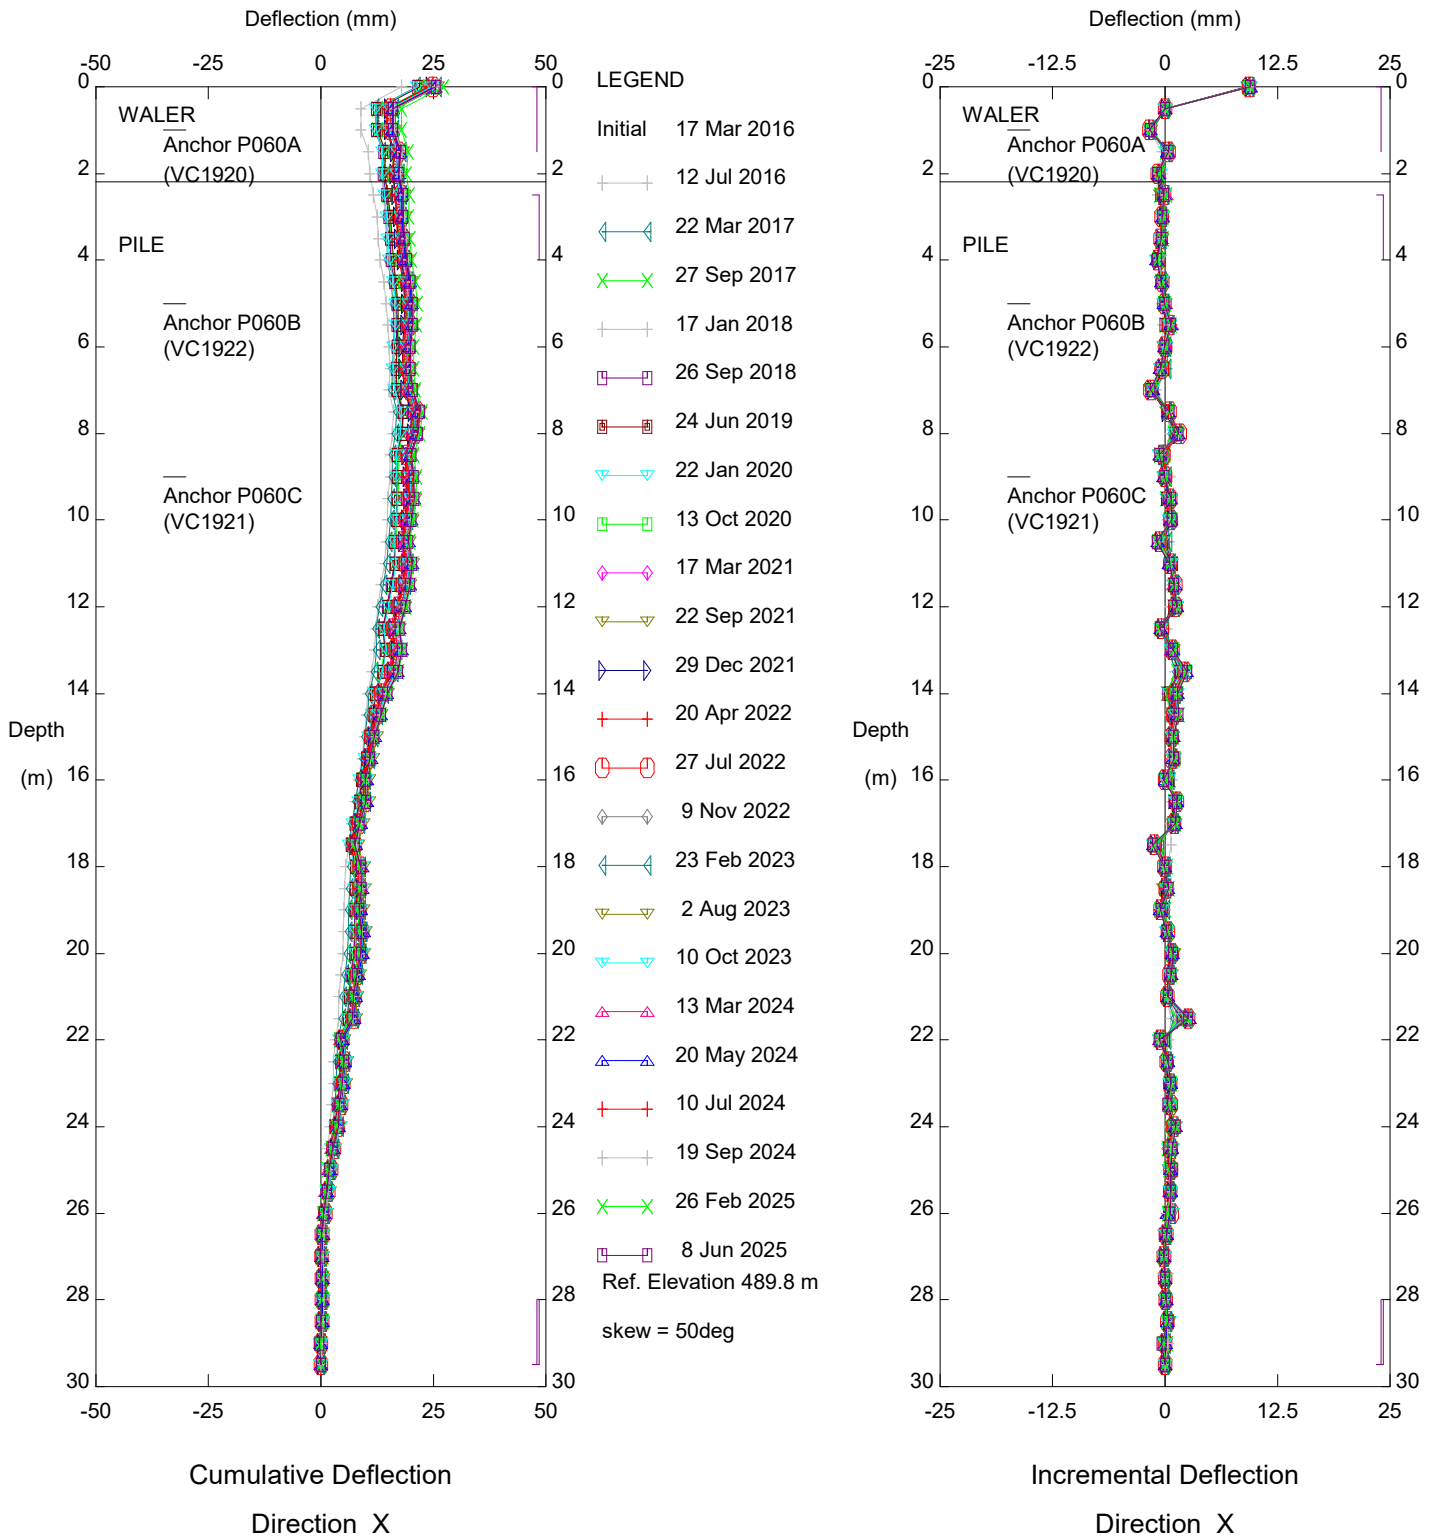
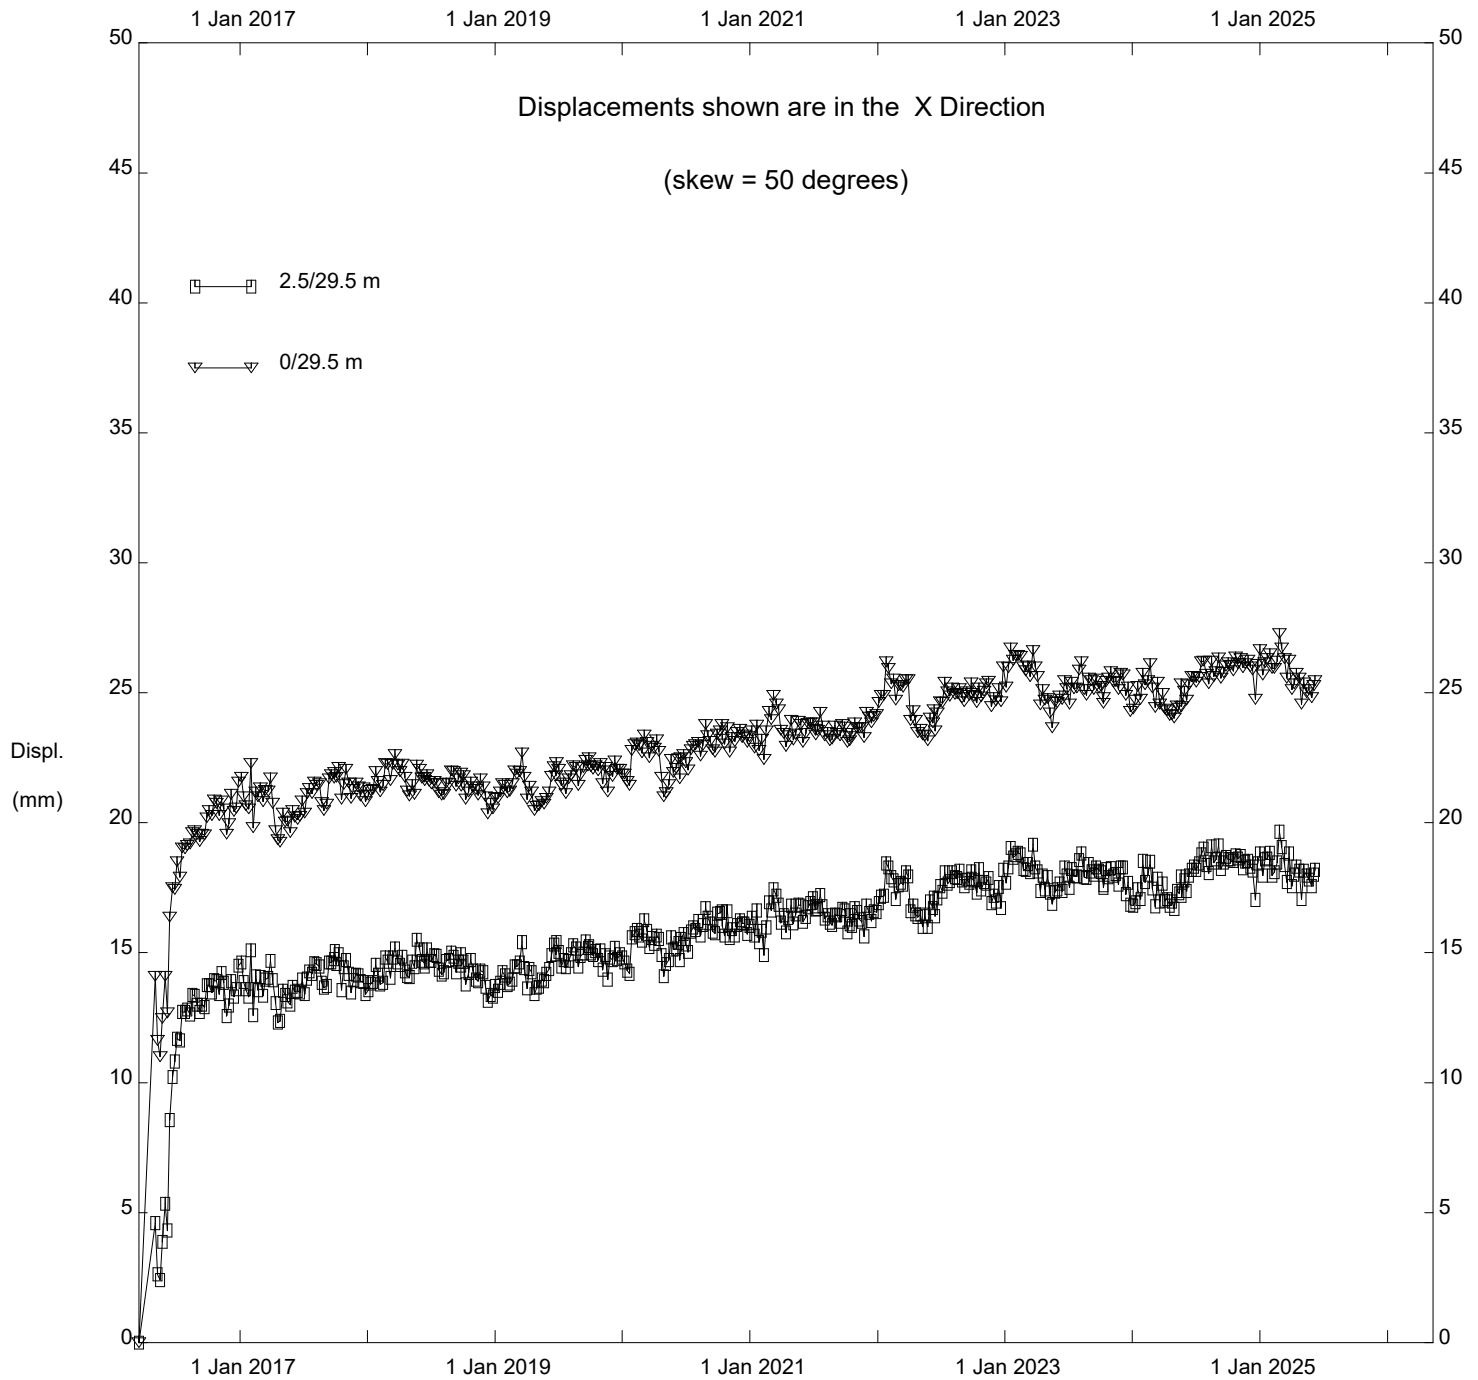
Hwy 986:01 Daishowa West, Inclinometer SAA-P060

Discussion	
Zones of New Movement:	None
Interpretation of Monitoring Results:	<p>Slope Indicators and SAAs</p> <p>SI16-3 is located 7 m downslope of the pile wall and has three movement zones. Rates of movement of 1.8 mm/yr over 0.1 m to 3.8 m depth, less than 0.1 mm/yr over 9.3 m to 11.1 m depth, and no discernible movement over 14.1 m to 16.0 m depth, were measured since the fall of 2024 readings. These movement rates are reduced from, or consistent with those observed over the past 3 years.</p> <p>SAA-P060 showed no discernible movement over 2.5 m to 29.5 m depth, nor over the full length of the pile and waler since the fall of 2024 readings. SAA-P060 has shown a cumulative pile head deflection of 18.2 mm to date in the downslope direction and a long-term rate of movement of 0.75 mm/yr. SAA-P060 has shown an overall relatively steady rate of movement since the end of construction with a total incremental movement of about 6.2 mm in the downslope direction since completion of construction. Transitory seasonal</p>

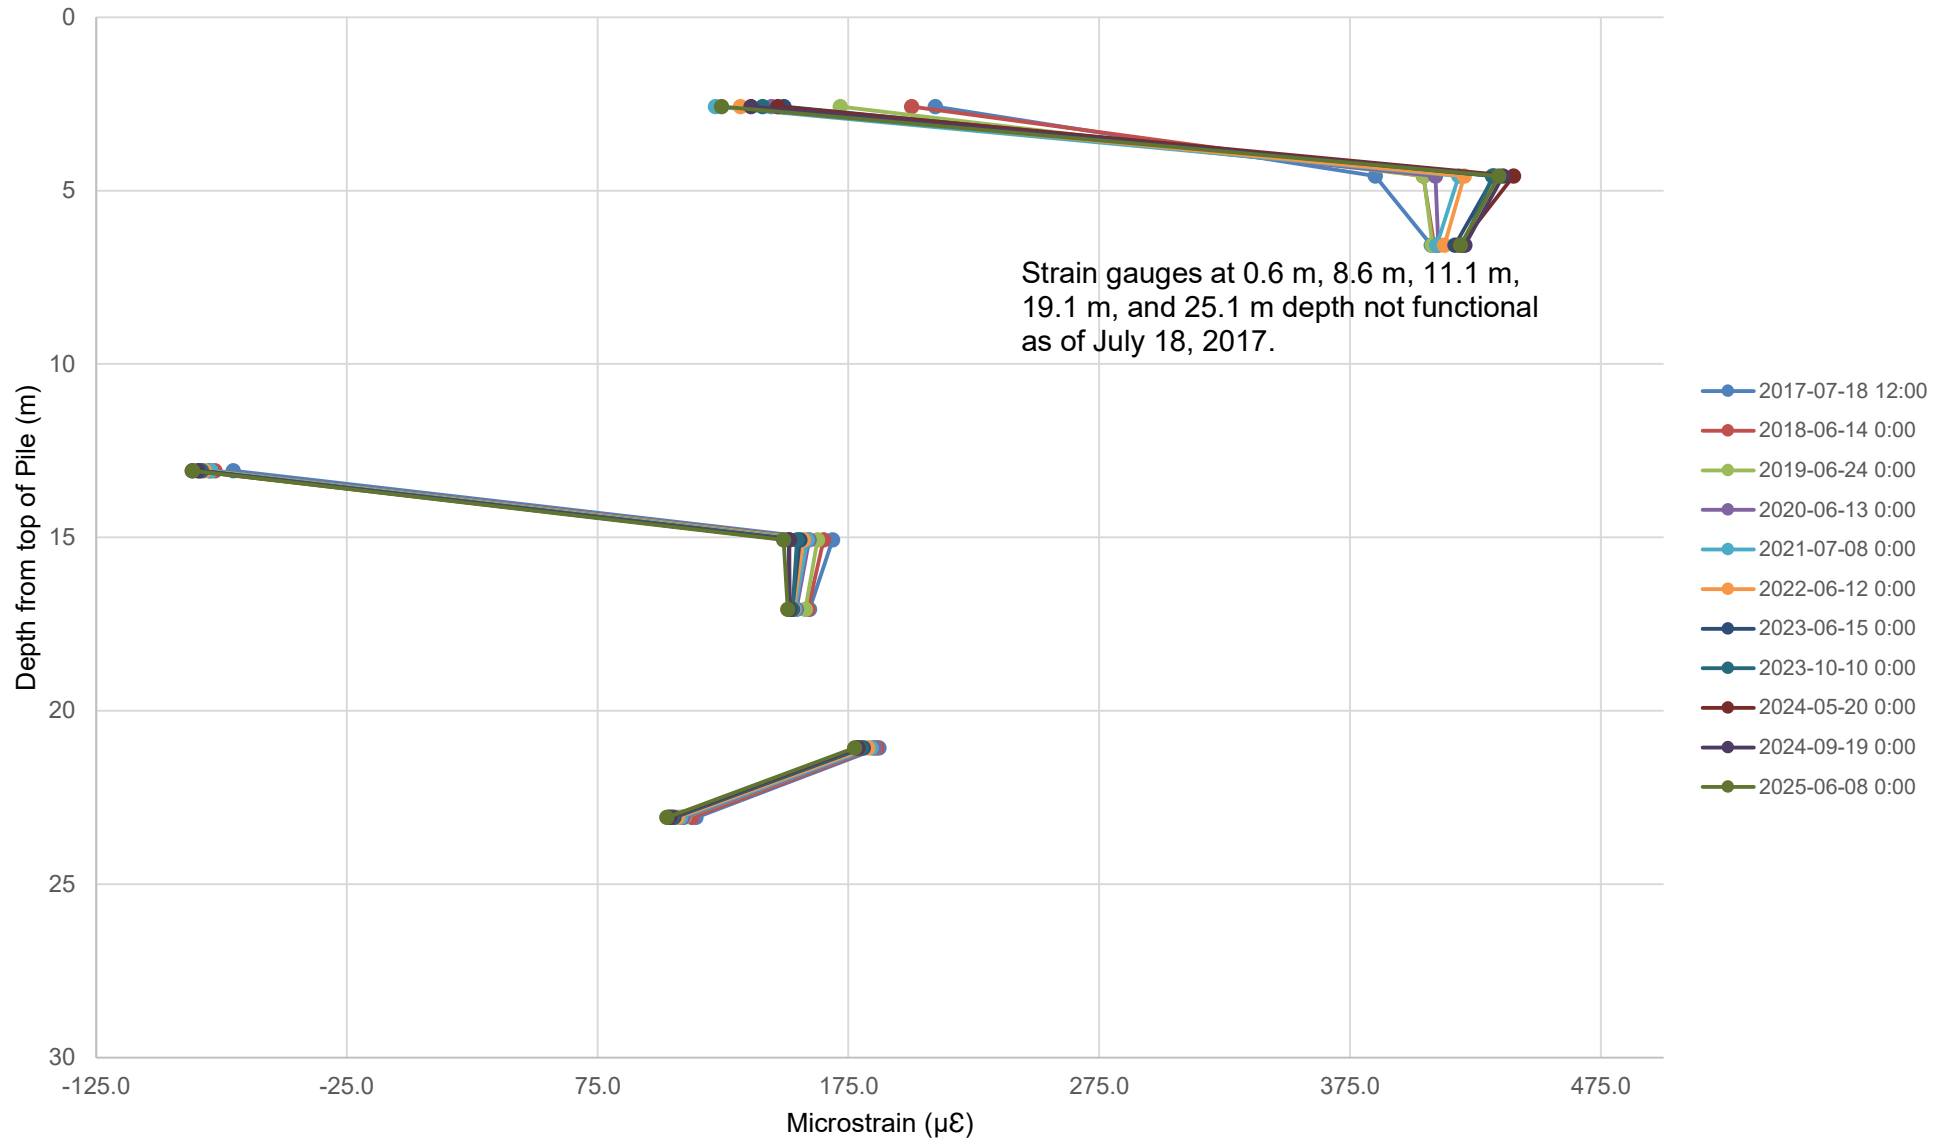
FIGURE PH071-5
LOAD CELL DATA FOR HWY 986:01, DAISHOWA WEST (PILE P022)

Instrumentation Repairs:	No instrument repairs are required at this time.
Additional Comments:	Load cells VC1924 (anchor P022A) and VC1923 (anchor P022B) have not shown a clear trend of leveling off and projected loads are up to 50 kN above the design load level. With respect to these observations, a review of the current anchor load distribution could be undertaken to better assess the pile wall performance.
