November 26, 2025

Alberta Transportation and Economic Corridors  
2<sup>nd</sup> Floor, 803 Manning Road N.E.  
Calgary, Alberta  
T2E 7M8

**CON0022161 Southern Region GRMP Instrumentation Monitoring**  
**Site S004; H02:08, km 6.284 Willow Creek**  
**Section C – 2025 Fall Readings**

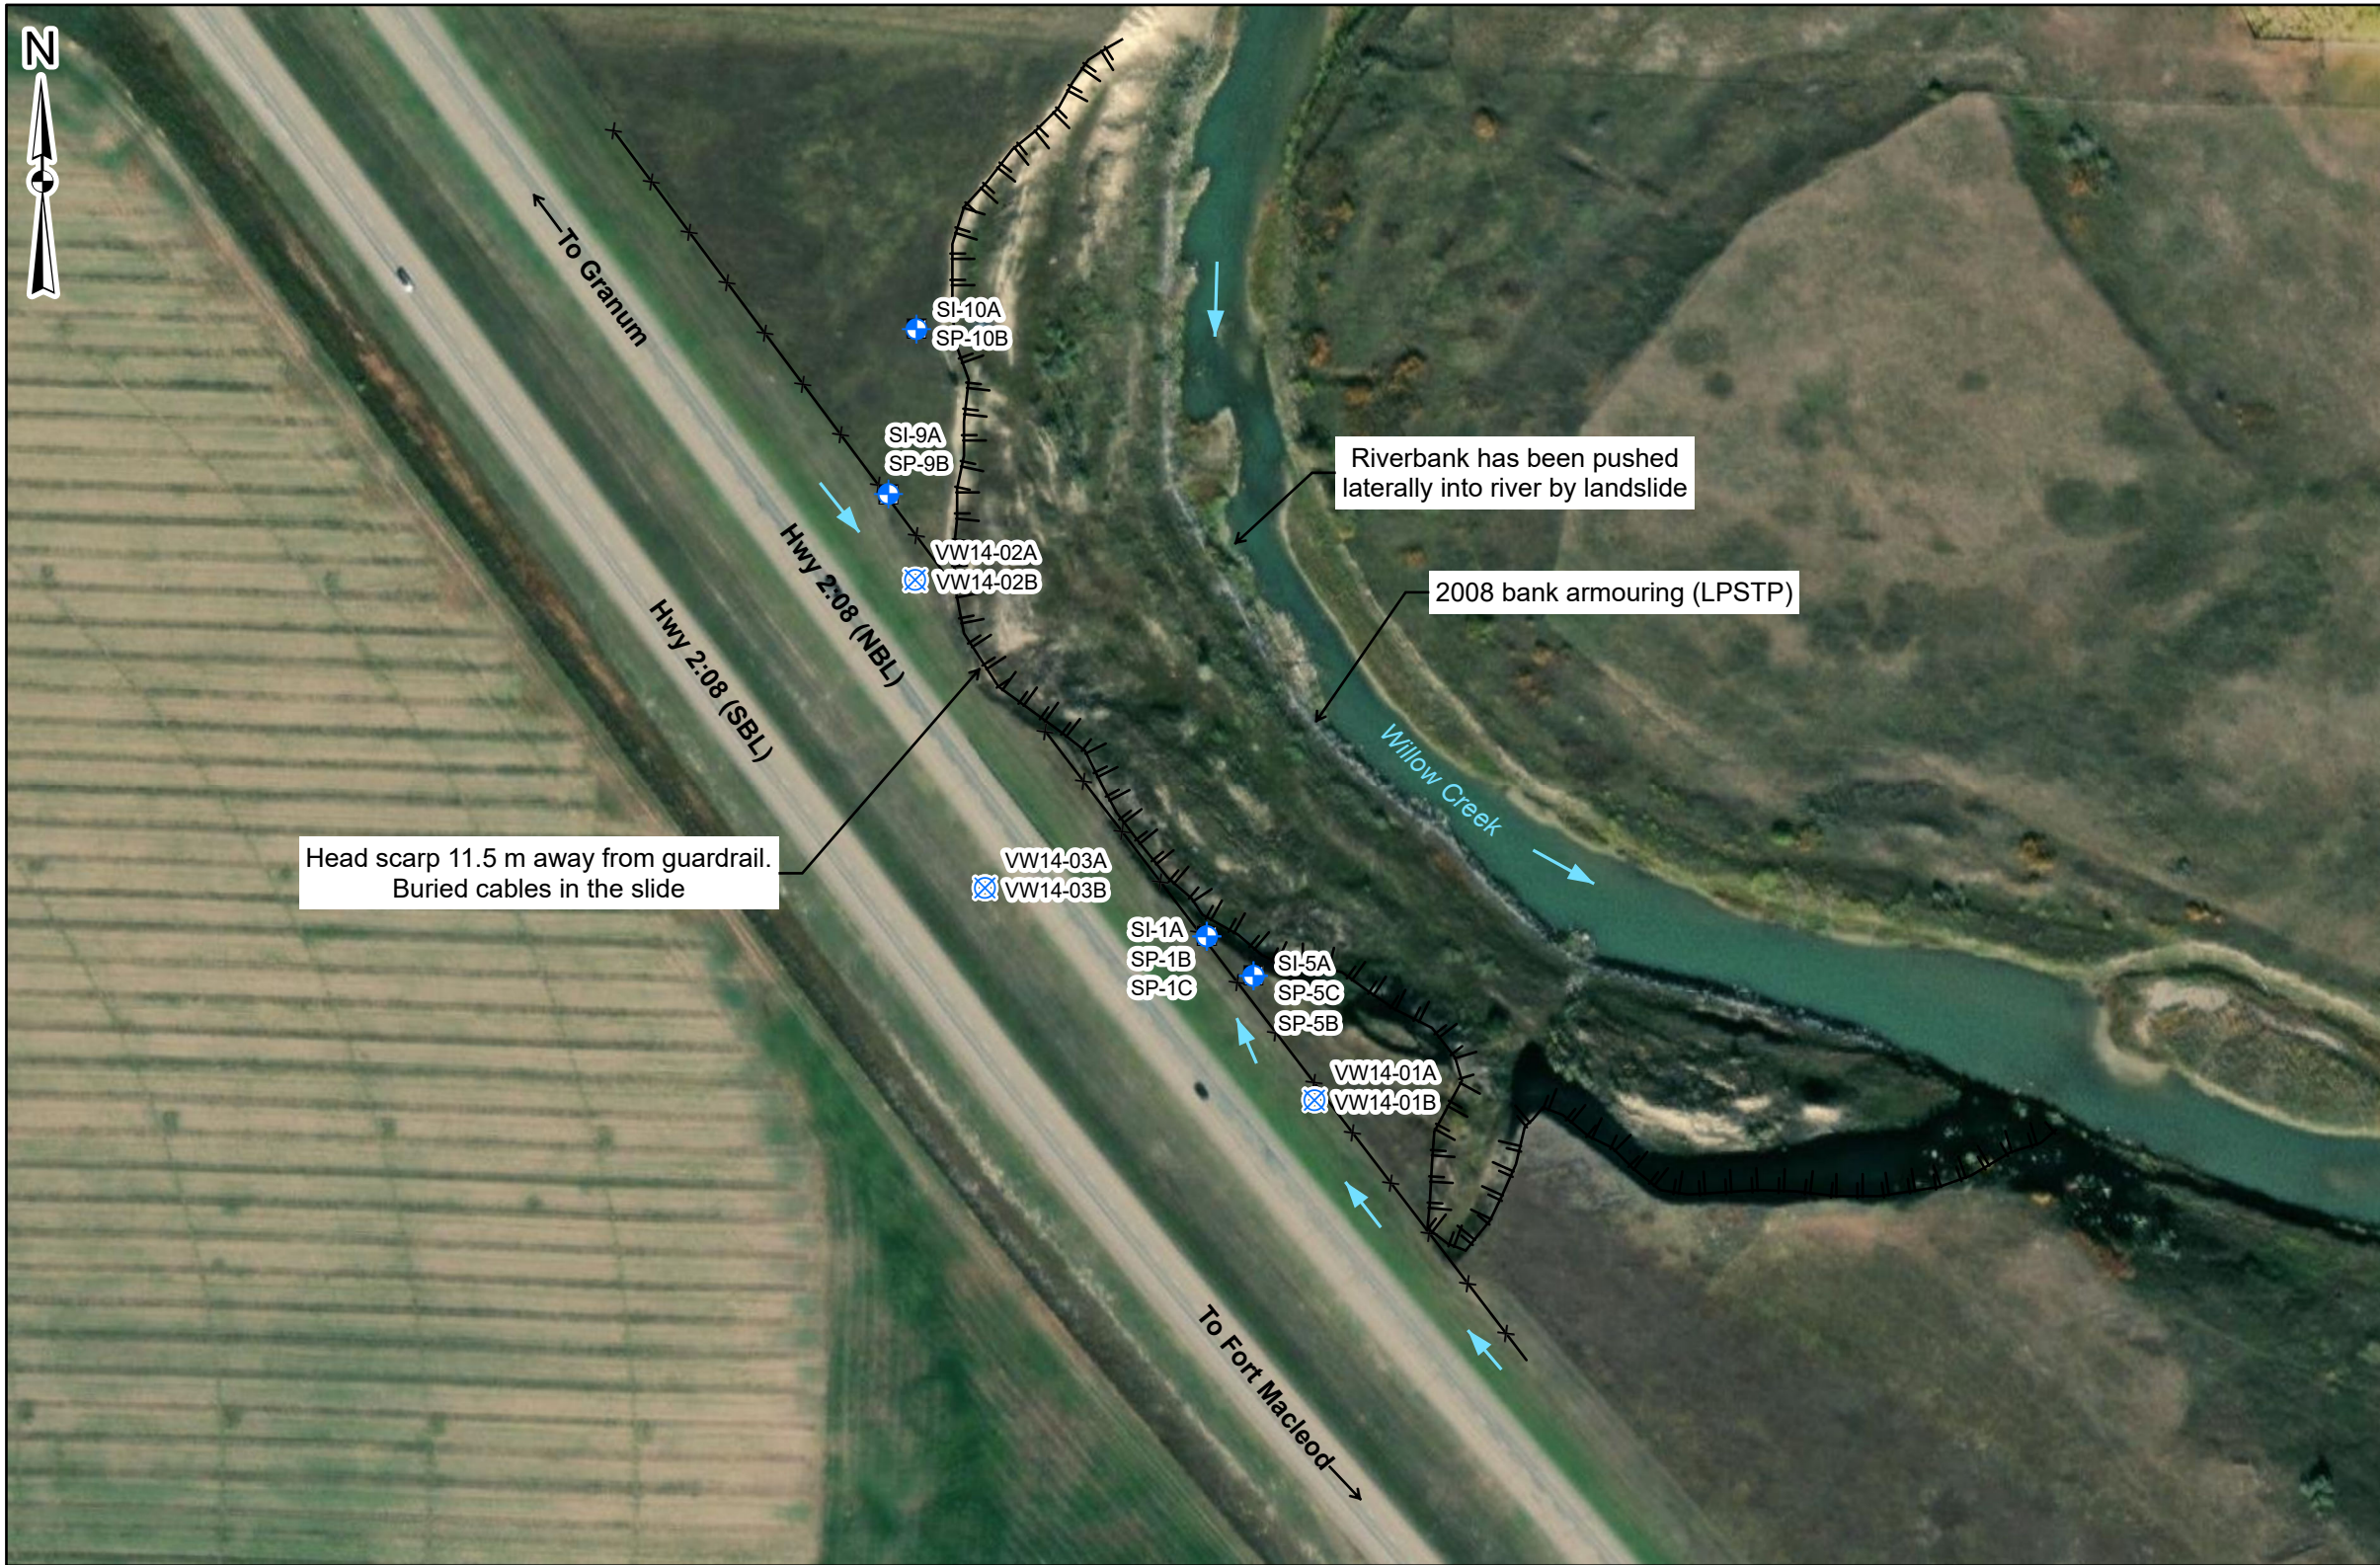
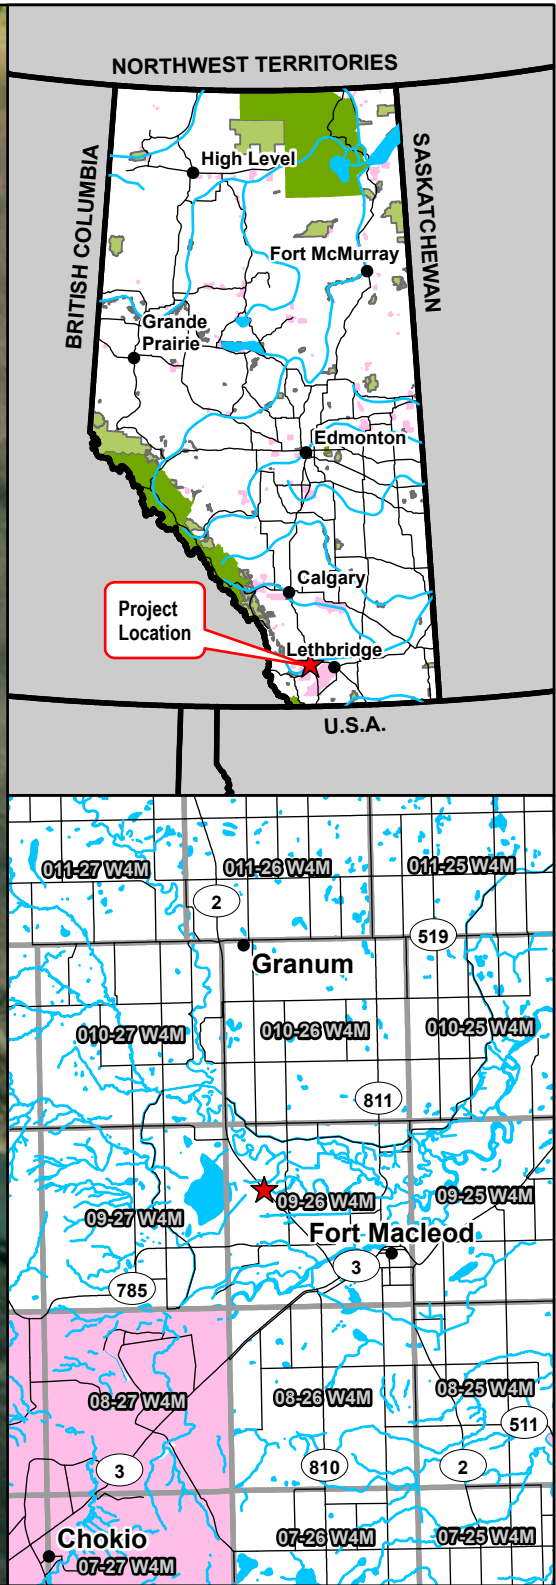
PROJECT	SOUTHERN REGION GEOHAZARD RISK MANAGEMENT PROGRAM		
TITLE	Site Plan S004 - Willow Creek (North of Ft. Macleod) Hwy 2:08, km 6.284		
SCALE	1:2,000	PROJECT No.	A05116A03
FIG No.	1

Six vibrating wire piezometers (VWPs) (VW14-01A/B, VW14-02A/B, and VW14-03A/B), six standpipe piezometers (SPs) (SP-1B/C, SP-5B/C, SP-9B, and SP-10B) and four slope inclinometers (SIs) (SI-1A, SI-5A, SI-9A, and SI-10A) were read on October 9, 2025, by Mr. Shawn Keegan, E.I.T. of KCB. These instruments were read as part of the Southern Region Geohazard Risk Management Program (GRMP). The site is located at Hwy 02:08 km 6.284, north of Fort Macleod, Alberta, approximately 1.9 km north of the junction of RR 264 and Hwy 2. The approximate site coordinates are 5514351 N, 320169 E (UTM Zone 12, NAD 83). A site plan is presented in Figure 1.

The geohazard at the S004 site consists of a landslide at the outside bend of Willow Creek with the slope crest retrogressing into the northbound lane ditch of Hwy 02:08. Previous remedial actions at the site include soil nailing, grading, bioengineering (live staking), and bank armouring in 2008. A guardrail was also installed in 2014.

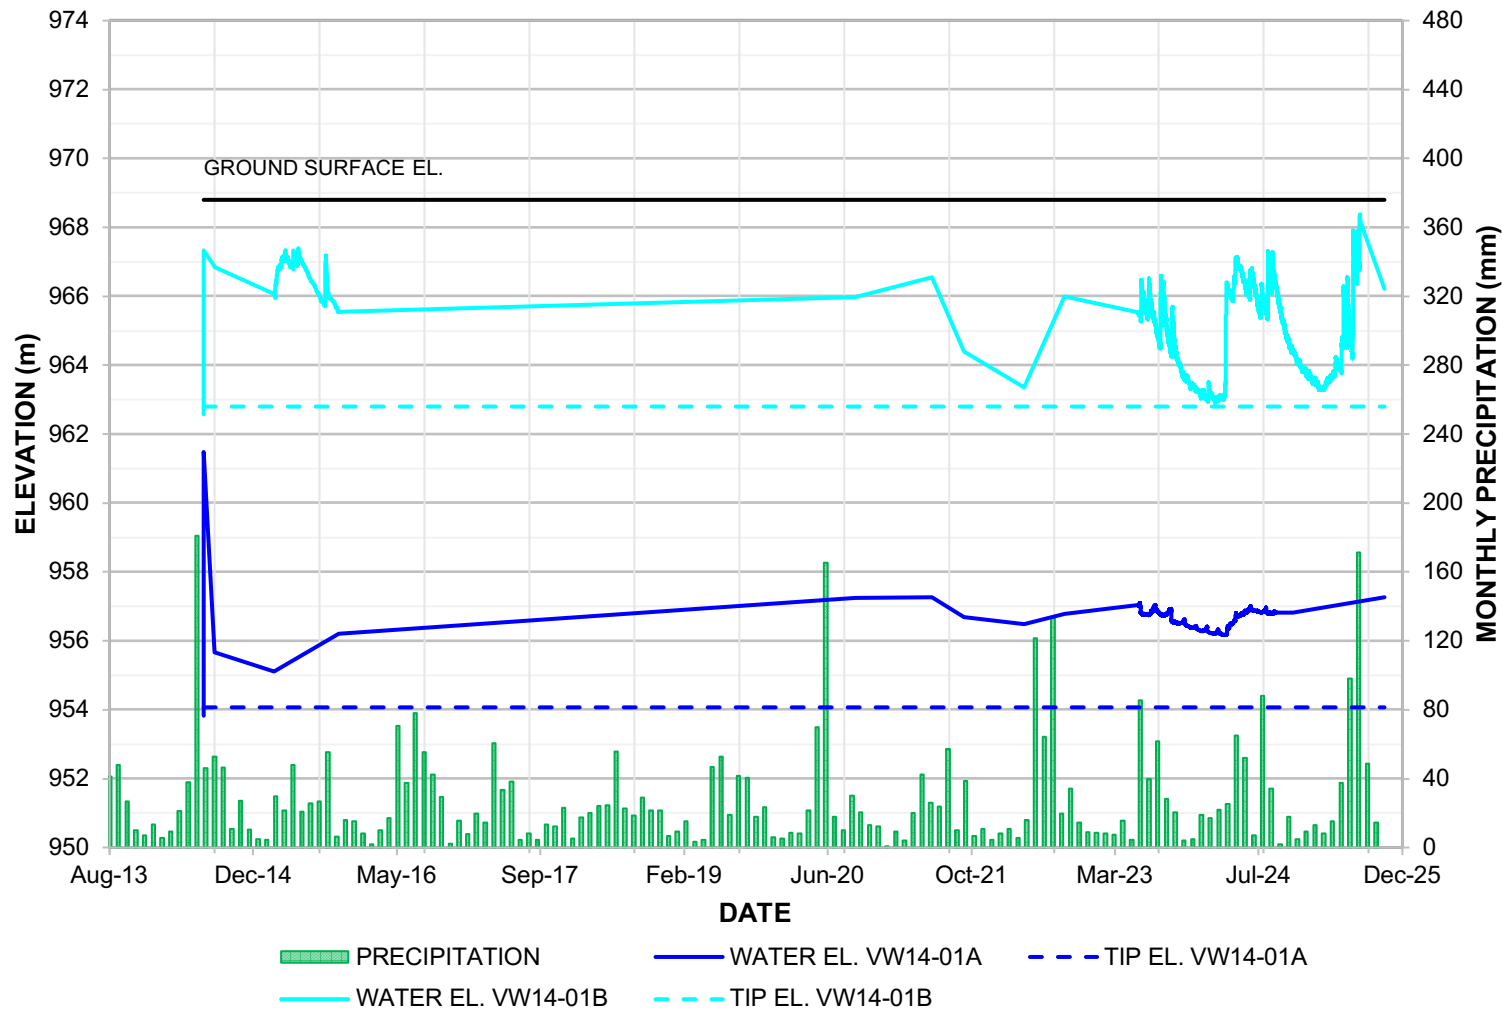
## VW14-01A AND VW14-01B

Based on the VWP data logged to date, there is no clear correlation between irrigation activity and water levels. Future data will help to corroborate trends and seasonal changes in water levels, which may influence slope stability. It is also important to note that the VWP's are located outside the slide mass, possibly indicating higher groundwater levels than within the slide itself.

The dataloggers VW14-01 and VW14-03 have a flash-mount installation and exhibit signs of internal water damage that impacted the battery. Battery problems at BH14-01A have disrupted data collection from fall 2024 to spring 2025. Similarly, at BH14-03, readings have been missing since fall 2024 due to a datalogger battery issue. The batteries for VW14-01 and VW14-03, which were replaced during spring 2025, were found dead in fall 2025. Another battery replacement was performed during the fall 2025 readings, and the daily reading was taken. The loggers have been placed in a new, sealed bag to ensure waterproof protection. If the water problem with the dataloggers persists, we recommend installing them above ground using an anchored post.
