SITE NUMBER AND NAME: S048 Castle Back Slope Failures	HIGHWAY & KM: 3:04, 23.708	PREVIOUS INSPECTION DATE: May 8, 2023	INSPECTION DATE: May 28, 2025
LEGAL DESCRIPTION: 15/06-12-007-01 W5M	NAD 83 COORDINATES: UTM Northing Easting 11 5492157 715695	RISK ASSESSMENT: PF: 9 CF: 2 TOTAL: 18	
AVERAGE ANNUAL DAILY TRAFFIC (AADT): 4,100 (west), 4,340 (east), (Ref. No. 78050)		CONTRACTOR MAINTENANCE AREA (CMA): 522

SOUTHERN REGION GEOHAZARD RISK MANAGEMENT PROGRAM

Site Plan
S048 - Castle Back Slope Failures
Hwy 3:04, km 23.708

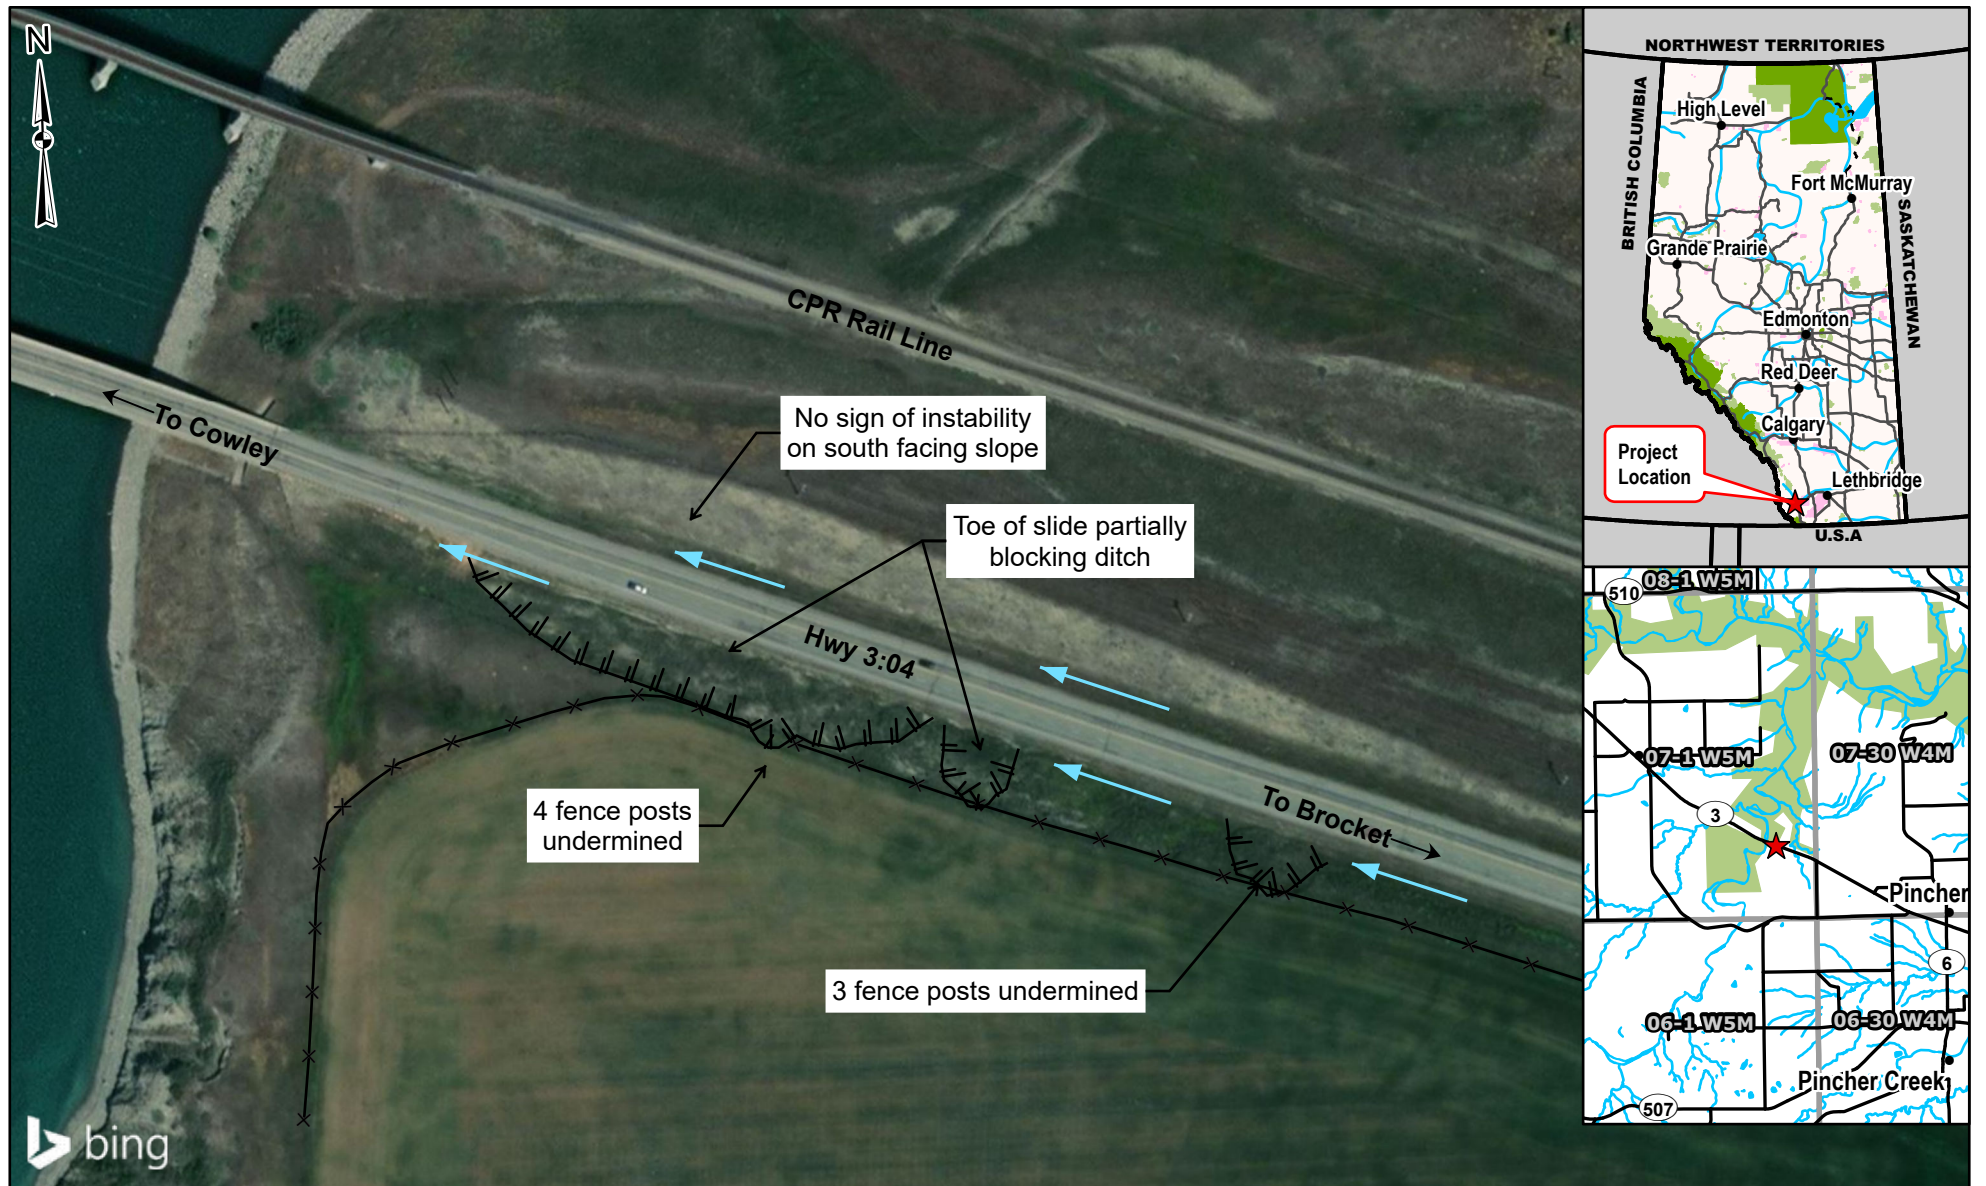
PRIMARY SITE ISSUE: Multiple slope instabilities on the south (eastbound) highway back slope, which are believed to be partially attributed to a high groundwater table from precipitation and ground infiltration. Head scarps are encroaching on private land and impacting the private fence. The head scarps are merging into one larger slide. Failed material is partially blocking the south (eastbound) ditch.
APPROXIMATE DIMENSIONS: The slope failures are along an approximate 200 m length of the highway's backslope. The backslope is between 6 m and 10 m high and slopes at approximately 3H:1V.
DATE OF ANY REMEDIAL ACTION: A high-tension cable barrier (HTCB) was installed along the edge of the south (eastbound) lane between the 2023 and 2025 inspections.

- The south (eastbound) highway back slope (north facing) is between approximately 6 m to 10 m high (increasing in height along the site from east to west) and sloped at approximately 3H:1V. In general, the instability is observed where the embankment height is greater than approximately 6 m (Photo 1).

- Failed material is partially blocking the south (eastbound) ditch and is impacting the ditch's flow capacity (Photos 2 to 3). There was no significant change between the 2023 and 2025 inspections.

- Groundwater from the prairie lands south of the site can drain towards the southside backslope of the highway and therefore, drive the movement. Conversely, the north lands appear to be draining away from the backslope on the north of the site, so groundwater effects may not be as adverse. Furthermore, since the south backslope is north facing, there is less direct sunlight, which decreases evapotranspiration from the slope surface. This orientation promotes a longer duration of snow cover in the spring, potentially leading to more infiltration, increasing the groundwater level and reducing the stability of the slope.

- The site should be regularly inspected by the Maintenance Contract Inspector (MCI).
- The site should be inspected every year as part of the Southern Region GRMP Section B inspections.
- Drainage for the south (eastbound) ditch should be improved by removing failed material partially blocking the ditch. Removed material should be kept to a minimum to re-establish flow capacity in the ditch without further destabilizing the slope.

south slope and conduct a hydrogeological analysis to assess the impact of the groundwater and evaluate potential repair options, including drainage improvement.
