July 10, 2024

CON0022161 Southern Region GRMP Instrumentation Monitoring
Site S002; H22:14, km 12.95 Priddis
Section C – 2024 Spring Readings

Site Plan
S002 - Priddis
Hwy 22:14, km 12.95

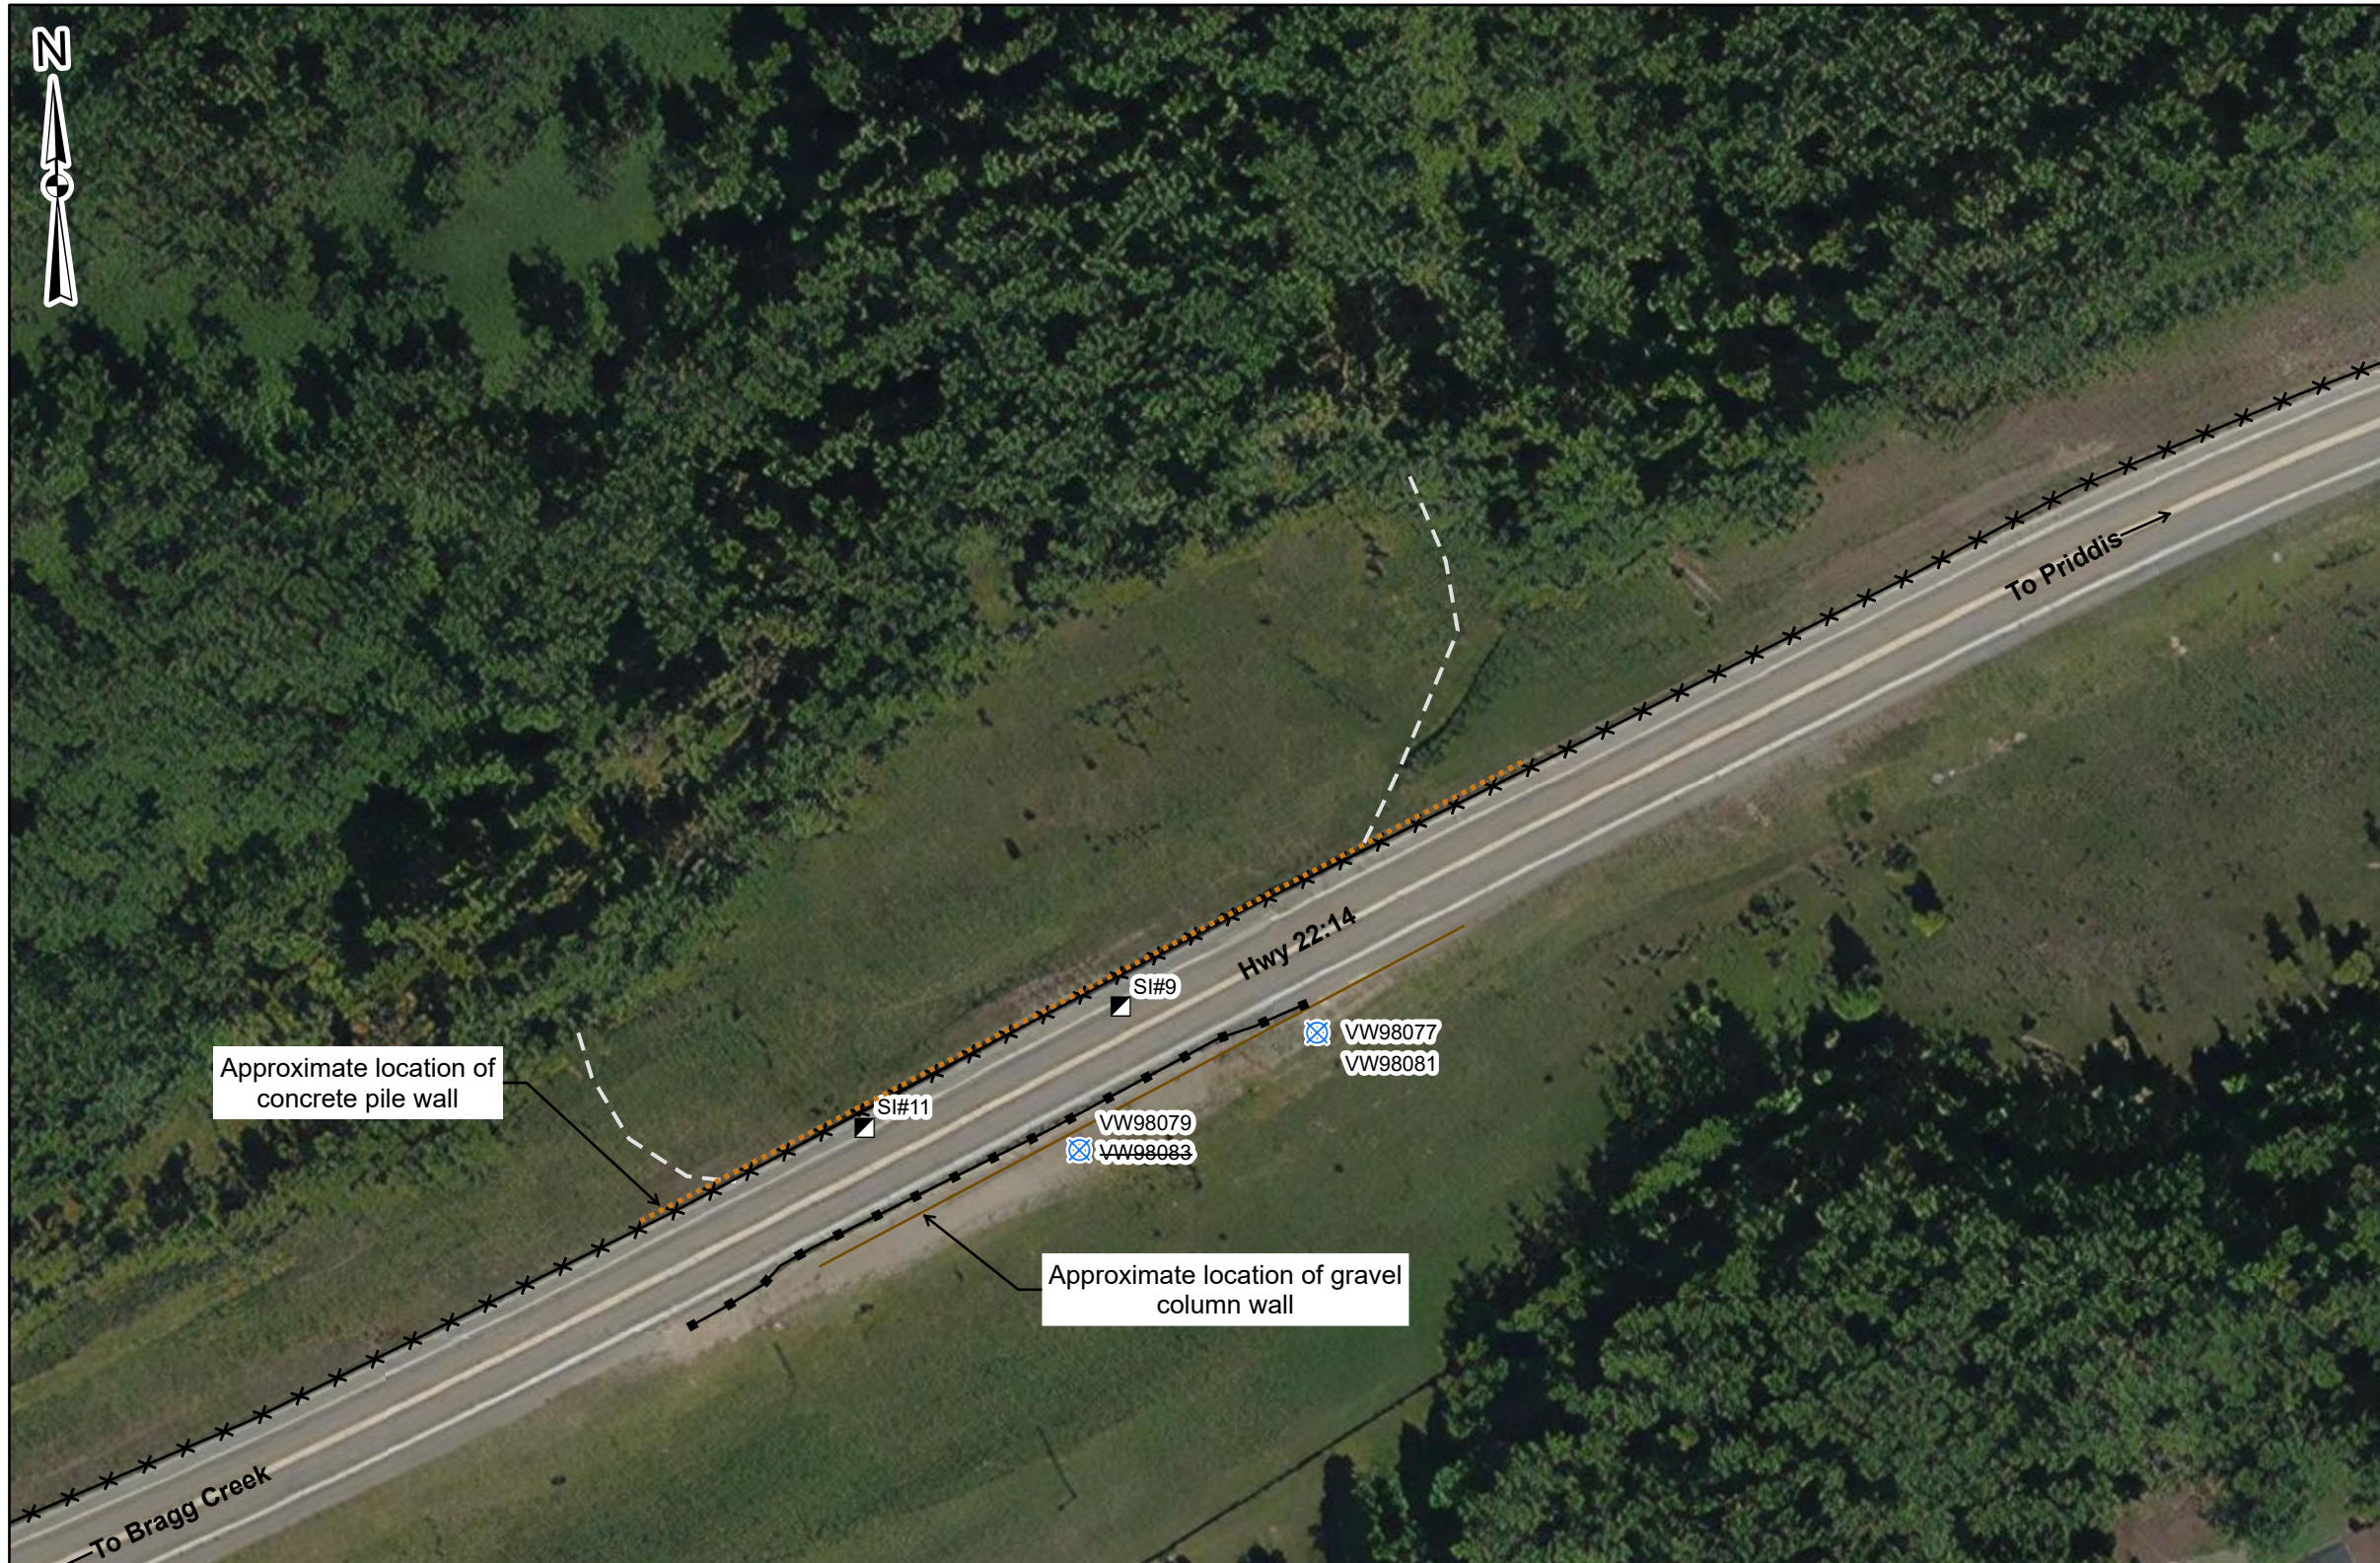
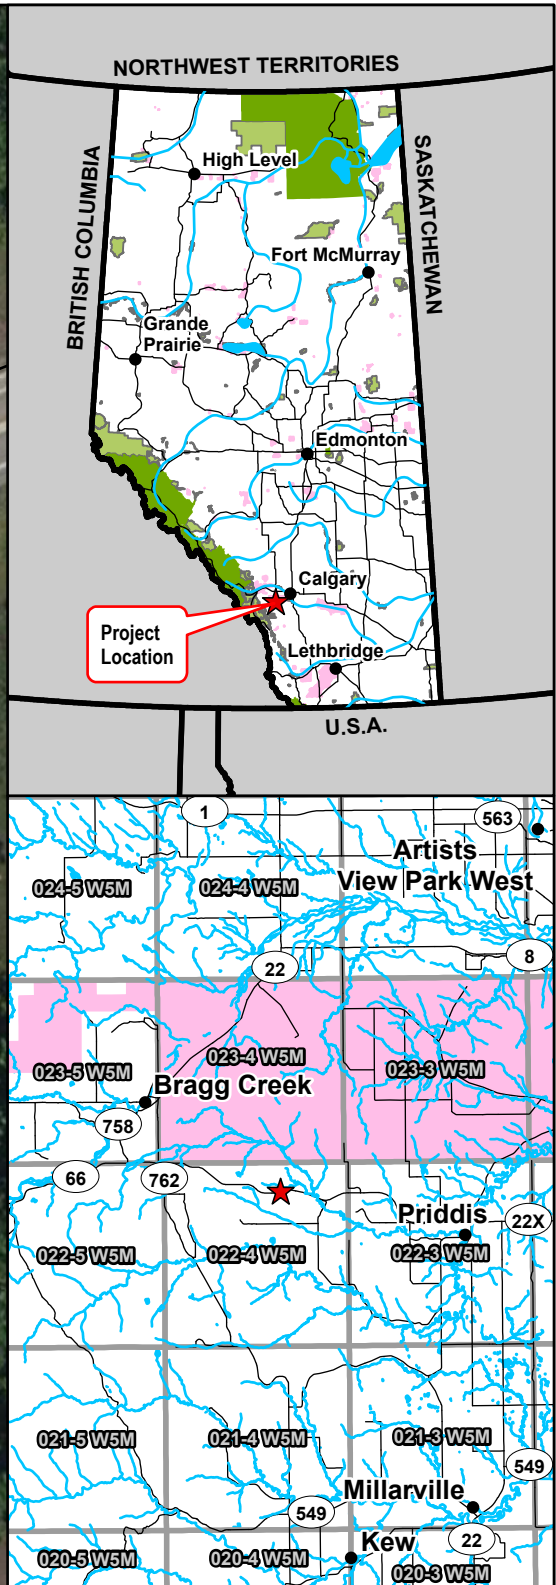
FIG No. 1

The geohazard at the S002 site consists of a slope failure on the north side of the highway, which is impacting the westbound lane and north shoulder. Previous remedial actions at this site include installing a concrete pile wall in 1992, along the north shoulder (westbound lane) of Hwy 22:14 in an effort to stabilize the highway. Additionally, a row of gravel columns was installed on the upslope (south) side of the highway. Pumps were installed in two of the columns with water level activated switches (operable, but turned off during the winter months). Regular pavement patching has also been completed at the site.
