November 26, 2025

Alberta Transportation and Economic Corridors  
2<sup>nd</sup> Floor, 803 Manning Road N.E.  
Calgary, Alberta  
T2E 7M8

**CON0022161 Southern Region GRMP Instrumentation Monitoring**  
**Site S003; H22:16 km 9.9 Cochrane**  
**Section C – 2025 Fall Readings**

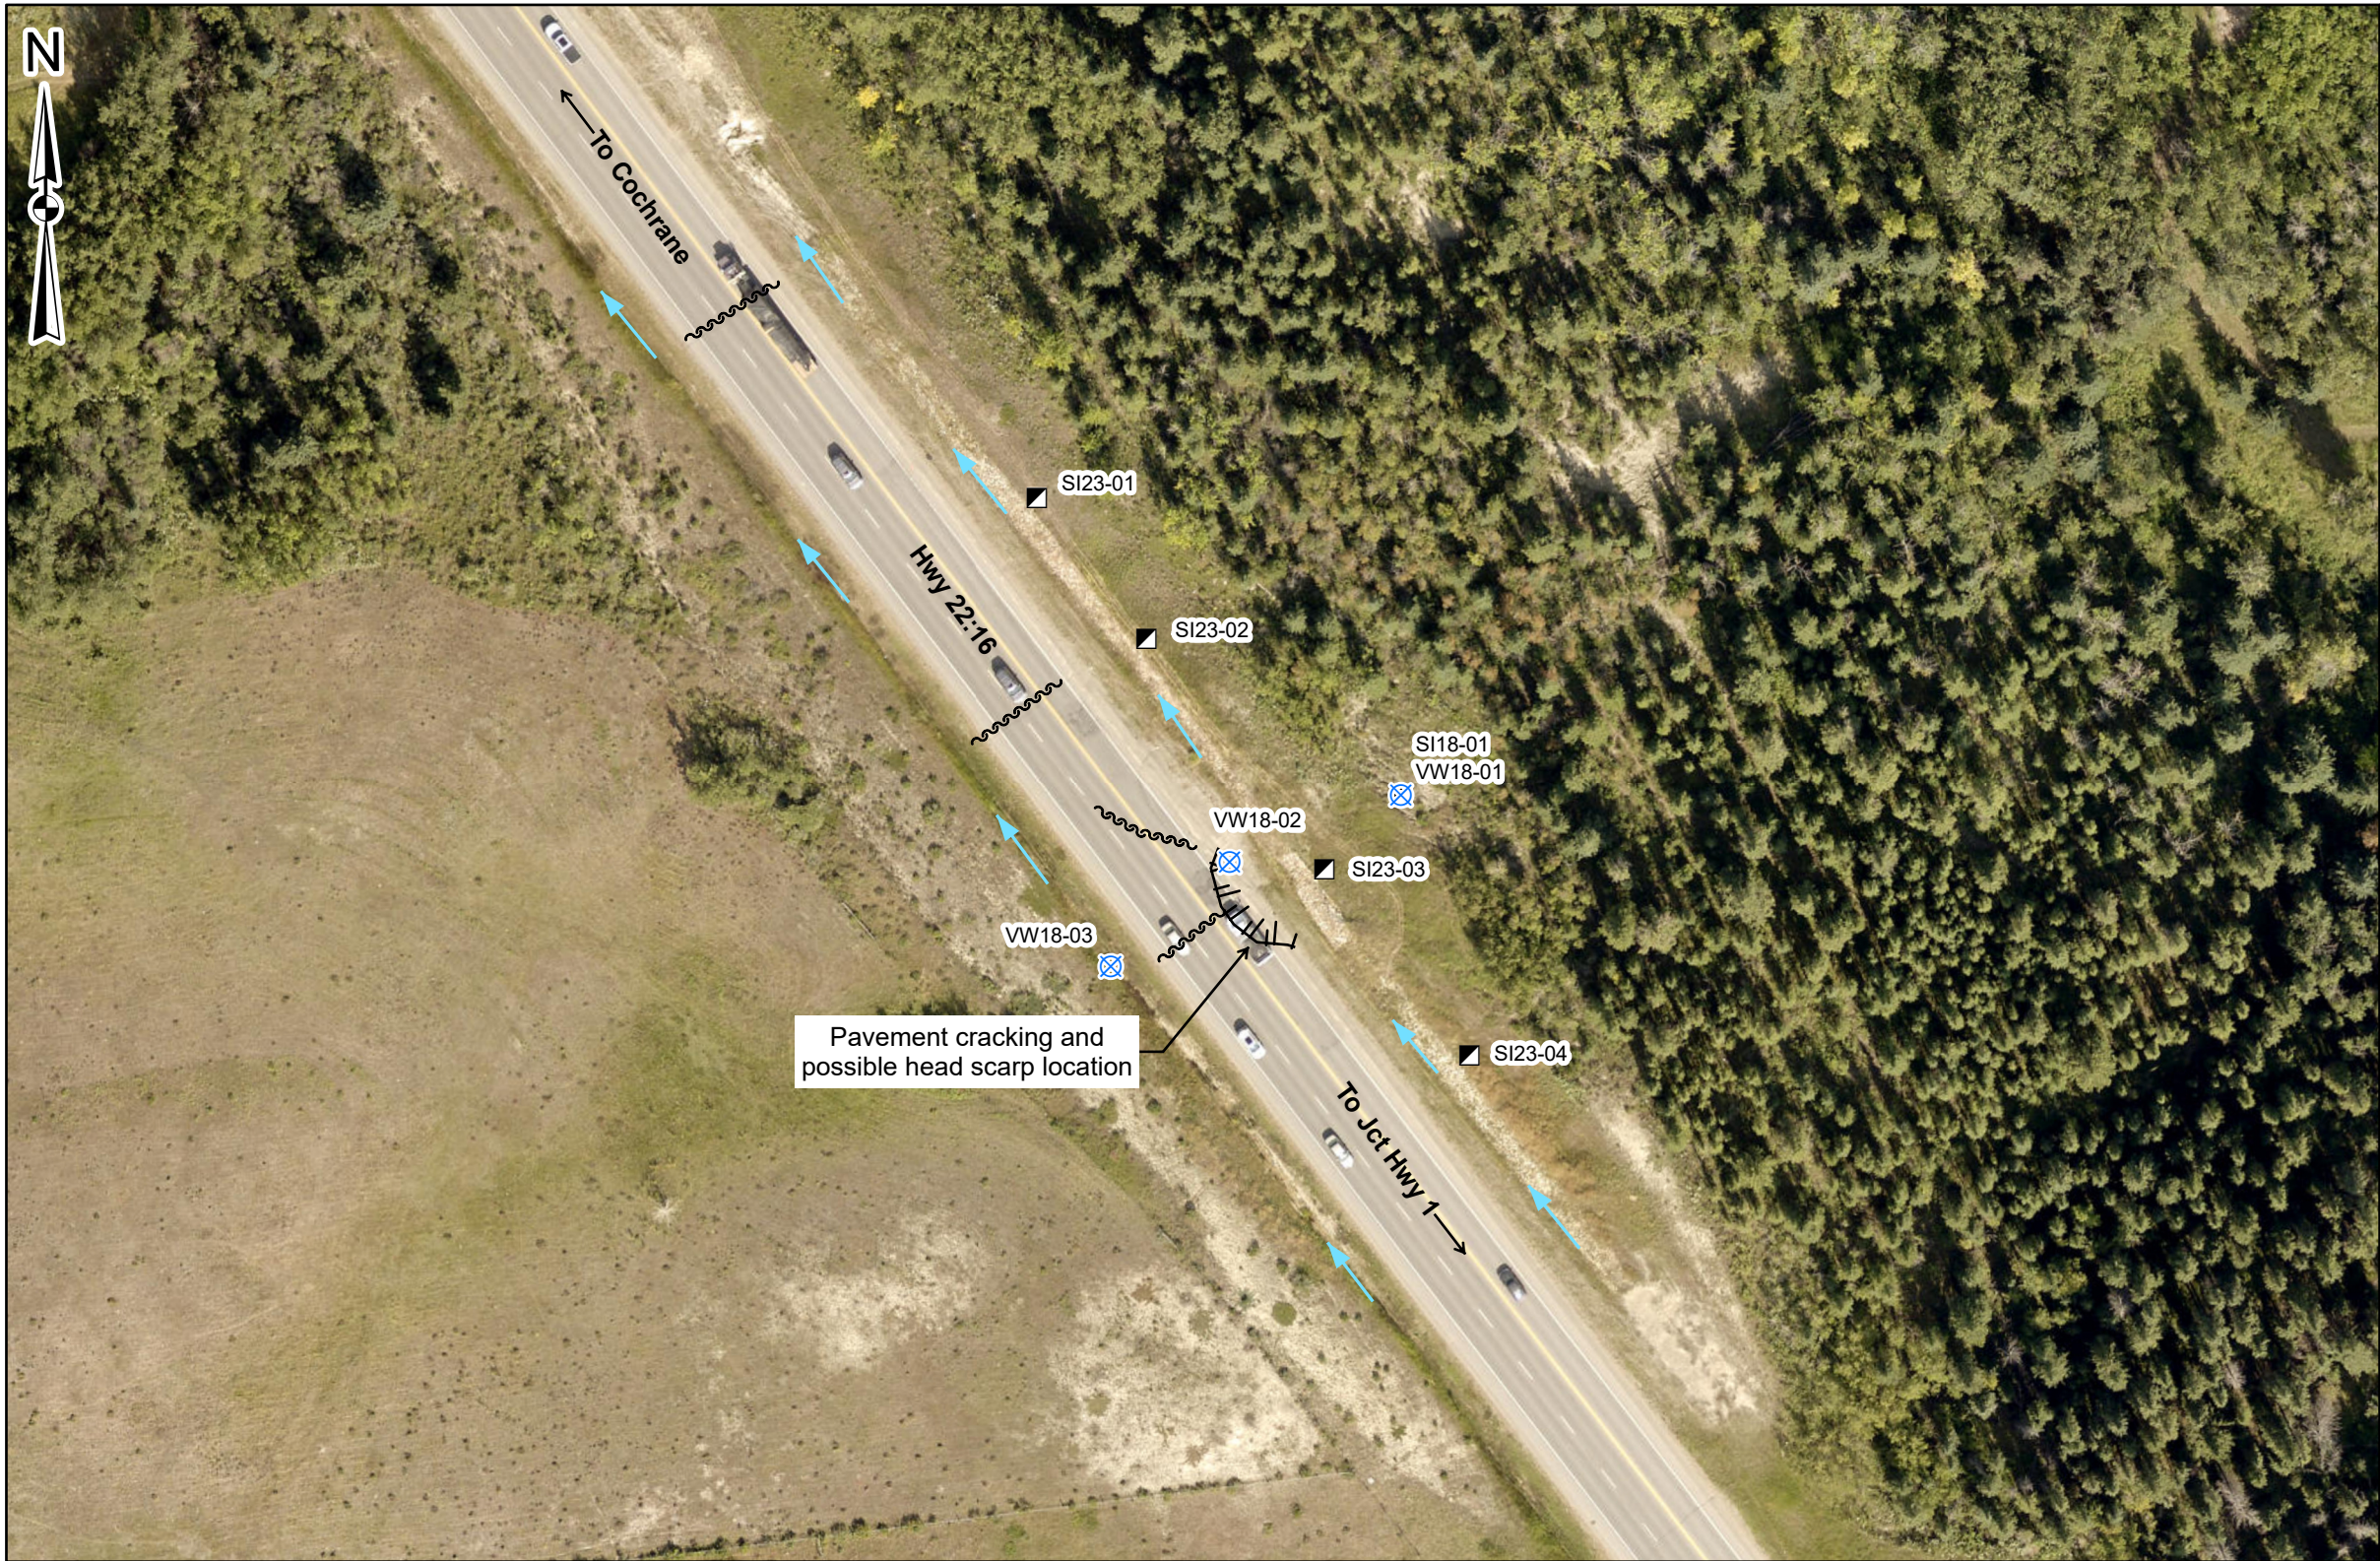
PROJECT SOUTHERN REGION GEOHAZARD RISK MANAGEMENT PROGRAM		
TITLE Site Plan S003 - Cochrane Hwy 22:16, km 9.875		
SCALE 1:1,000	PROJECT No. A05116A03	FIG No. 1

The geohazard at the S003 site consists of a landslide along the south slope of the Bow River valley. The landslide encroaches approximately 3 m into the northbound lane of Hwy 22:16. Previous remedial actions at this site included the construction of a ditch berm (date unknown) in the northeast (northbound lane) ditch to reduce surface water runoff from discharging onto the landslide. However, in late 2020, the ongoing movement of the slide area had caused the settlement of the ditch berm such that ditch flows were directed onto the slide area. In fall 2023, a pile wall consisting of 133 H-piles, spaced at 0.72 m, center to center, was constructed on the east side of the highway in the slide zone to stabilize the slope. The ditch across the slide area was also repaired to prevent water from flowing out of the ditch onto the slide mass.

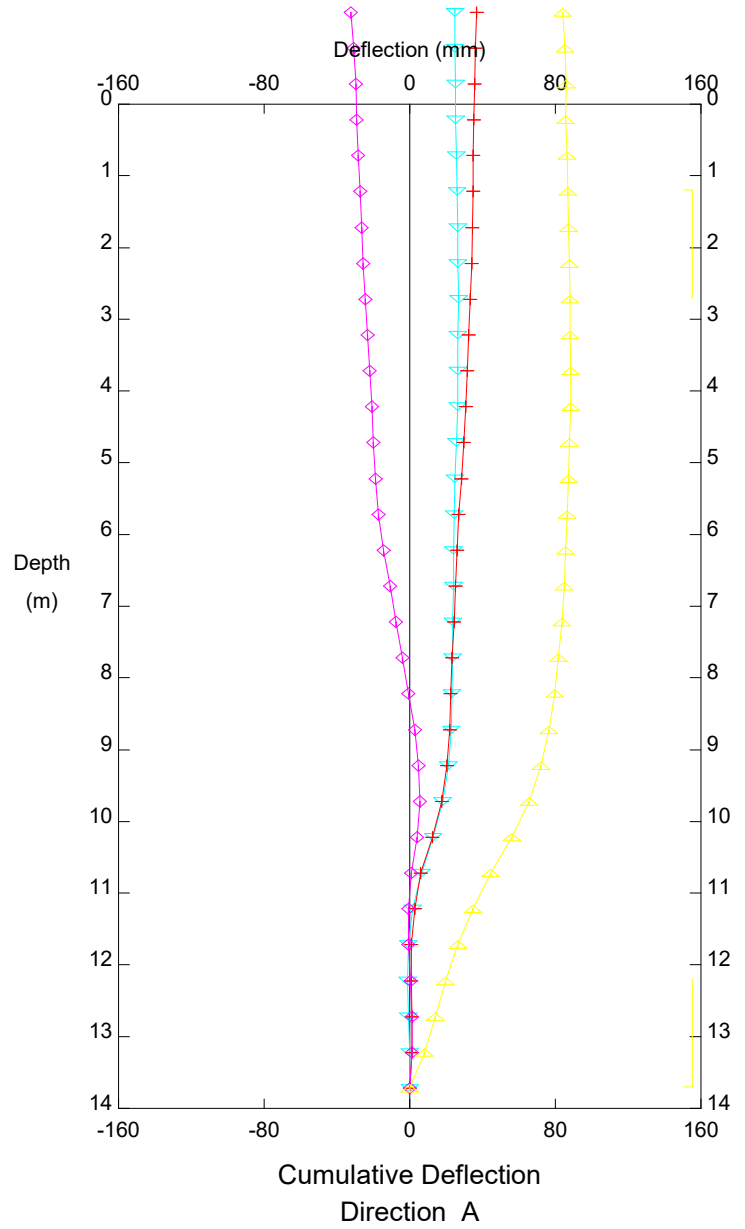
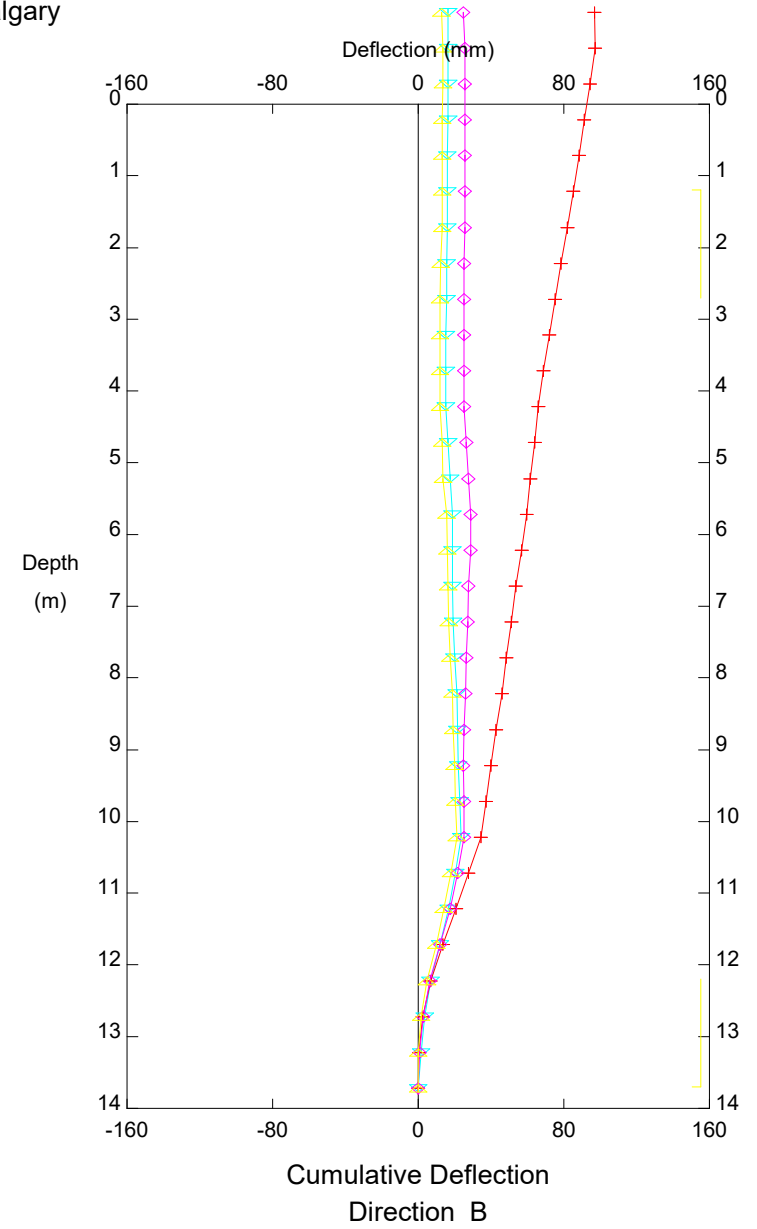
Cochrane, Inclinator 23-04

Voids are observed around the piles of the H-pile wall (Photo 3.1), particularly near the SI23-04 casing, causing the SI casing to be loose in the pile. These voids should be backfilled with a combination of sand and gravel.
