July 15, 2025

**CON0022161 Southern Region GRMP Instrumentation Monitoring**  
**Site S003; H22:16 km 9.9 Cochrane**  
**Section C – 2025 Spring Readings**

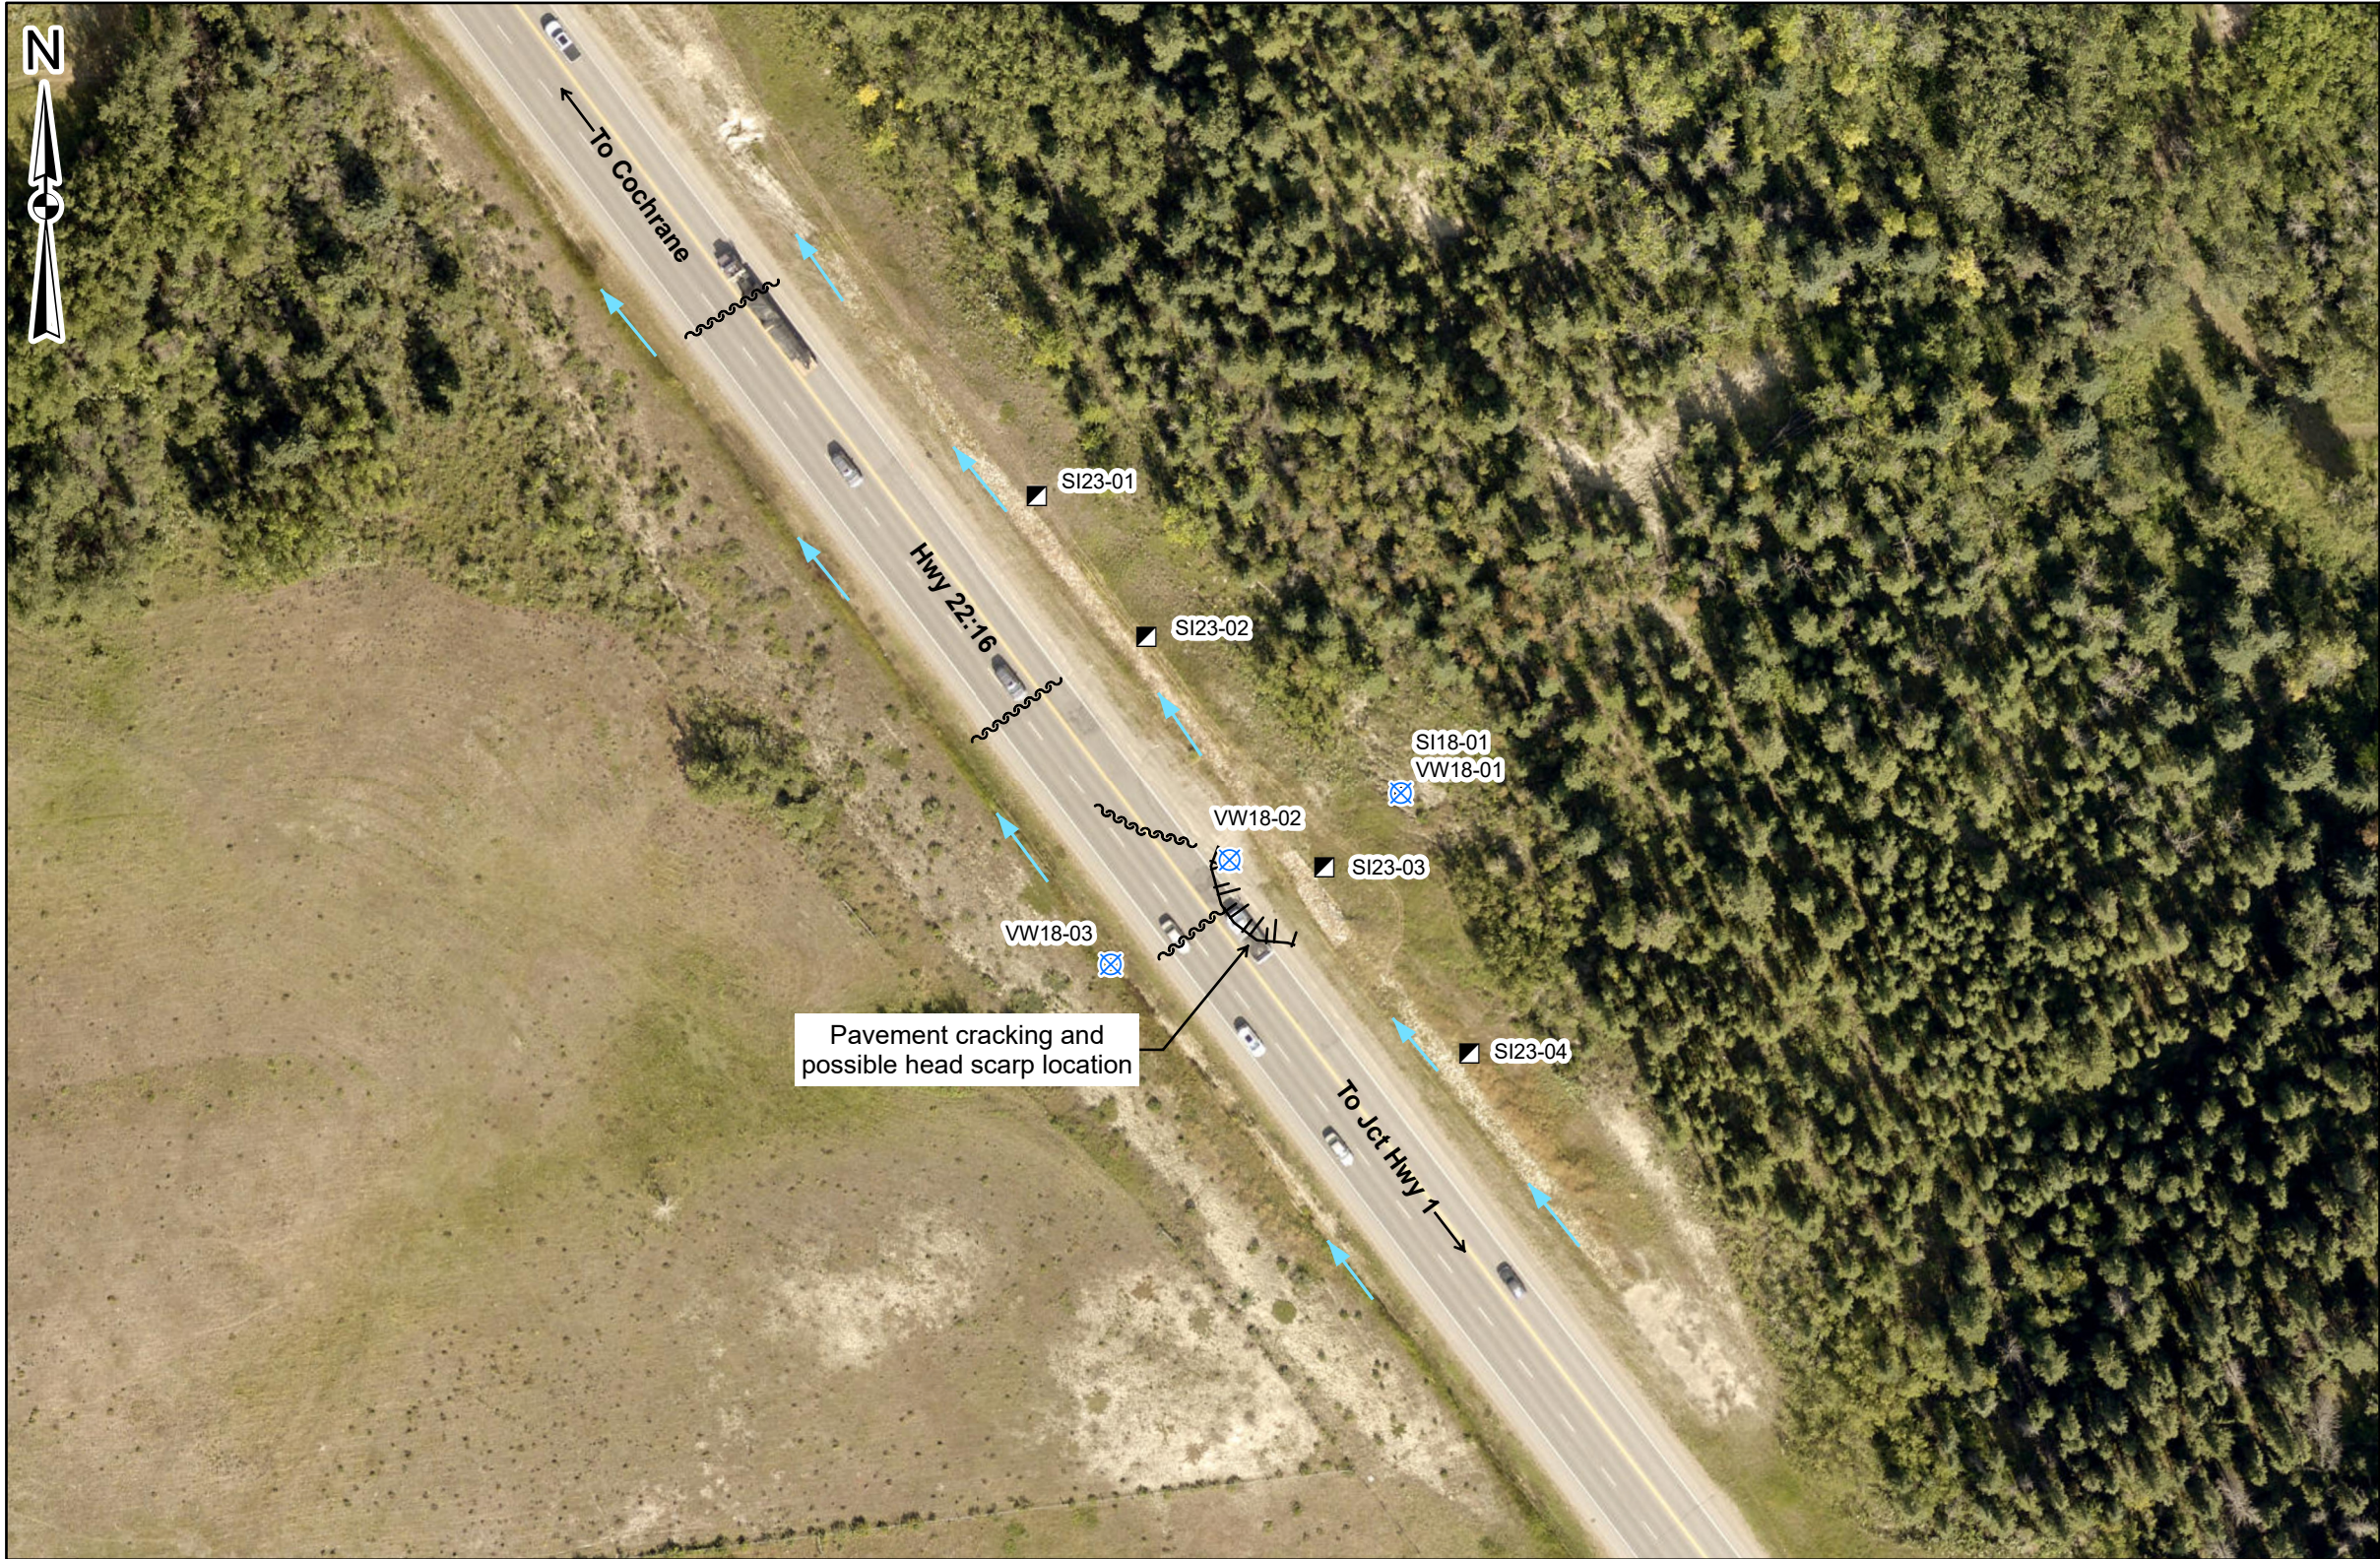
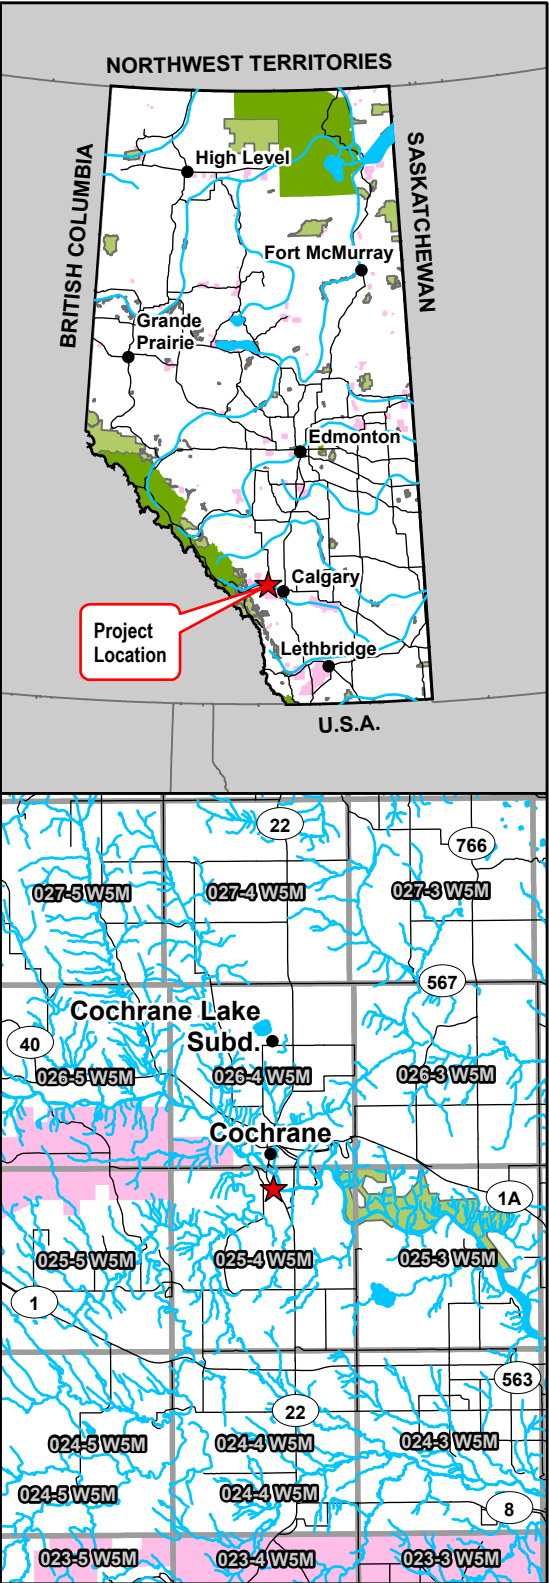
## FIGURE

Five slope inclinometers (SI) (SI18-01, SI23-01, SI23-02, SI23-03, and SI23-04), and two vibrating wire piezometers (VWPs) (VW18-01 and VW18-02) were read at the S003 site in Southern Region on May 20, 2025, by Mr. Bradley Lawson, P.Eng. of Klohn Crippen Berger Ltd. (KCB). VW18-03 was read on July 11, 2025 by Mr. Shawn Keegan, E.I.T. These instruments were read as part of the Southern Region Geohazard Risk Management Program (GRMP). The site is located on Hwy 22:16 km 9.9, south of Cochrane, Alberta, approximately 1 km south of the Bow River bridge. The approximate site coordinates are 5672089 N, 676024 E (UTM Zone 11, NAD 83), and the legal land description for the site is SW 34-25-4-W5. A site plan is presented in Figure 1.
