July 15, 2025

Alberta Transportation and Economic Corridors
2nd Floor, 803 Manning Road N.E.
Calgary, Alberta
T2E 7M8

CON0022161 Southern Region GRMP Instrumentation Monitoring
Site S026; H41:03, km 35.169 Elkwater Slides
Section C – 2025 Spring Readings

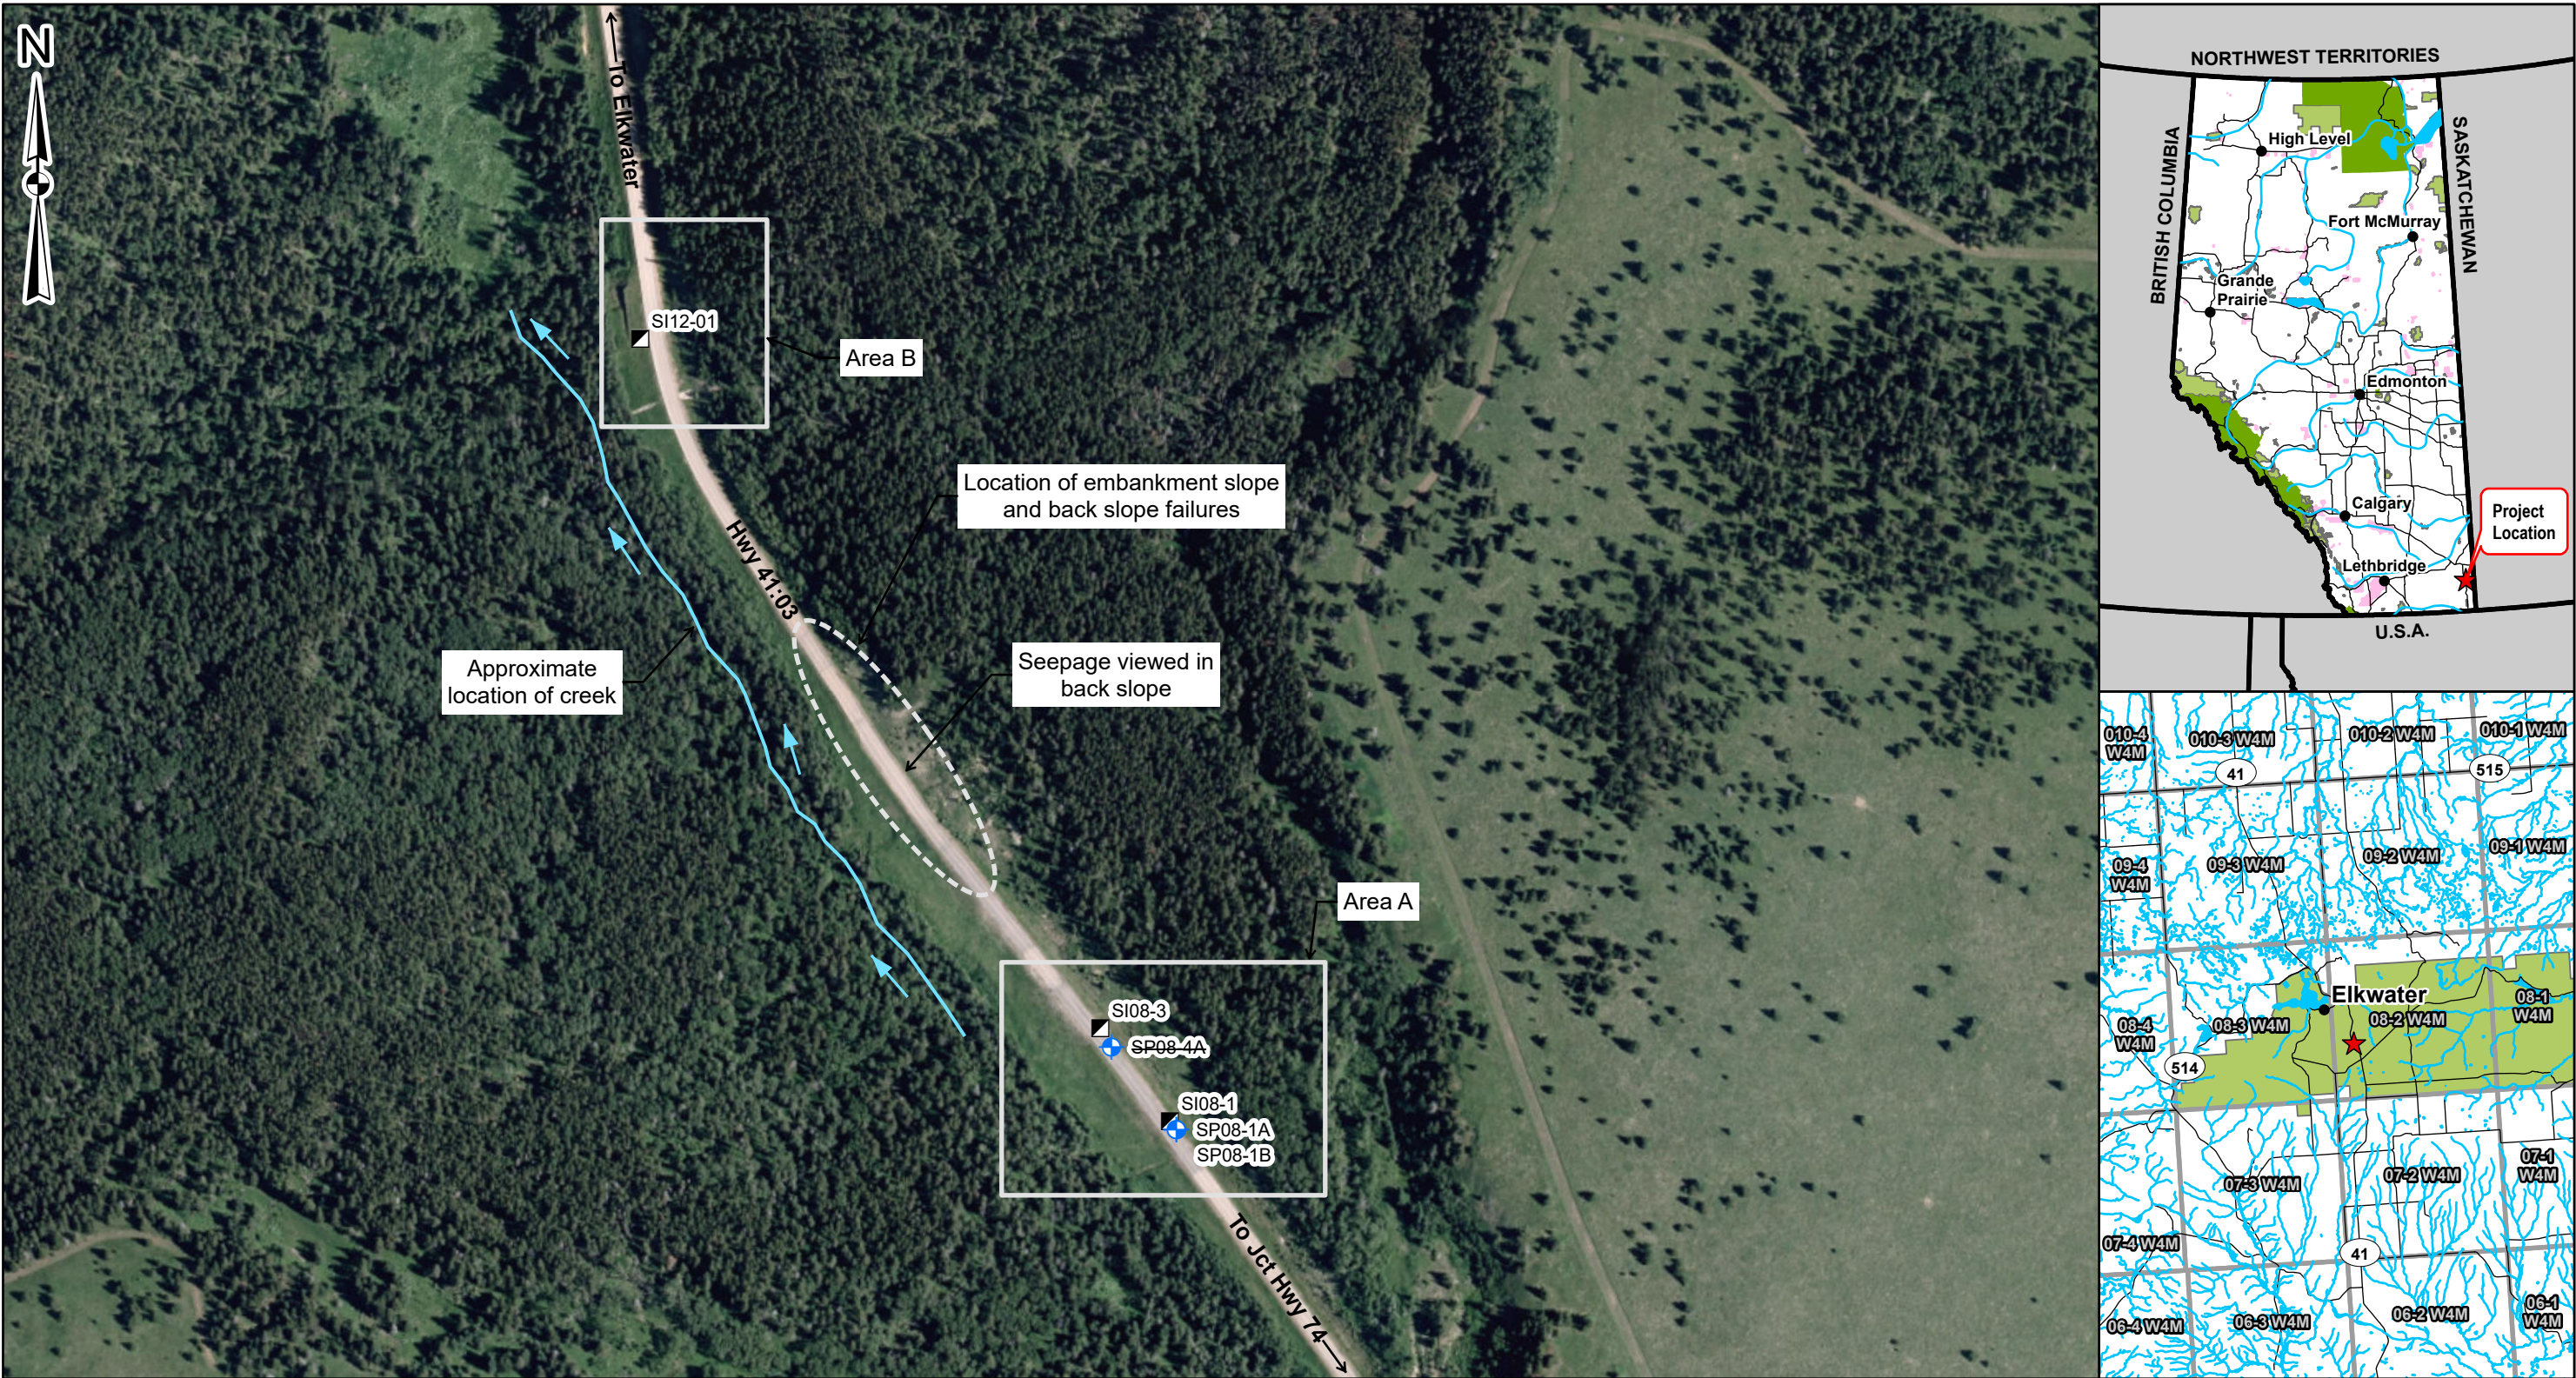
FIGURE

Three slope inclinometers (SIs) (SI08-1, SI08-3, and SI12-1) and two standpipe piezometers (SPs) (SP08-01A and SP08-01B) were read at the S026 site in the Southern Region on May 22, 2025, by Mr. Shawn Keegan, E.I.T. of Klohn Crippen Berger Ltd. (KCB). These instruments were read as part of the Southern Region Geohazard Risk Management Plan (GRMP). The site is located at Hwy 41:03 km 35.2, approximately 4 km south of the turnoff from Hwy 41:03 to the Town of Elkwater, Alberta. The approximate site coordinates are 5499046 N, 553536 E (UTM Zone 12, NAD 83). A site plan is presented in Figure 1.
