SITE NUMBER AND NAME: <b>S045-I Threepoint Creek</b>		HIGHWAY & KM: 549:02, 12.315	PREVIOUS INSPECTION DATE: May 29, 2017	INSPECTION DATE: <b>May 1, 2018</b>
LEGAL DESCRIPTION: 02-08-021-03 W5M	NAD 83 COORDINATES: UTM Northing Easting 11 5626611 684647		RISK ASSESSMENT: PF: 7 CF: 4 TOTAL: 28	
AVERAGE ANNUAL DAILY TRAFFIC (AADT): 900 (east), (Ref No. 65170)			CONTRACTOR MAINTENANCE AREA (CMA): 27

PROJECT SOUTHERN REGION GEOHAZARD RISK MANAGEMENT PROGRAM		
TITLE Site Plan S045-1 - Threepoint Creek H549:02, km 10.704		
SCALE 1:2,000	PROJECT No. A05115A03	FIG No. 1

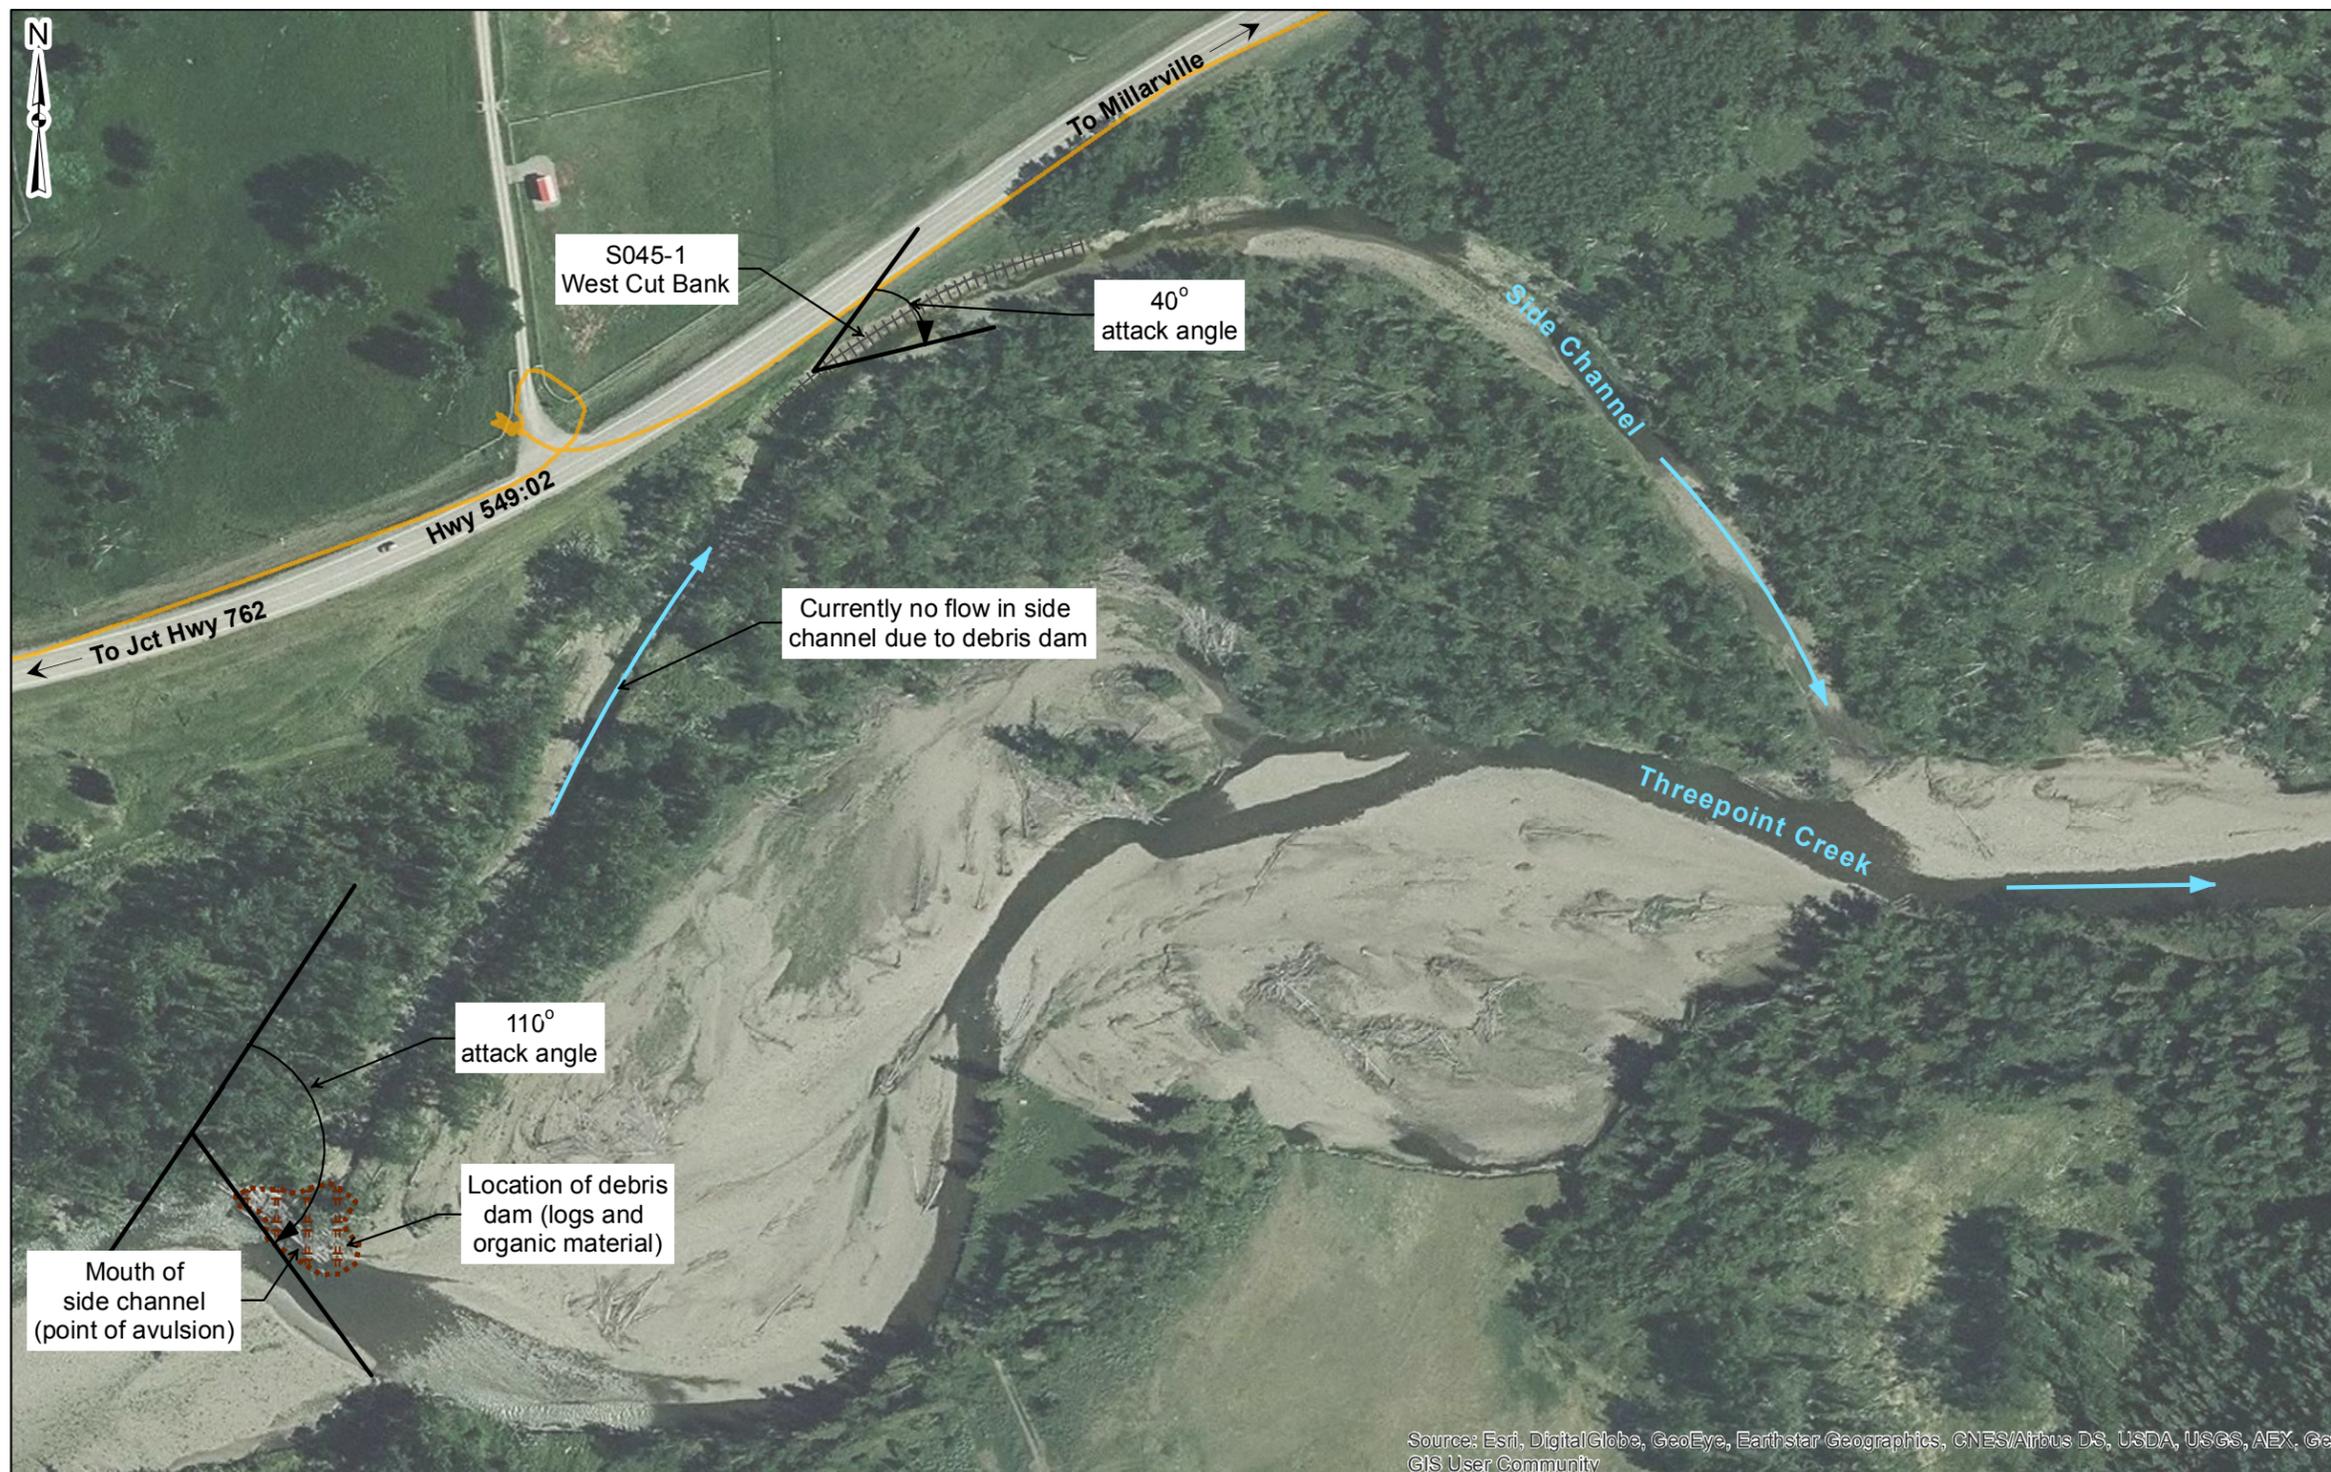
SUMMARY OF SITE INSTRUMENTATION:  None  LAST READING DATE: n/a	INSPECTED BY: Chris Gräpel (KCB) Peter Roy (KCB) Alex Frotten (AT) Roger Skirrow (AT)
PRIMARY SITE ISSUE: Crest of erosion scarp from side channel approximately 6 m from edge of pavement.	
APPROXIMATE DIMENSIONS: Approximately 80 m length of highway, erosion scarp approximately 8 m in height, sloped approximately 0.5H:1V.	
DATE OF ANY REMEDIAL ACTION: None.

<b>COMMENTS</b>
No change to erosion scarp for 4 years due to debris down at side channel entrance.
Side channel is blocked by debris dam (wood debris) deposited in June 2013. Minimal water flow in side channel (estimate 0.1 m <sup>3</sup> /s, or less). If debris dam fails, water will enter side channel again and likely reinitiating of creek erosion. Repair of the erosion should be conducted while debris dam is controlling water in the side channel.
Repair design is underway to protect the bank from further erosion, that will likely include bank reconstruction and riprap placement.
In short term, a HTCB should be installed to minimize potential for motorists going over the steep erosion scarp.
