September 6, 2016

Alberta Transportation 2nd Floor, 803 Manning Road NE Calgary, Alberta T2E 7M8

CON0017609 Southern Region GRMP - Call-Out Reports S050 - Hwy 549:02-01 Embankment Earth Slide (km 4.831) DRAFT

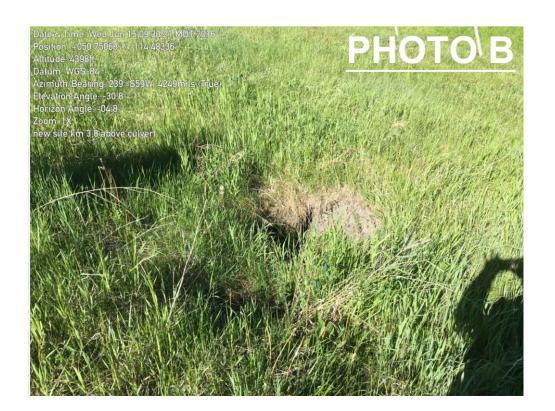
Photo 3 Damaged culvert at Hwy 549:02-01 at km 3.8. Photo taken southward June 15, 2016.

than attempt to fill it. However removal by open cut and backfill will likely disturb an already compromised/failed embankment slope. It is therefore recommended that the culvert be removed and backfilled in conjunction with the failed embankment slope remediation in 2017. The site will need to be protected through the winter months using the provisions outlined above involving monitoring, signage, barricades, and speed reduction.

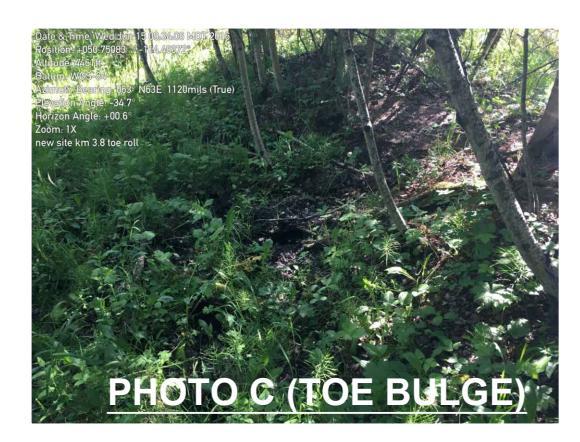
Photo 4 Damaged culvert at Hwy 549:02-01 at km 3.8. Photo taken southward June 15, 2016
