July 10, 2024

**CON0022161 Southern Region GRMP Instrumentation Monitoring
Site S036; H800:02, km 9.05 Belly River
Section C – 2024 Spring Readings**

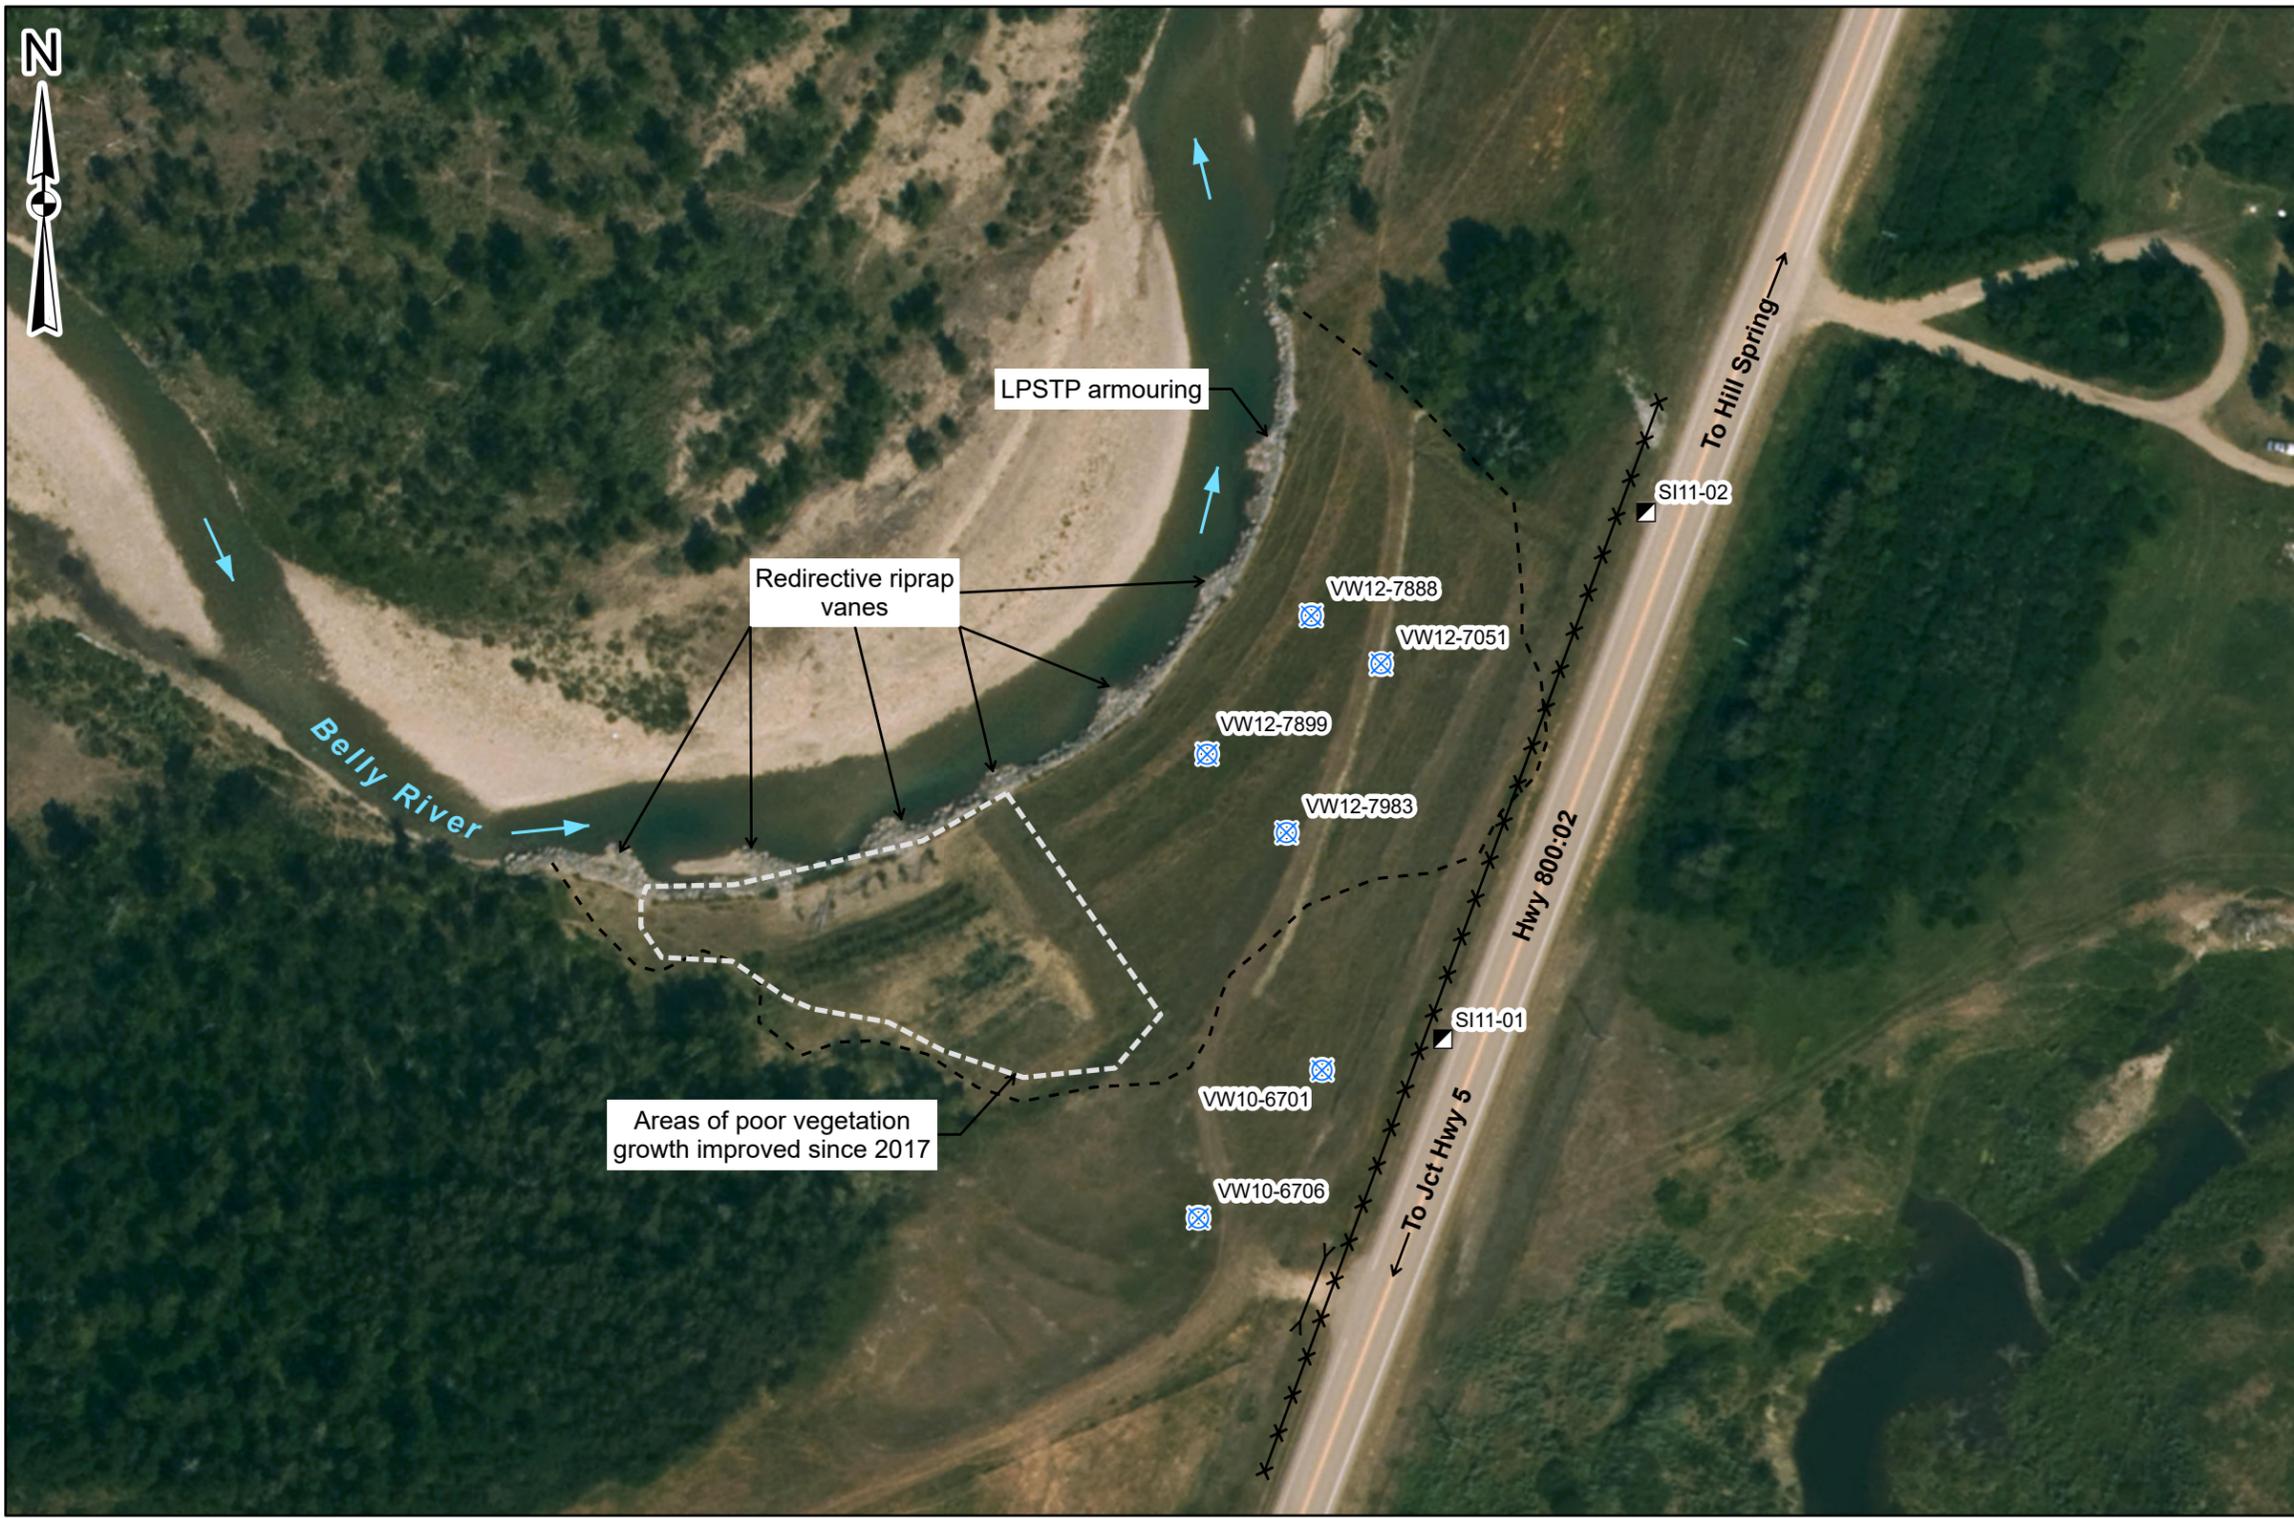
PROJECT SOUTHERN REGION GEOHAZARD RISK MANAGEMENT PROGRAM		
TITLE Site Plan S036 - Belly River Hwy 800:02, km 9.05		
SCALE 1:1,250	PROJECT No. A05116A03	FIG No. 1

Two slope inclinometers (SIs) (SI11-1 and SI11-2) and six vibrating wire piezometers (VWPs) (VW10-6701, VW10-6706, VW12-7899, VW12-7983, VW12-7888, and VW7051) were read at the S036 site in Southern Region on May 15, 2024, by Mr. Bradley Lawson, E.I.T., of Klohn Crippen Berger Ltd. (KCB). These instruments were read as part of the Southern Region Geohazard Risk Management Program (GRMP). The site is located on Hwy 800:02 km 9.05, approximately 9 km south of the Village of Hill Spring, Alberta, on the east side of the Belly River, in the Blood Tribe 148 Reserve. A permit was issued by Blood Tribe Land Management to Mr. Lawson before the instrumentation readings were completed. The approximate site coordinates are 5454362 N, 308507 E (UTM Zone 12, NAD 83), and the legal land description for the site is NW 18-03-27-W4. A site plan is presented in Figure 1.

The geohazard at the S036 site consists of a landslide approximately 200 m long on the outside (south) bend of the Belly River riverbank. Previous remedial actions at the site include:
