Bi-Annual GRMP Review Meeting Peace Region: Swan Hills District March 7, 2018

Area Summary

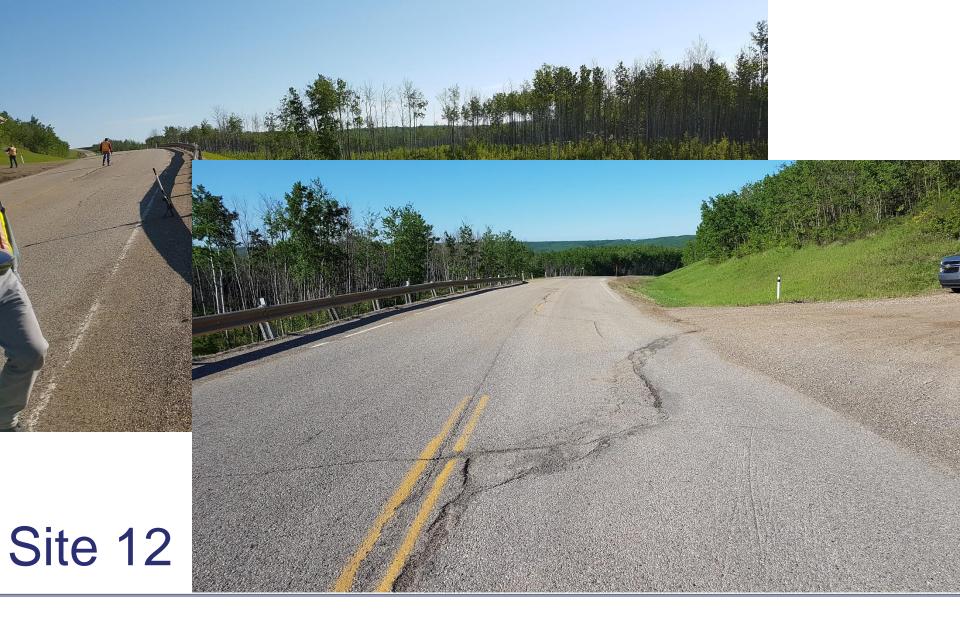
Site 12

DIMENSION	LENGTH (m)			
LABEL	2017	2016	2015	2014
X * (WIDTH)	5.0	-		-
Y (A1 TO CREST)	3.9	4.4	5.6	6.0
Z (A2 TO CREST)	6.9	7.55	8.6	8.7

^{*} LOCATION RESET IN 2017
