Investigation and Design of Coal-Mine Mitigation below a Highway Chris Grapel, M.Eng., P.Eng. Tri-Party 2018

S012 – Spray Lakes Road site

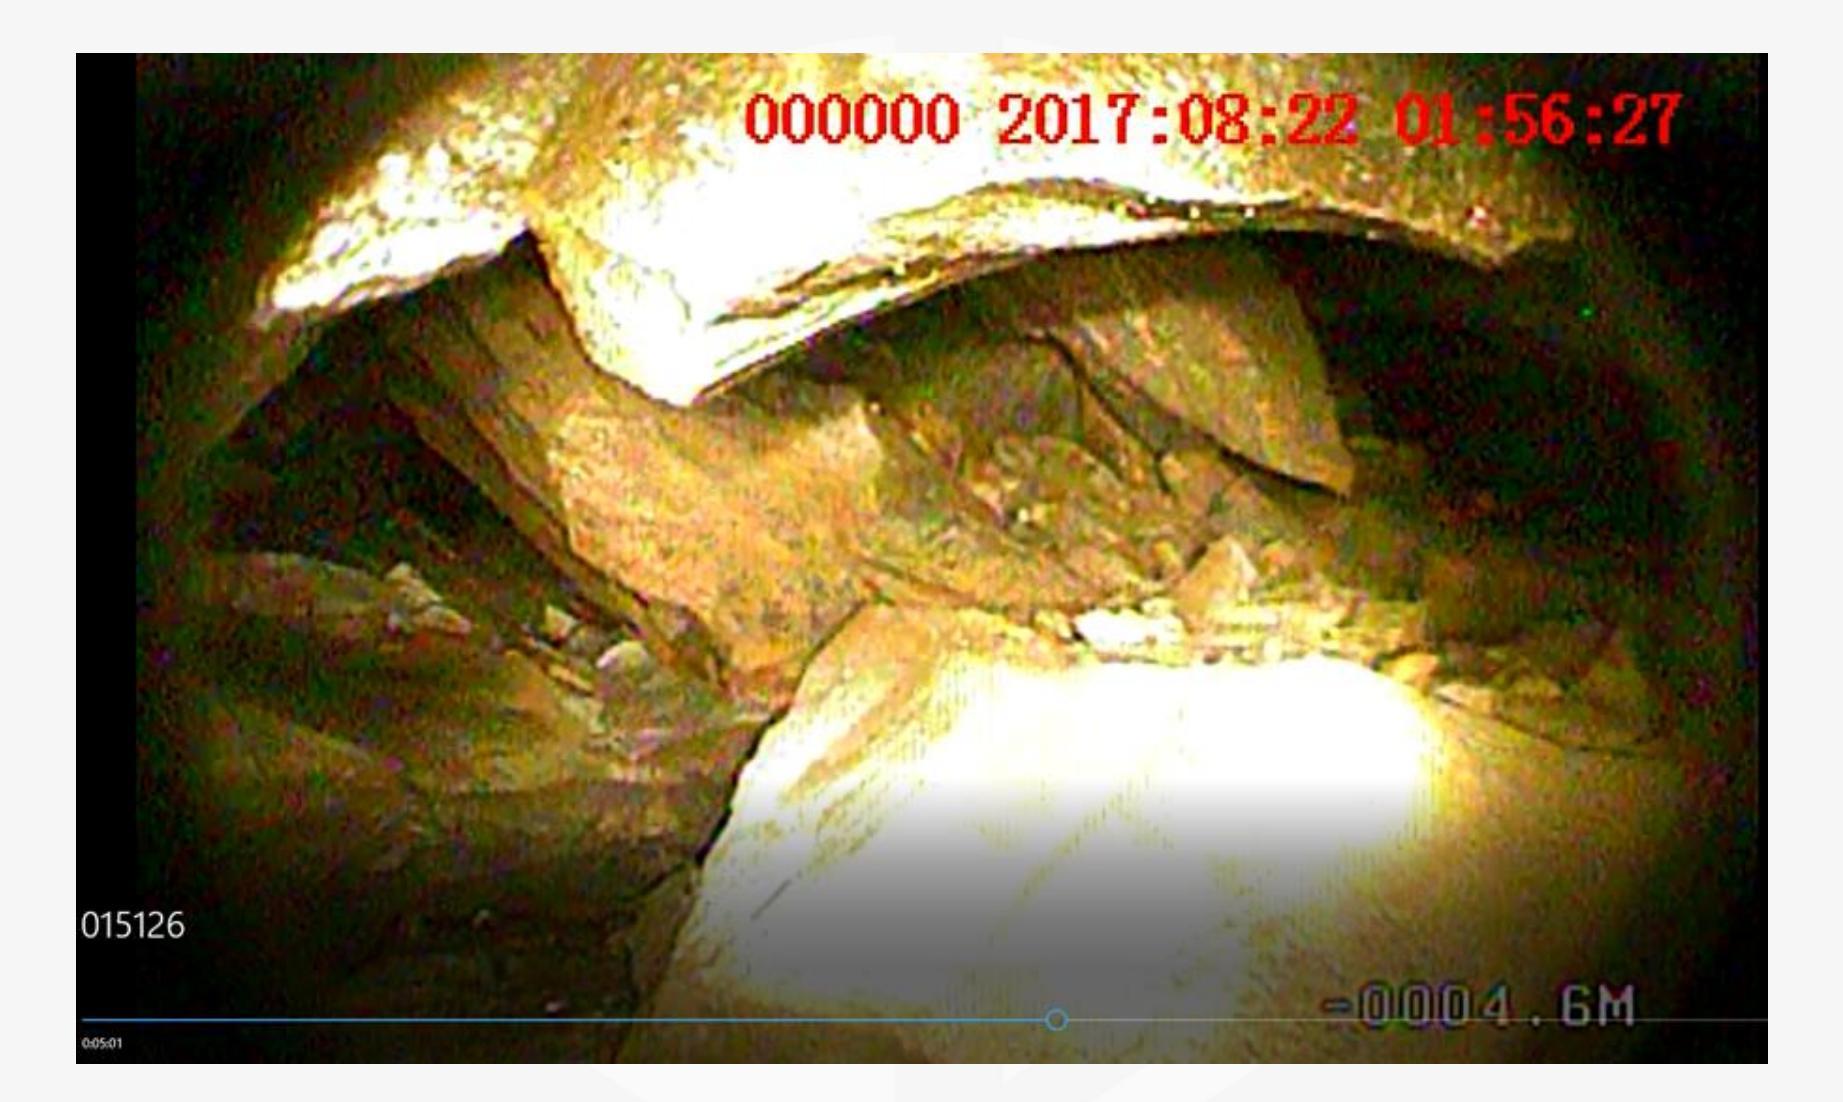
Downhole-Video Camera

- No evidence of pavement movement noted in InSAR data or pavement LiDAR data
- Some previous observations of new pavement cracks
- Downhole video camera survey noted cracking in the bedrock exposed in the borehole walls above the open void
- ERT data indicates higher resistivity above void, below highway, which could indicate dilating (i.e. opening) bedrock joints
- Continued monitoring of S012 site without repair not recommended

- Urethane foam injection
 - Upper portion of mine to be backfilled with urethane foam injected through boreholes drilled from road surface into coal-mine void
 - Open voids and voids in collapse material to be backfilled with urethane foam
 - Extent of foam injection will be limited to upper portions of mine so foam does not impede groundwater discharge from mine
 - Additional drilling conducted in early spring 2018 to assess mine conditions at depth
 - Final design underway for tendering for 2019 construction
