Alberta Transportation
Bi-Annual GRMP
Meeting

North Central
Region – NC76,
NC82, and
NC57 Overview

NC76 – Blue Ridge Slide

NC57 – HWY 624 Embankment Failure

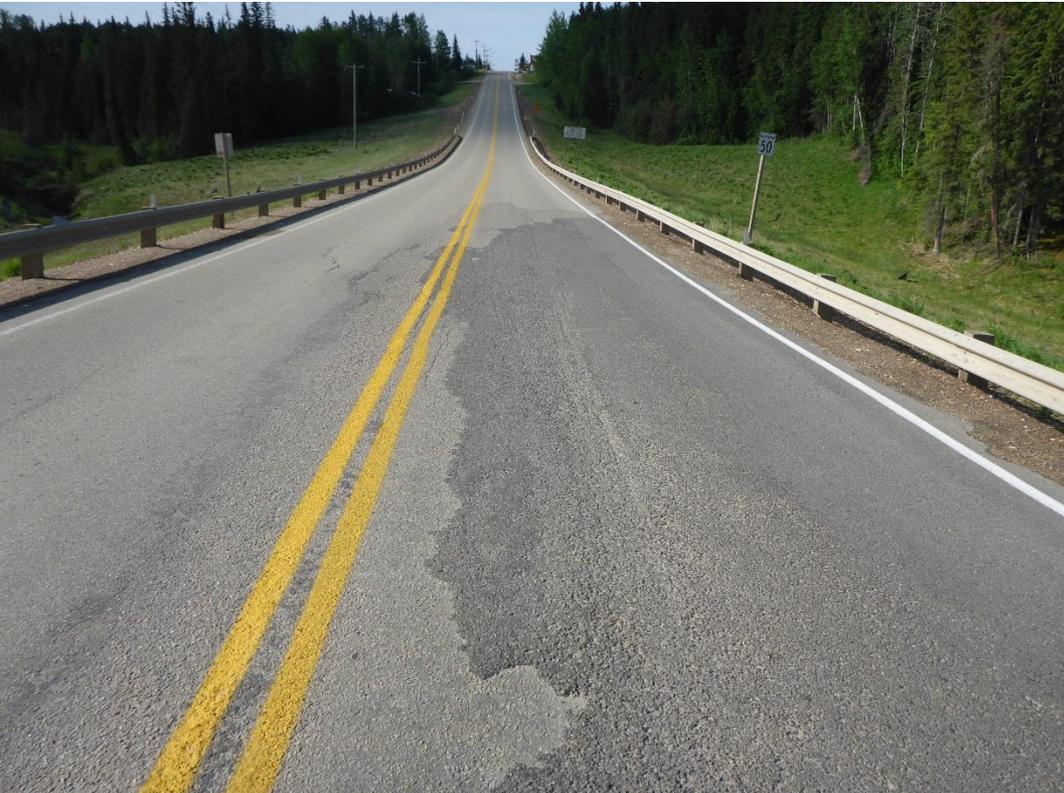
- Fill embankment through valley of Bull Creek (12 m to 15 m high)
- Side slopes at 3.5H:1V
- Slope failures during culvert replacement in 2009
- Call-out in October 2011 and subsequently included in inspection list
- Instruments installed in 2012

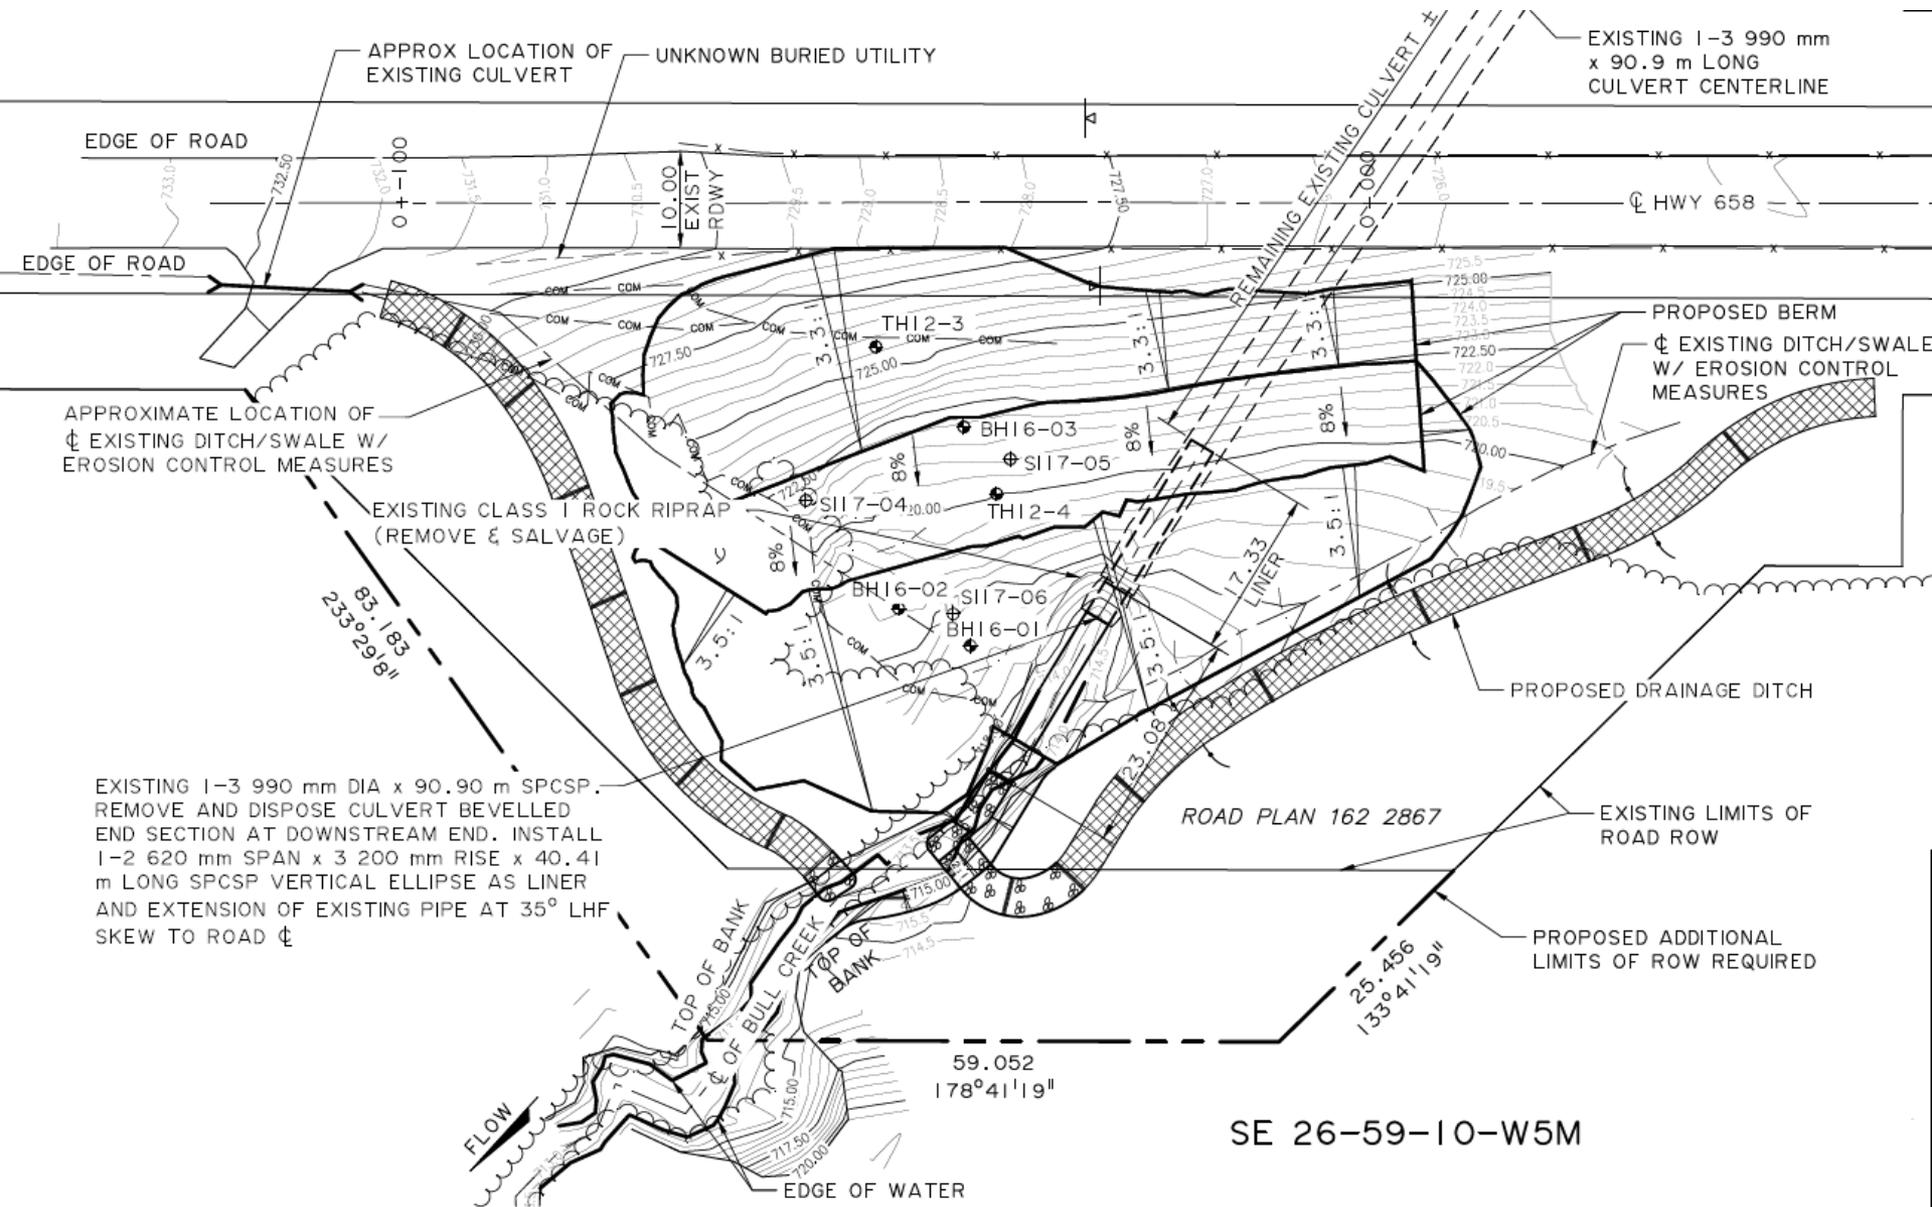
- Limited space due to creek
 - Pile wall – Cantilevered pile alone inadequate for support. Needed anchors.
 - Large number of anchors required became costly – went with berm solution (additional ROW needed for construction access)
- Relatively weak clay till
 - Concerns with constructability of a shear key due to poor soil and groundwater conditions – built a larger berm instead
- High groundwater table and springs
 - Drainage blanket with interceptor drains

PROPOSED BERM
 EXISTING DITCH/SWALE W/ EROSION CONTROL MEASURES

EXISTING 1-3 990 mm DIA x 90.90 m SPCSP. REMOVE AND DISPOSE CULVERT BEVELLED END SECTION AT DOWNSTREAM END. INSTALL 1-2 620 mm SPAN x 3 200 mm RISE x 40.41 m LONG SPCSP VERTICAL ELLIPSE AS LINER AND EXTENSION OF EXISTING PIPE AT 35° LHF SKEW TO ROAD

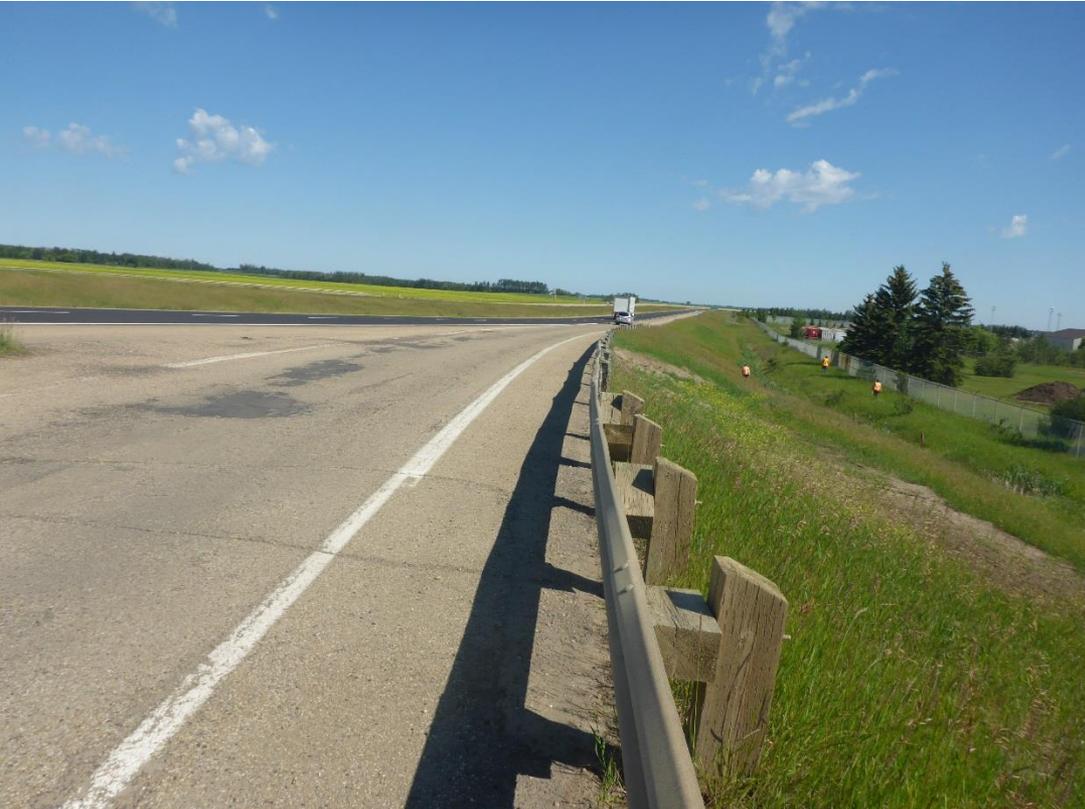
- Two slides
 - North 55 m x 20 m
 - South 30 m x 15 m
- 4 m to 5 m high embankment, 3H:1V
- Standing water in east ditch – No grade
- Test pits showed soft soils, possible high water table, and uncontrolled fill
- No instrumentation

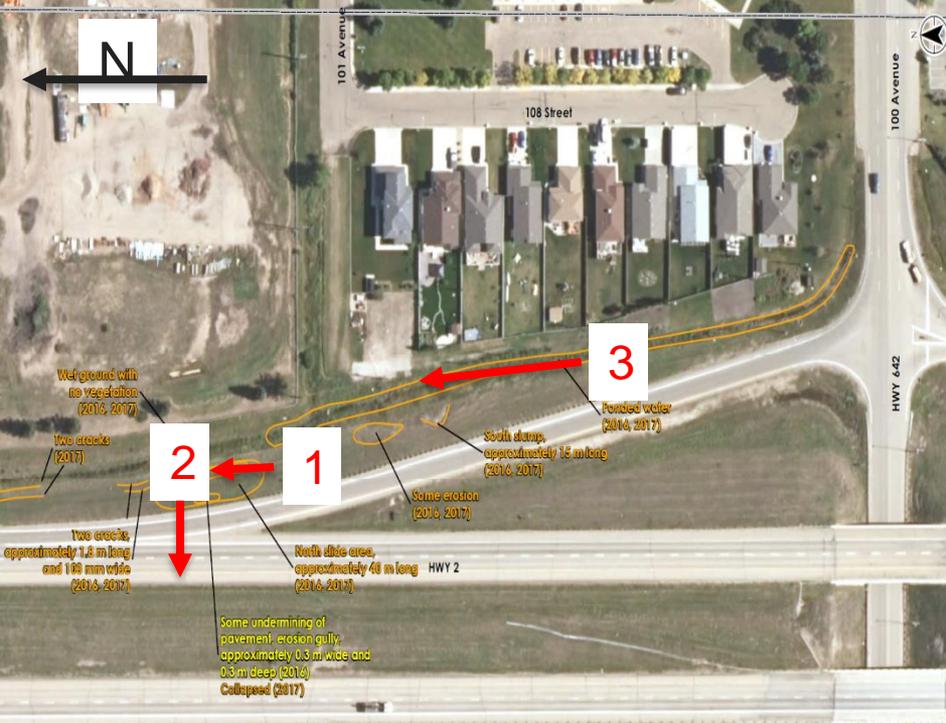
Photo 1 – Looking north at north slide

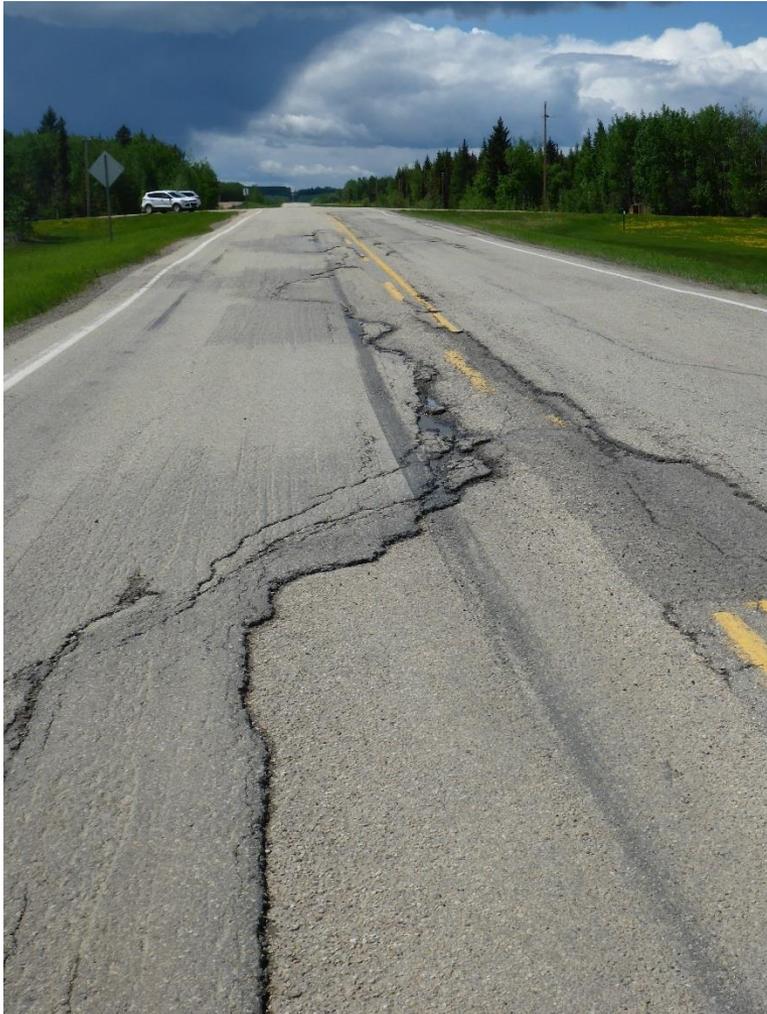
- 2 m embankment with 6H:1V to 7H:1V side slopes
- Settlement and lateral spreading of highway
- First embankment failure in 2006
- Repaired in 2007 with granular sub-drains installed.
- Highway 624 performed well until 2014

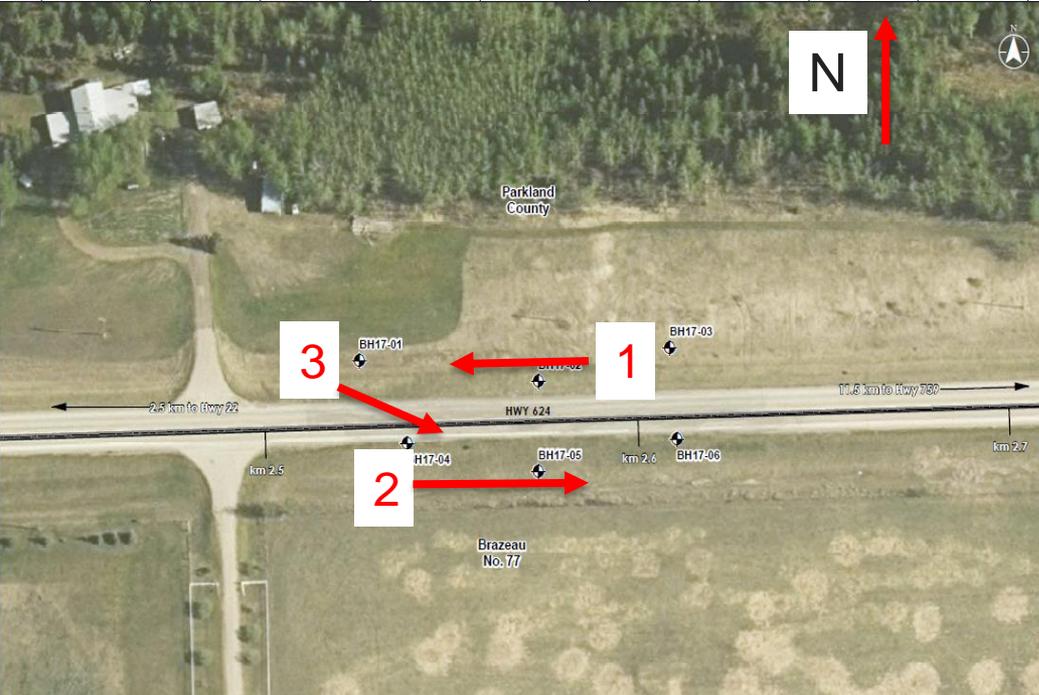
Photo 1 – Looking west gentle slope
