Erosion Ditch Repair
H614:02 and H894:04
Using ArmorMax System (an anchored reinforced vegetation system)
Fred Cheng - Geotechnical and Materials Section
Tom Somerville, FST – Vermilion District - Central Region
May 2012

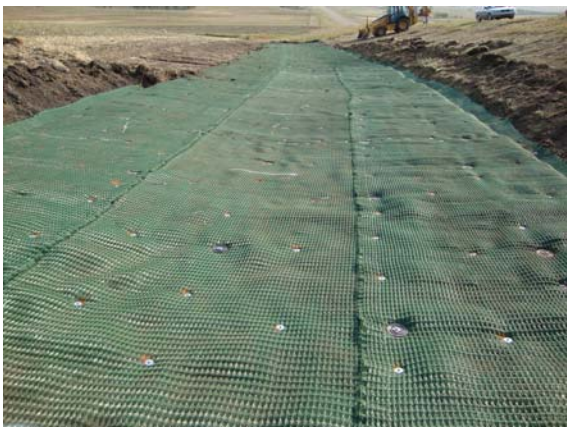
H614:02

All in all, the project went without a hitch. The sites have been monitored regularly by Carillion and district staff since installation. ArmorMax was found to perform very well on this 7% ditch. No ditch erosion has been noticed and grass catch is full. GeoRidge barriers will be removed in coming months.
