June 9, 2017

Alberta Transportation
4th Floor, Provincial Building
4920 51 Street
Red Deer, Alberta
T4N 6K8

**CON0017608 Central Region GRMP Instrumentation Monitoring
Site C061; H20:02, km 12.212 Frost Heave
Section C – 2017 Spring Readings
DRAFT**

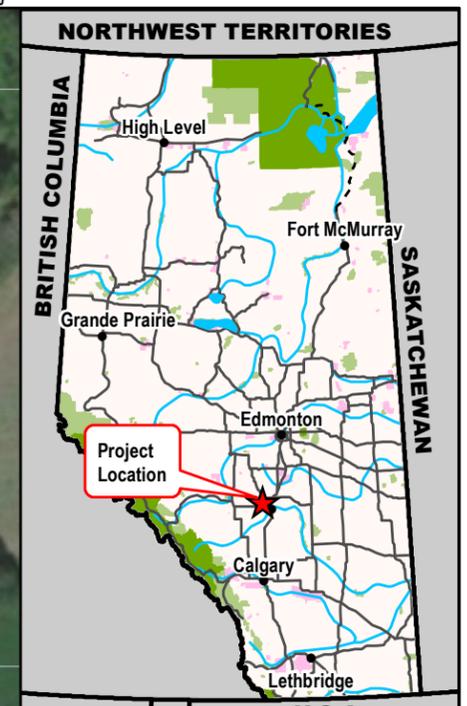
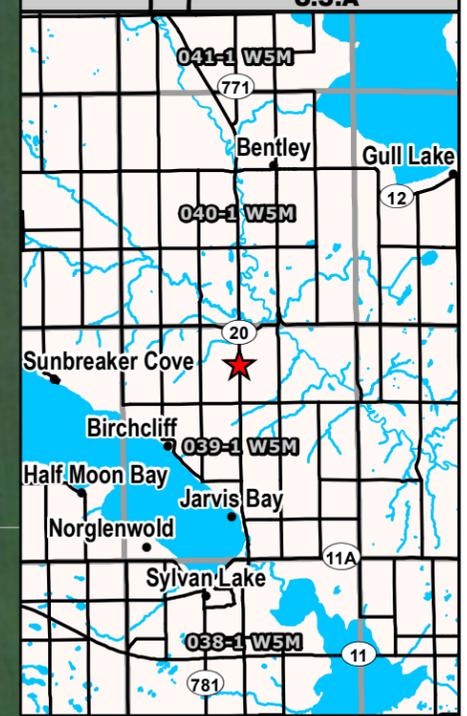
| | | TITLE Site Plan C061 - Frost Heave Hwy 20:02, km 12.212 |

One vibrating wire piezometer (VW40482) and one thermistor cable (TS4286) were read at geohazard site C061 on May 11, 2017 by Ms. Courtney Mulhall, E.I.T. and Mr. Lekan Mitchell, E.I.T. of Klohn Crippen Berger Ltd. (KCB). The site is located on Hwy 20:02, km 12.212, approximately 10 km north of Sylvan Lake, Alberta. The site coordinates are 52°23.564' N, 114°4.592' E (NAD 83). A site plan is presented in Figure 1.

Instrumentation installation details are tabulated in Table 1.1. Instrument locations are shown in Figure 1.
