SITE NUMBER AND NAME C061 Frost Heave		HIGHWAY & KM 20:02, 12.212	PREVIOUS INSPECTION DATE Feb 28, 2018	INSPECTION DATE Feb 21, 2019
LEGAL DESCRIPTION SE 33-39-1-W5M	NAD 83 COORDINATES: UTM Northing Easting 11 5808688 699107		RISK ASSESSMENT PF: 8 CF: 3 TOTAL: 24	
AVERAGE ANNUAL DAILY TRAFFIC (AADT): 5,930 (north) & 6,260 (south) (Ref No. 997219)			CONTRACT MAINTENANCE AREA (CMA): 19

SUMMARY OF SITE INSTRUMENTATION: Operational: One vibrating wire piezometer and one ground temperature cable. LAST READING DATE: May 11, 2017	INSPECTED BY: Chris Gräpel (KCB) Ryan Gazley (KCB) Tony Penney (AT) Dewayne Wlad (AT)
PRIMARY SITE ISSUE: Frost heave of road due to frost susceptible embankment fill.	
APPROXIMATE DIMENSIONS: Approximately 400 m along highway.	
DATE OF ANY REMEDIAL ACTION: Drainage redirected to southbound ditch

PROJECT	CENTRAL REGION GEOHAZARD RISK MANAGEMENT PROGRAM	
TITLE	C061 Site Inspection Hwy 20:02 km 12.212	
SCALE	PROJECT No.	FIG No.
1:1,000	A05115A02	1

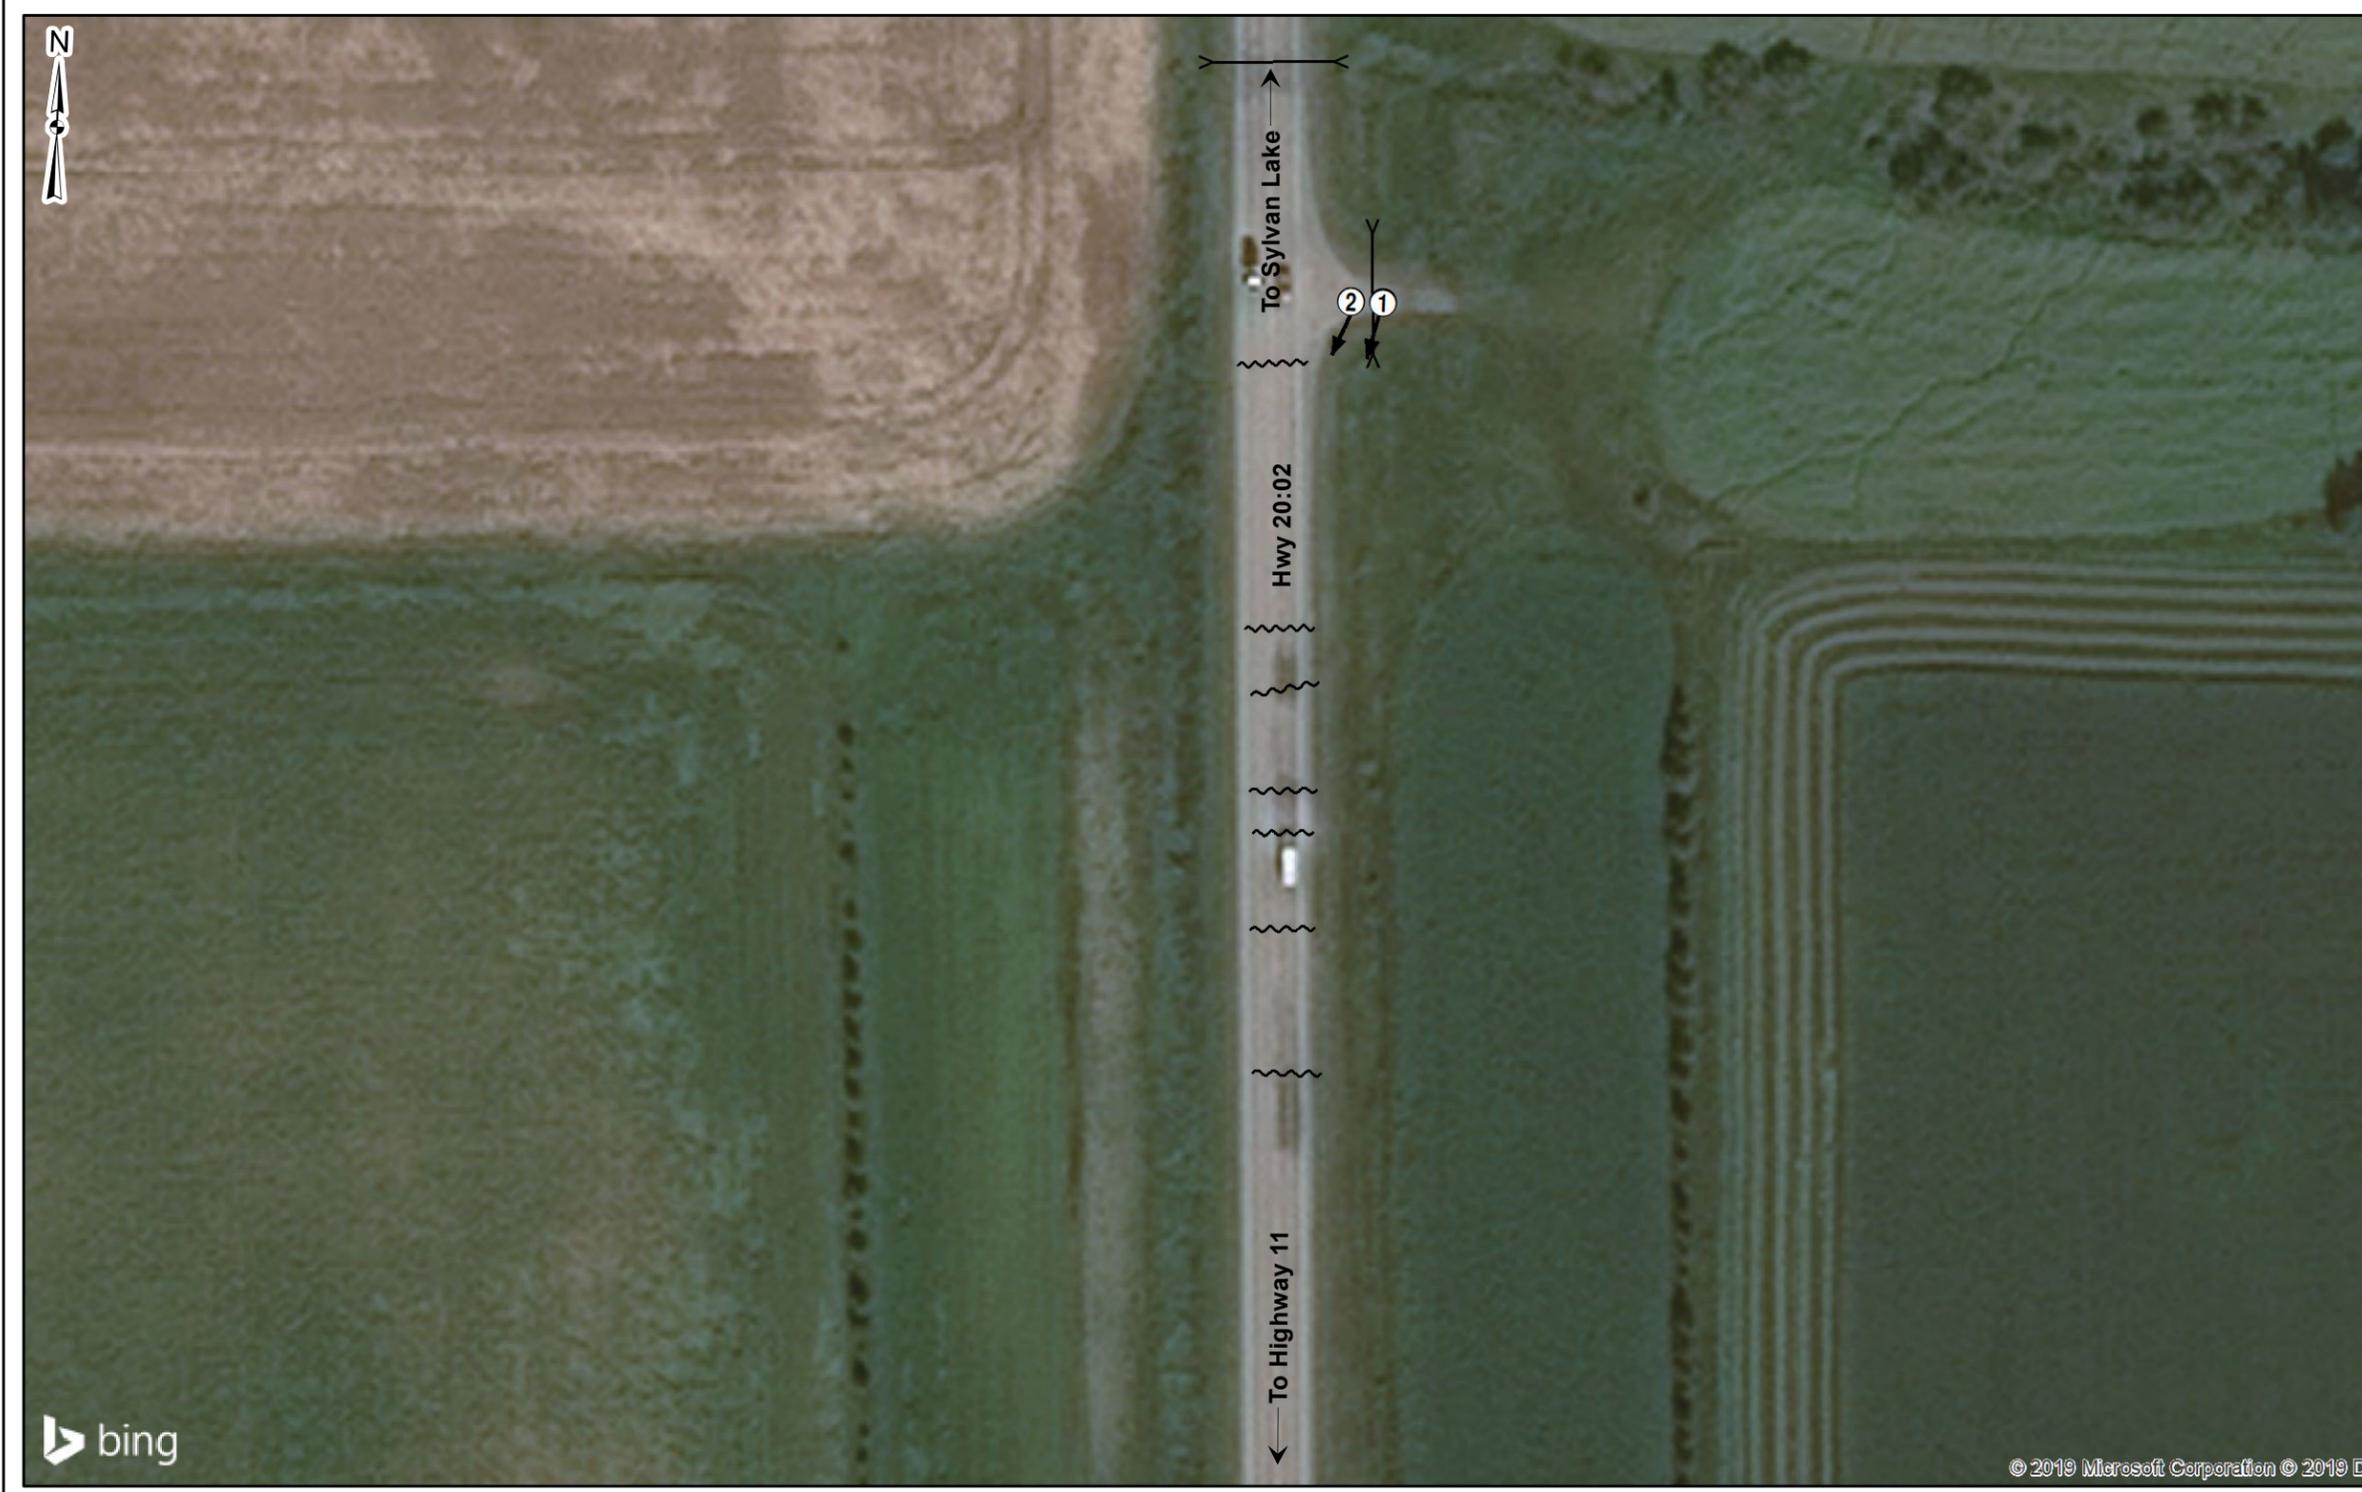
ITEM	CONDITION EXISTS		DESCRIPTION AND LOCATION	NOTICABLE CHANGE FROM LAST INSPECTION	
	YES	NO		YES	NO
Pavement Distress	X		Three patches on northbound lane in center of heaving area. Transverse pavement cracks were noted.		X
Slope Movement		X			X
Erosion		X			X
Seepage	X		A spring was observed in the southbound ditch at the south end of the site during the March 2, 2017 inspection		X
Culvert Distress		X			X

COMMENTS
Traffic does not seem to be slowing down despite hazard signs warning drivers of uneven pavement and a 65 km/hr speed limit.
Both lanes appear to be equally uneven. The MCI reported that the heaving conditions are better this winter as compared to last winter, which may be due to reduced levels of precipitation during 2018.
Transverse pavement cracks observed at the three patched areas. Pavement cracks extend the entire width of the highway.
The maintenance contractor has not had to place any levelling asphalt patches this winter.
This site will be repaired in spring 2019 as detailed in Alberta Transportation Tender TND0019153.
