**ALBERTA TRANSPORTATION
GEOHAZARD ASSESSMENT PROGRAM
PEACE REGION – PEACE RIVER/HIGH LEVEL
2018 INSPECTION**

Site Number	Location	Name	Hwy	km
PH22	13 km W. Cleardale	Clear River East Hill-Site 6	64:02	22.8-23.1
Legal Description		UTM Co-ordinates (NAD 83)		
S28-84-11-W6		11 N 6243933	E 334702

Date	PF	CF	Total
Previous Inspection:	June 1, 2017	10	3	30
Current Inspection:	May 18, 2018	10	3	30
Road AADT:	420		Year:	2017
Inspected By:	Barry Meays, Don Proudfoot (Thurber); Ed Szmata, Ken Szmata, Roger Skirrow (AT).			
Report Attachments:	<input checked="" type="checkbox"/> Photographs		<input checked="" type="checkbox"/> Plans	<input type="checkbox"/> Maintenance Items

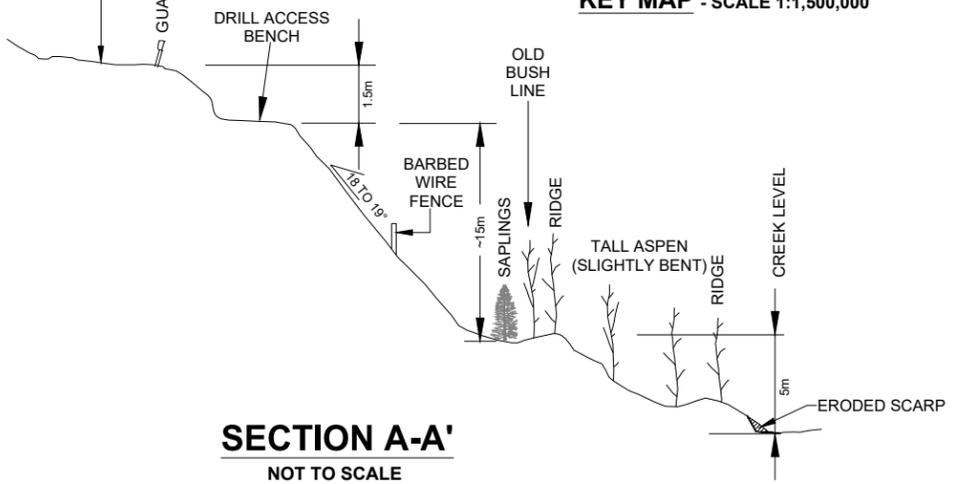
SECTION A-A'
NOT TO SCALE

Assessment (Refer to Figure PH22-1):
It was concluded in 2011 that the drains mentioned in the old road files 50 m downslope of hwy may not have been installed, since they could not be located. Movements that were previously monitored in SI58 appear to be ongoing (but slow) based on a kink in the south guardrail and bow in the fence on the south embankment at this location. There is a possibility that a large slide scarp circles north of highway and joins the two observed dips spaced 200 m apart along the highway.
