ALBERTA TRANSPORTATION GEOHAZARD ASSESSMENT PROGRAM PEACE REGION – GRANDE PRAIRIE DISTRICT 2019 CALL OUT

THURBER ENGINEERING LTD.

Site Number	Location			Na	ame		Hwy	km		
GP06B	N of Grand	N of Grande Cache		Tear Drop Slides			40:36	21.8		
Legal Description)					nates (NAD 8				
NW30-58-7-W6 11U N 5,990,745 E 366,610										
			Date		PF	CF	Tota	al		
Previous Inspection:		J	une 8, 2019		9	4				
Current Inspection			uly 12, 2019		14	5 70				
Road AADT:	-		900			Year: 2018				
		Bar	arry Meays, Nicole Wilder (Thurber)							
		Ed	Ed Szmata, Dwayne Lowen (AT)							
Report Attachments:			Photograph	ance Items						
Primary Site Issue:		Landslide in a 20 m high, 2H:1V highway embankment fill.								
			About 190 m wide along highway, by ~40 m long from highway down							
Dimensions:			to toe.							
Date of any rem	ediation:									
Maintenance:			Crack Sealing and Patching. SB lane closed to traffic on July 12, 2019 due to ongoing rapid landslide movements. Gravel added to west shoulder and traffic lights currently in place to manage traffic on one lane of open roadway

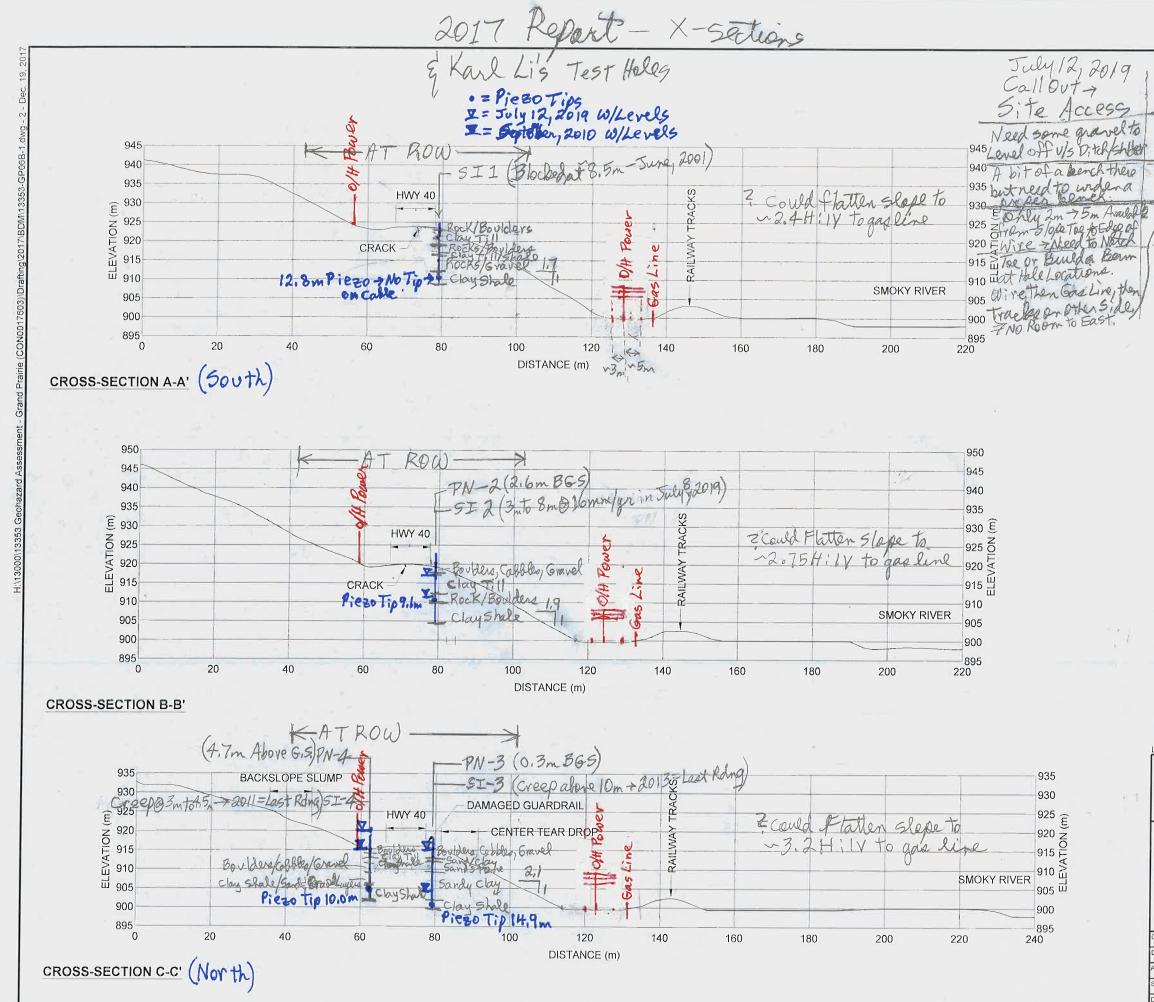
Proposed Test Holes 3 Hales U/S Ditch 3 om D/S Edge of Road - active Zones (1 just N. of SIZ) 2 at Tee 8 Test Hales. Total LIDAR PROVIDED BY ALBERTA TRANSPORTATION Alberta Transportation PEACE REGION (GRANDE PRAIRIE) GP06B-1: HWY 40:36 TEAR DROP SLIDES **CROSS-SECTIONS** DWG No. 13353-GP06B-1-2 DRAWN BY ML DESIGNED BY BDM DWP 1:1000 DATE MAY 30, 2017 THURBER ENGINEERING LTD. FILE No. 13353

It is therefore recommended that some additional boreholes should be drilled, and instrumentation installed to provide information on the soil and groundwater conditions, to carry out detailed slope stability analyses, and to confirm slope stabilization design measures. Three test holes along the upslope ditch (to ~ 15 m), four test holes along the downslope side of the highway (to ~25 m), and two test holes along the downstream toe (to ~ 10 m) to define the current slide are recommended, complete with slope inclinometer and nested vibrating wire piezometer installations. Access notes are shown on the cross-sections figure. Additional test holes adjacent to the highway could be considered to define the lateral slide extents to the north and south of the current slide zone. Newer LiDAR should also be obtained, along with performing an updated topographic site survey.
