<b>SITE NUMBER AND NAME:</b> GP052 Puskwaskau River Slide		<b>HIGHWAY &amp; KM:</b> 736:02, 27.011	<b>PREVIOUS INSPECTION DATE:</b> May 30, 2020	<b>INSPECTION DATE:</b> July 19, 2021
<b>LEGAL DESCRIPTION:</b> NW 26-74-01-W6M	<b>NAD 83 COORDINATES:</b> UTM Northing Easting 11 6144232 434495		<b>RISK ASSESSMENT:</b> 1: PF: 10 CF: 4 TOTAL: 40 2: PF: 11 CF: 6 TOTAL: 66	
<b>AVERAGE ANNUAL DAILY TRAFFIC (AADT):</b> 130 (north) & 140 (south) (Reference No. 70000833)			<b>CONTRACT MAINTENANCE AREA (CMA):</b> 504

PROJECT GRANDE PRAIRIE SOUTH REGION GEOHAZARD RISK MANAGEMENT PROGRAM		
TITLE Site Plan GP052 Puskwaskau River Slide Hwy 736:02, km 27.011		
SCALE 1:1,750	PROJECT No. A05116A01	FIG No. 1

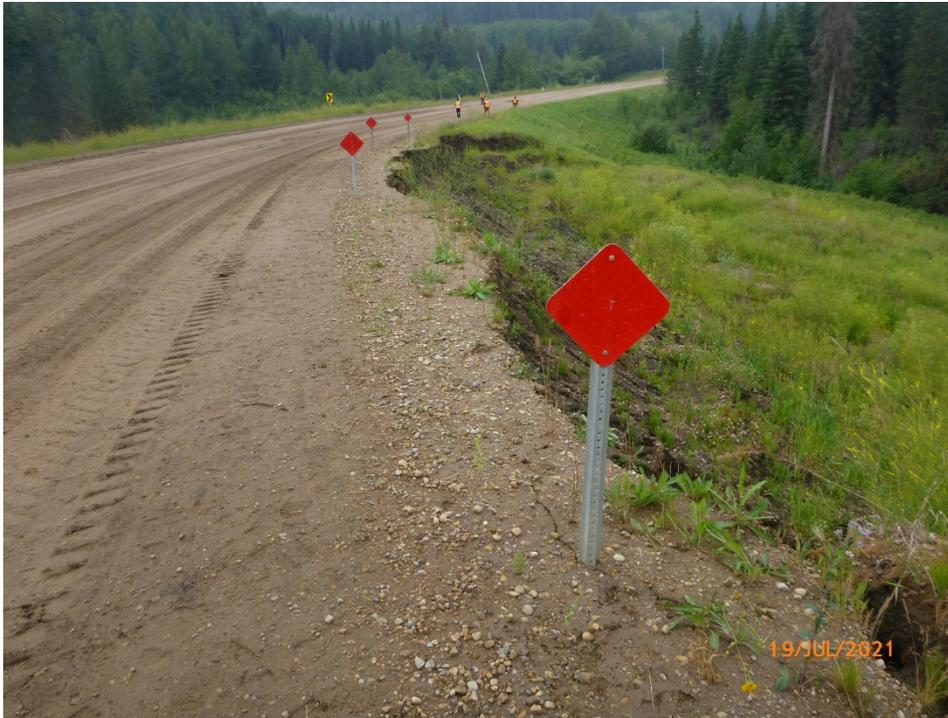
**Photo 4** Hazard markers have been installed in the shoulder of the road. Note cracking behind head scarp of embankment slope failure indicating retrogression of slide. Photo taken July 19, 2021 facing south.

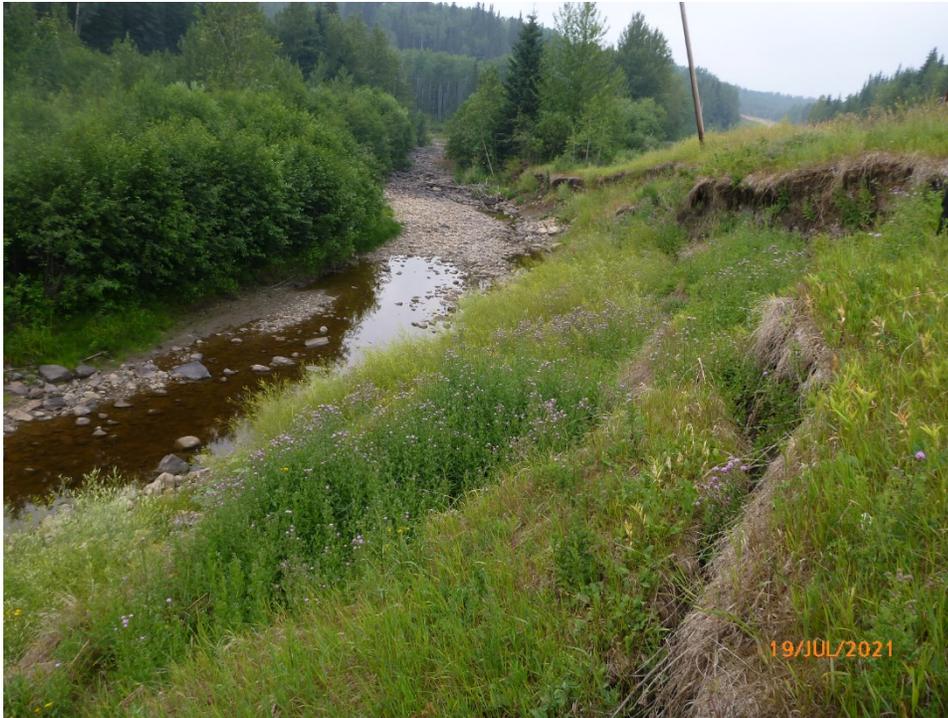
**Photo 6** The erosion on the east (northbound) side of Highway 736 is approximately 2.5 m from the edge of the highway and is beginning to impact a power pole. Photo taken July 19, 2021 facing south.
