**PEACE REGION – SWAN HILLS
GEOHAZARD RISK ASSESSMENT
SITE INSPECTION FORM**

SITE NUMBER SH 27A	SITE NAME Judy Creek Ditch Erosion	HIGHWAY & KM HWY 32:12 KM 48.1	PREVIOUS INSPECTION DATE 02 July 2014	INSPECTION DATE 24 June 2015
LEGAL DESCRIPTION LSD 06-15-64-10-W5M	UTM NAD 84 COORDINATES N 6044314 E 601633	PREVIOUS RISK ASSESSMENT		
		PF: 12	CF: 3	TOTAL: 36
		CURRENT RISK ASSESSMENT		
		PF: 12	CF: 3	TOTAL: 36

**GEOHAZARD ASSESSMENT
 PEACE REGION (SWAN HILLS)**

**SH27A DITCH EROSION NEAR JUDY CREEK
 HIGHWAY 33:12, KM 48.1
 SITE LOCATION, PLAN AND CROSS-SECTION**

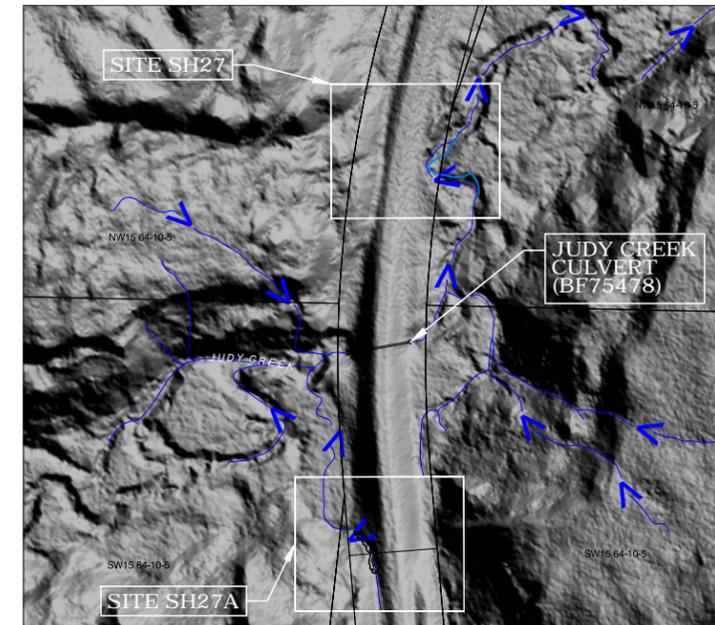
SITE PLAN

Erosion gully in the west ditch along Highway 32:12 (Photos 1 to 3). Retrogression and widening of the erosion gully could undermine the highway. An underground fibre optic cable has been exposed by the gully in 2013.

- APPROXIMATE DIMENSIONS:**
- See plan attached
 - Erosion gully extended ~20 m along the fall of the slope of the ditch to the north, parallel to the road, and then turned to the northwest and extended a further 20 m along the fall of the slope to the northwest;
 - At its start, the erosion gully has formed a vertical drop. In 2014, the erosion gully was ~2.5 m deep and 8 m wide near the start of the gully;
 - The erosion gully was ~5.7 m from the white line on the west side of the highway at its closest location.

Designs works to repair the erosion gully were completed in summer 2015 with construction expected to commence later in 2015 under the High Water Mitigation Works for the Swan Hills Region. The design consists of installing a perforated sub-drain, reconstructing the ditch grade with compact granular material, and armouring the gully with riprap. For further details, refer to the design documents in Part F of the site binder.
