**ALBERTA TRANSPORTATION
GEOHAZARD ASSESSMENT PROGRAM
PEACE REGION – SWAN HILLS
2022 INSPECTION**

Site Number	Location	Name	Hwy	km
SH011-3 SH011-4	Little Smoky River	Little Smoky River Valley, North Hill – Sites #3 and #4	744:02	18.26-18.52 18.62-18.90
Legal Description		UTM Co-ordinates		
Site 3: SE20-76-22-W5M		11U E 476,536	N	6,161,182
Site 4: SE20-76-22-W5M		11U E 476,872	N	6,161,121

**SH011-4: HWY 744:02 LITTLE SMOKY RIVER VALLEY
2022 SITE INSPECTION PLAN**

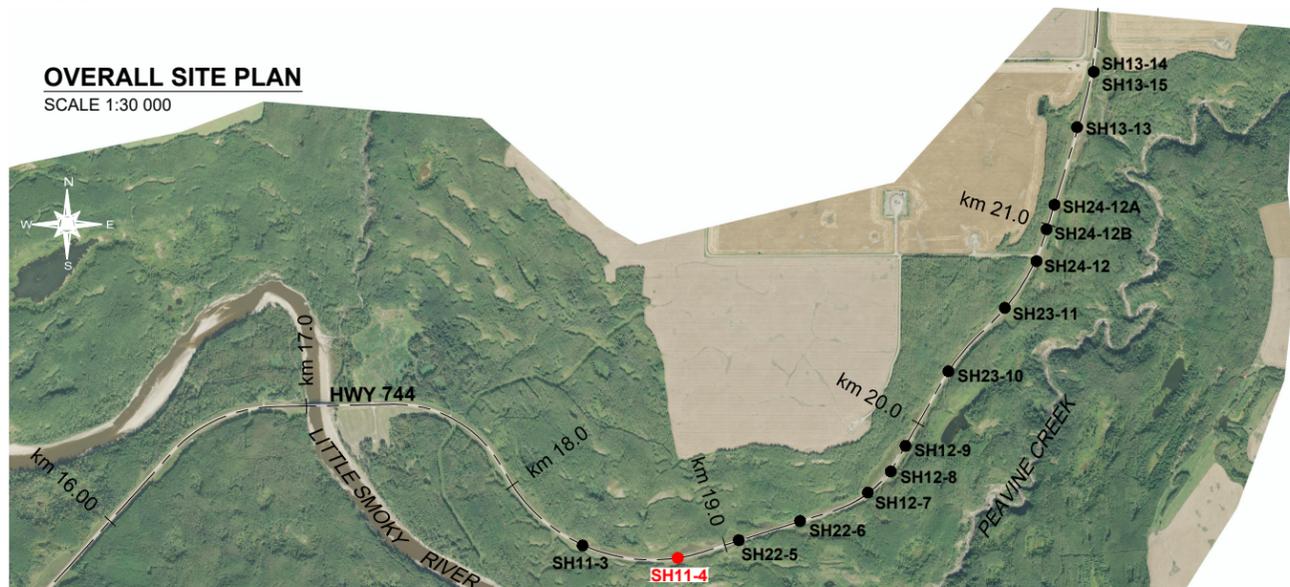
DETAILED SITE PLAN
SCALE 1:1000

Observations (Site 4):	Description	Worsened?
<input checked="" type="checkbox"/> Pavement Distress	Site was recently overlaid. Some of the previous longitudinal and traverse cracks have reflected through and there are minor pavement undulations due to movement.	<input checked="" type="checkbox"/>
<input checked="" type="checkbox"/> Slope Movement	Site is located on an active deep-seated landslide moving toward the Little Smoky River.	<input checked="" type="checkbox"/>
<input type="checkbox"/> Erosion		<input type="checkbox"/>
<input type="checkbox"/> Seepage		<input type="checkbox"/>
