July 14, 2023

CON0022161 Southern Region GRMP Instrumentation Monitoring Site S036; H800:02, km 9.05 Belly River Section C – 2023 Spring Readings

ATTACHMENTS Figure Appendix I Instrumentation Plots

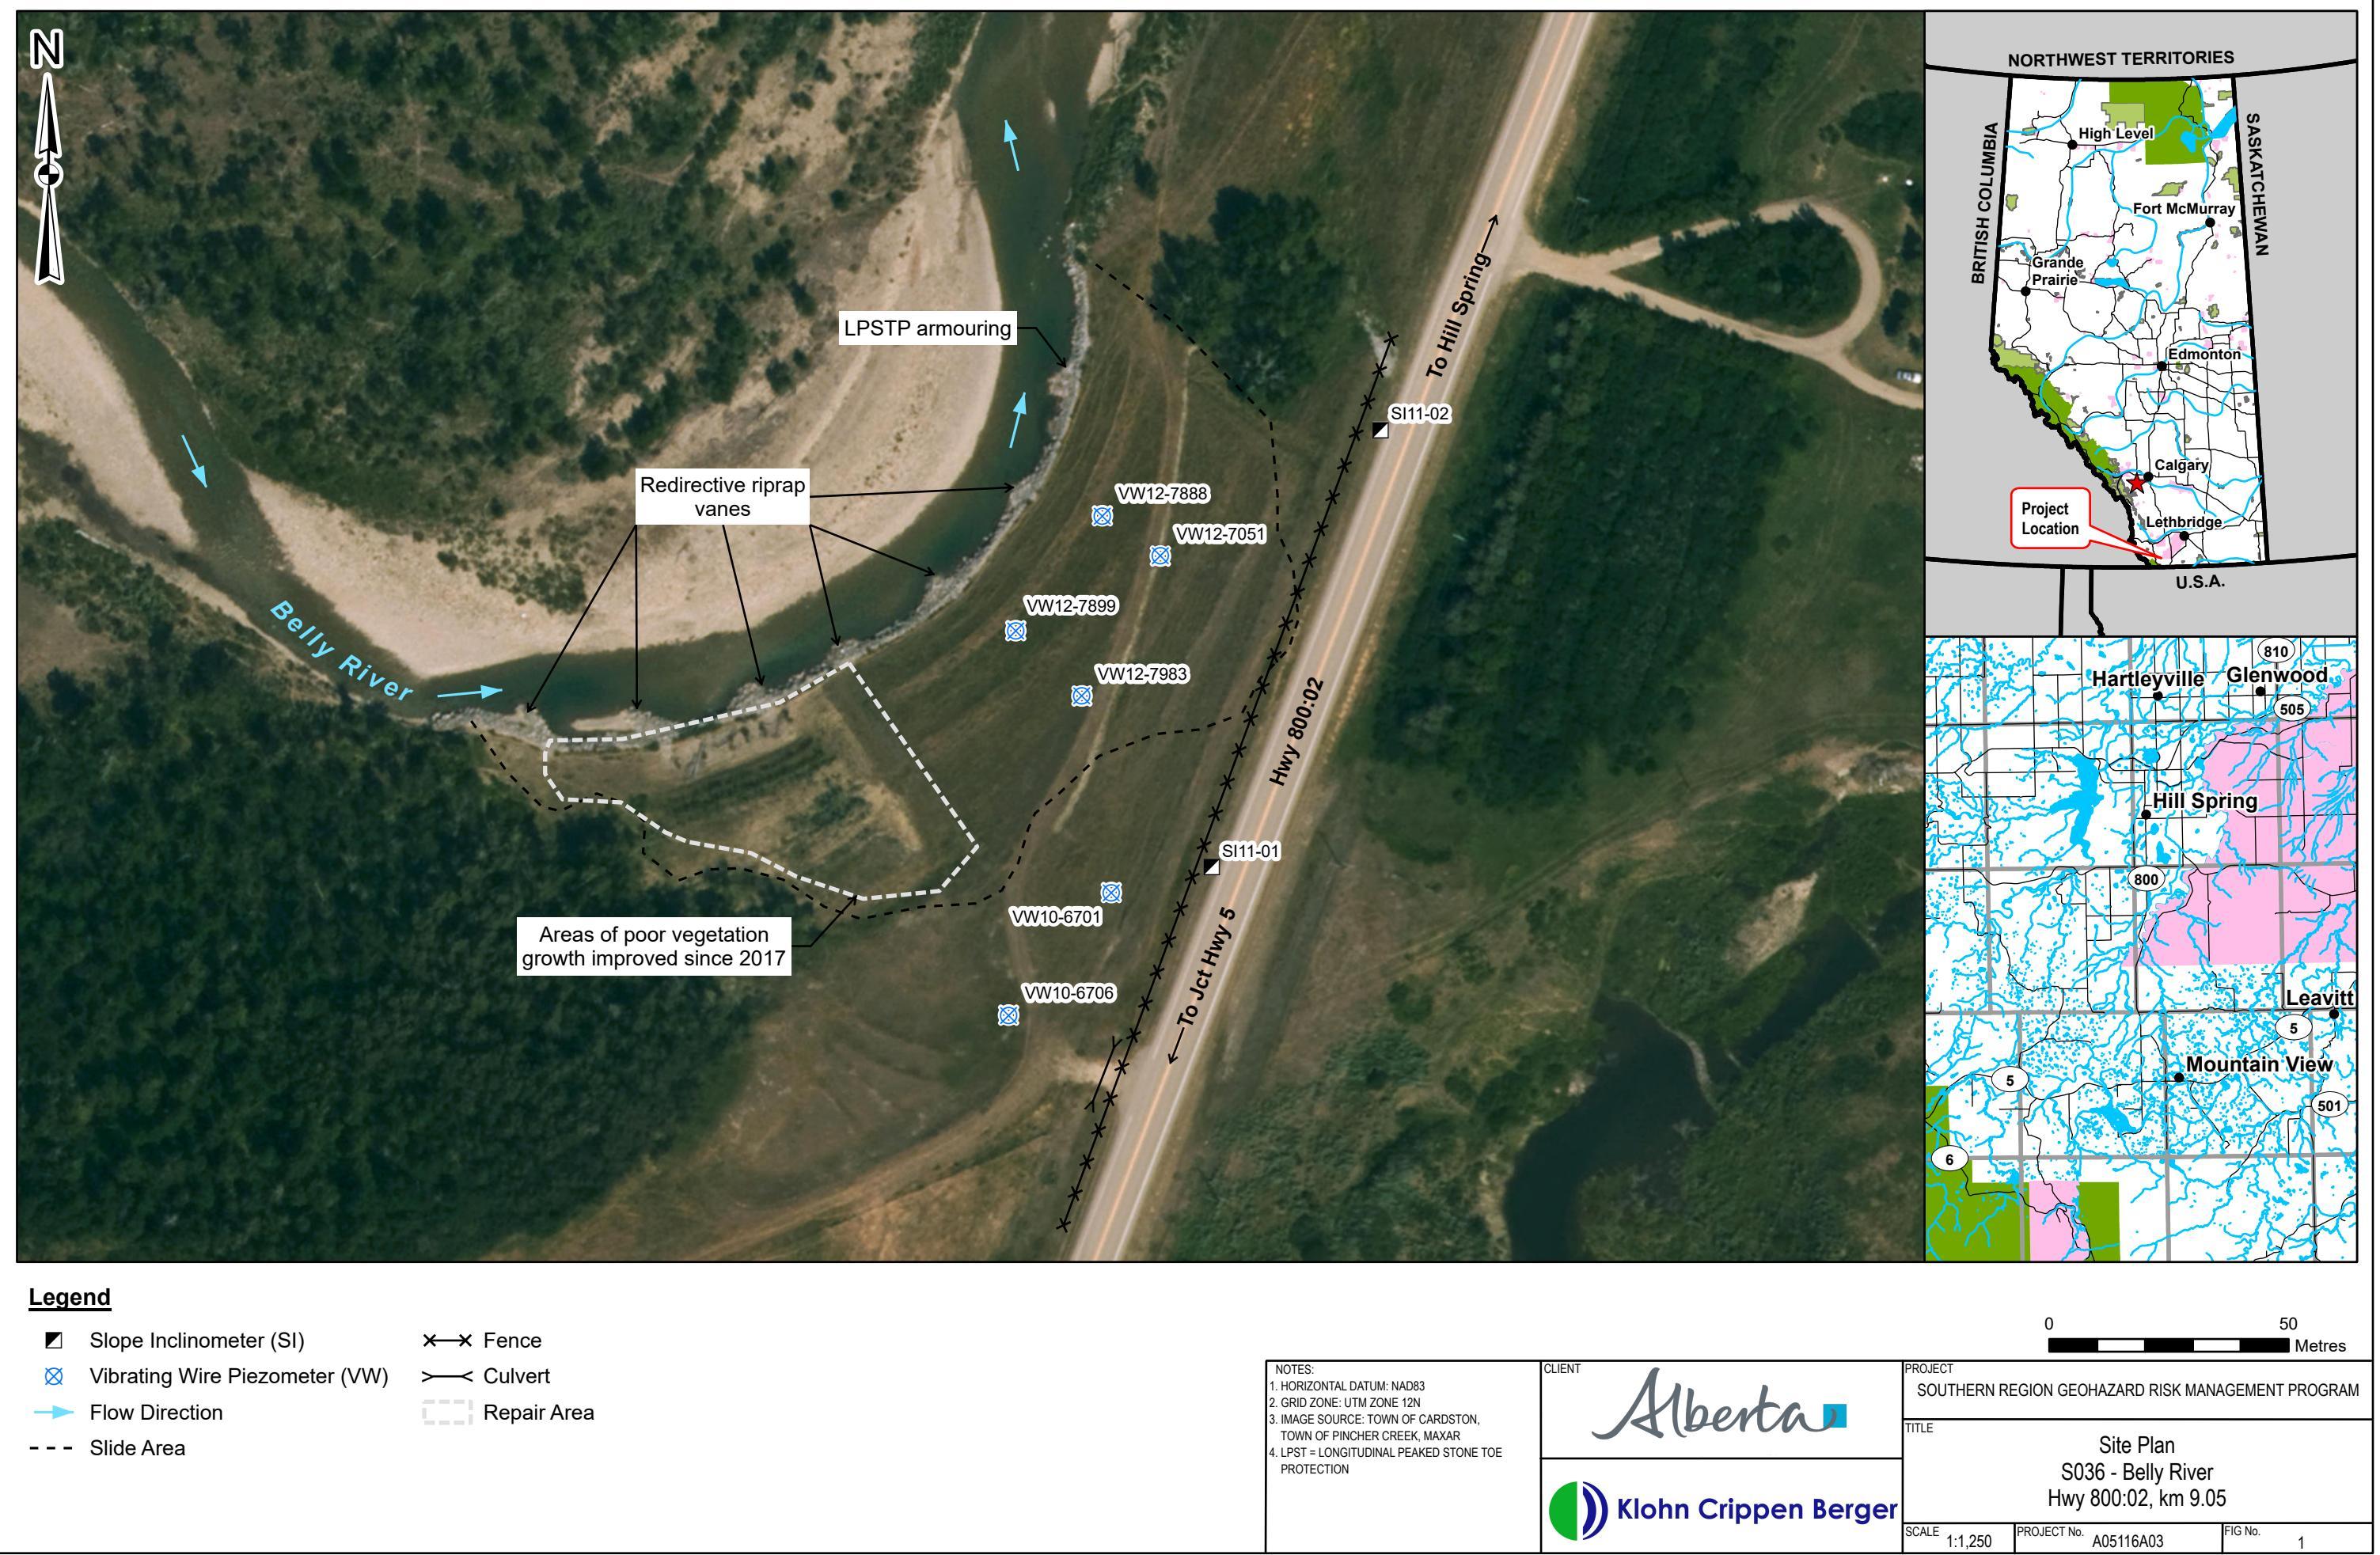
FIGURE

Two slope inclinometers (SIs) (SI11-1 and SI11-2) and six vibrating wire piezometers (VWPs) (VW10-6701, VW10-6706, VW12-7899, VW12-7983, VW12-7888, and VW7051) were read at the S036 site in Southern Region on June 14, 2023, by Mr. Bradley Lawson, E.I.T., of Klohn Crippen Berger Ltd. (KCB). These instruments were read as part of the Southern Region Geohazard Risk Management Program (GRMP). The site is located on Hwy 800:02 km 9.05, approximately 9 km south of the Village of Hill Spring, Alberta, on the east side of the Belly River, in the Blood Tribe 148 Reserve. A permit was issued by Blood Tribe Land Management to Mr. White before the instrumentation readings were completed. The approximate site coordinates are 5454362 N, 308507 E (UTM Zone 12, NAD 83), and the legal land description for the site is NW 18-03-27-W4. A site plan is presented in Figure 1.
