BI-ANNUAL GRMP REVIEW MEETING NORTH CENTRAL REGION: ATHABASCA DISTRICT

Kehiwin Lake Landsides, Hwy 41:23 Near Elk Point, Alberta (NC24): Remedial Measures and Challenges

NC04 Erosion Issues, Hwy 55:10 & 813:02 in Athabasca, Alberta: Remedial Measures

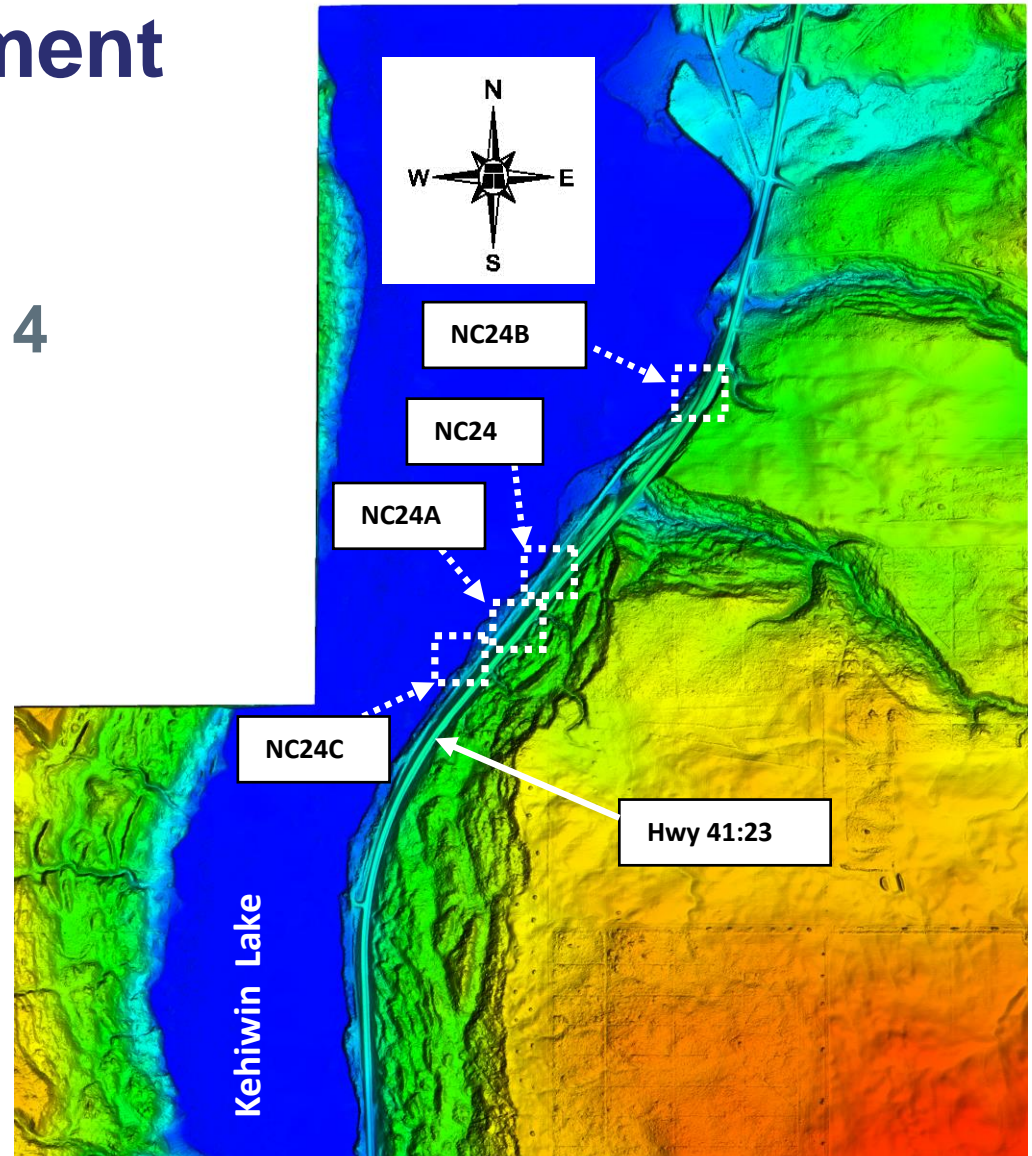
Shaded Relief Plan
Showing Landslide Sites

- Five Landslides between 2001 and 2014
- NC 24- 2001-2009
- NC24A- 2010-2011
- NC 24B- 2010-2011
- NC24C-2011- 2017
- NC24D-2014-2017

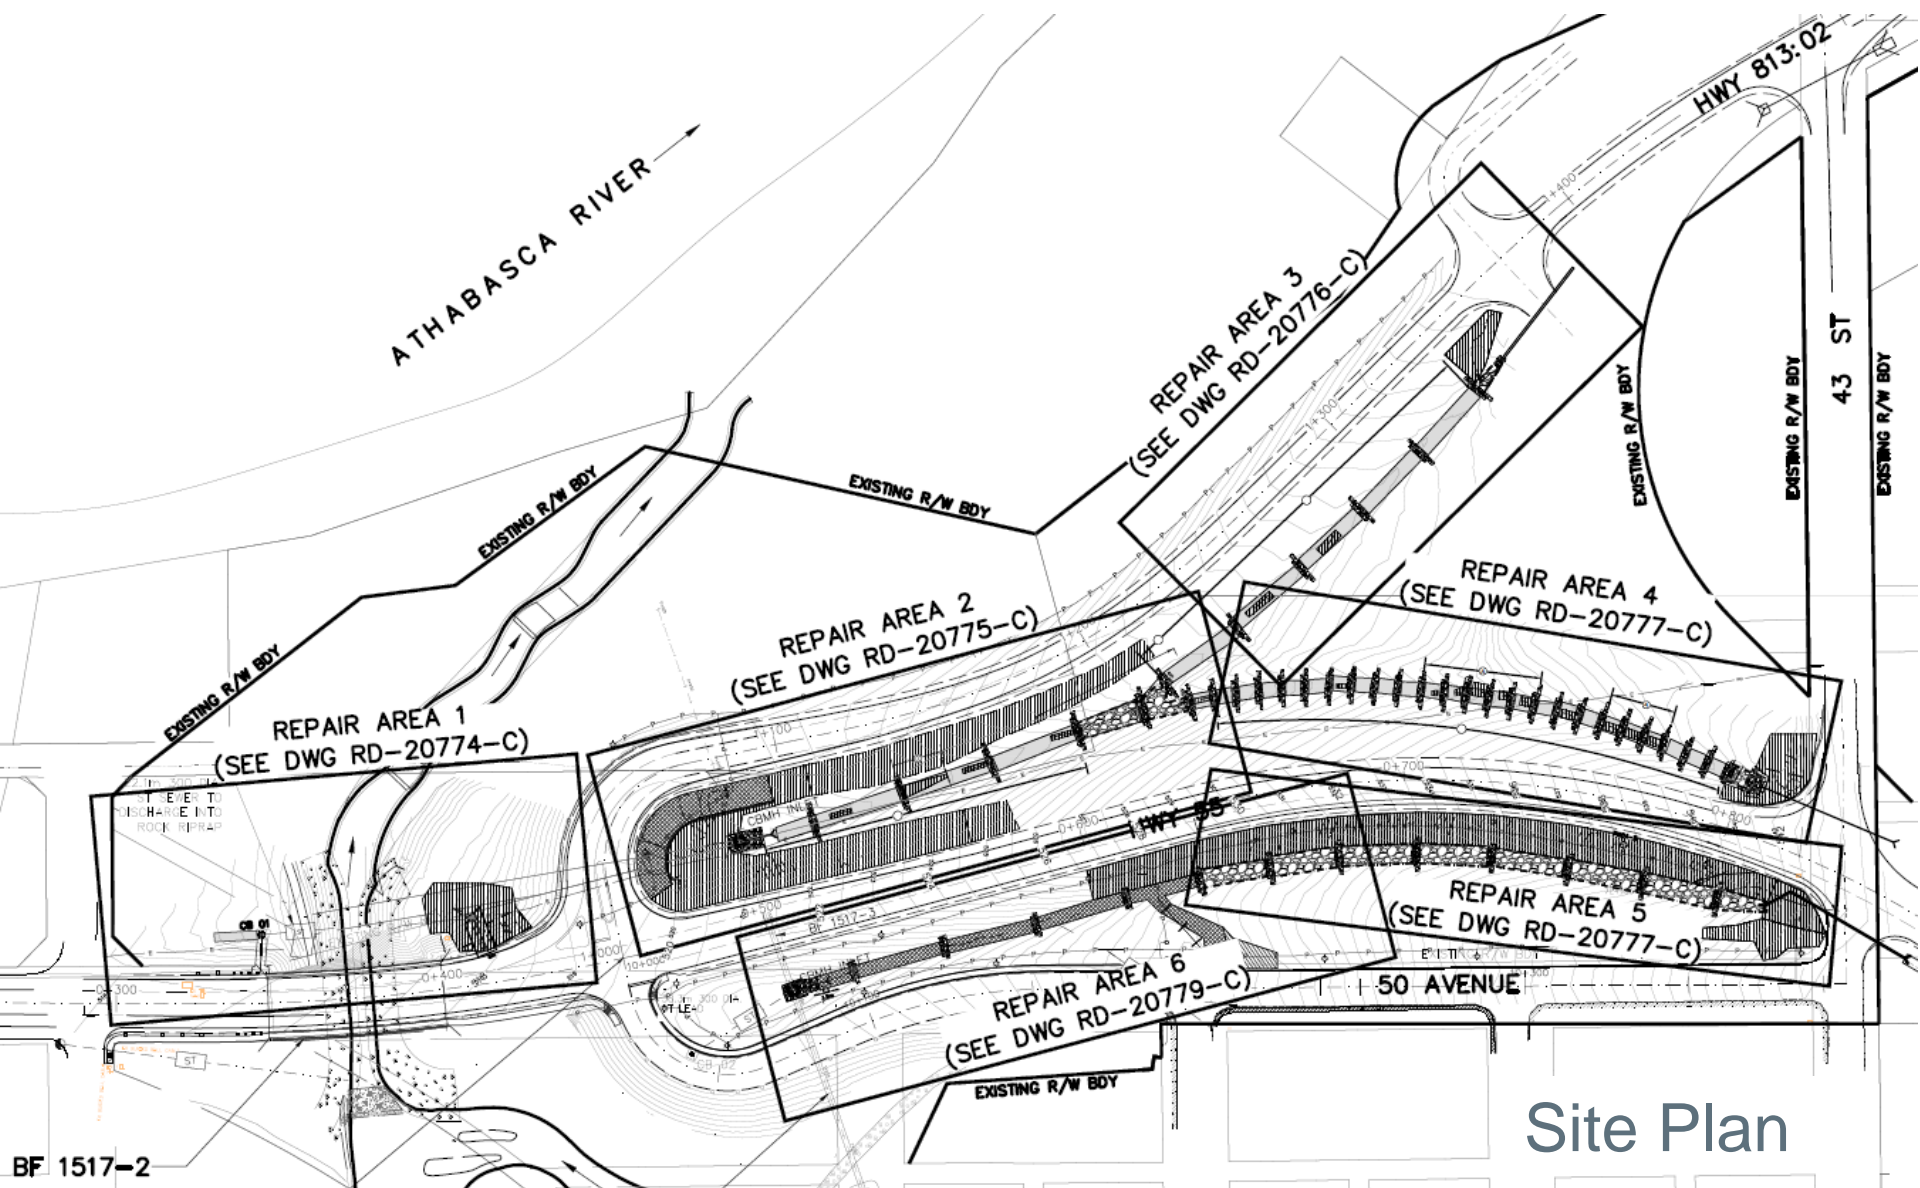
BF 1517-2

- Concentrated runoff flowing over bare slopes
- Bare slopes possibly due to excessive salting of the hill
- Soils in area are sandy and susceptible to erosion
- Gabion weirs at the bottom are space far apart

Regrade ditches and line with combination of Flexamat (rolled concrete blanket) and Class 1M riprap

Compost blanket everywhere else; high-stress areas also covered with permanent TRM

Seed mix was unique blend suggested by Nilex as more salt-resistant than typical AT blends

Add drain trough at NE side of bridge

Widen NW trough and add settling basin

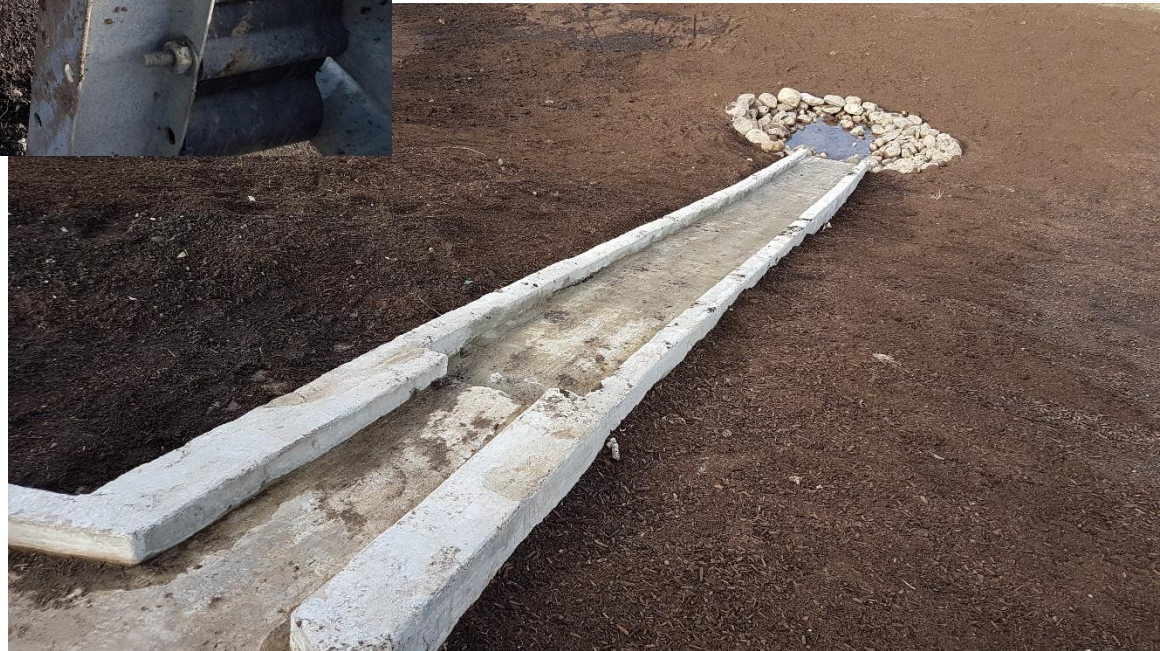
NE corner – new drain
trough with
dissipation bowl

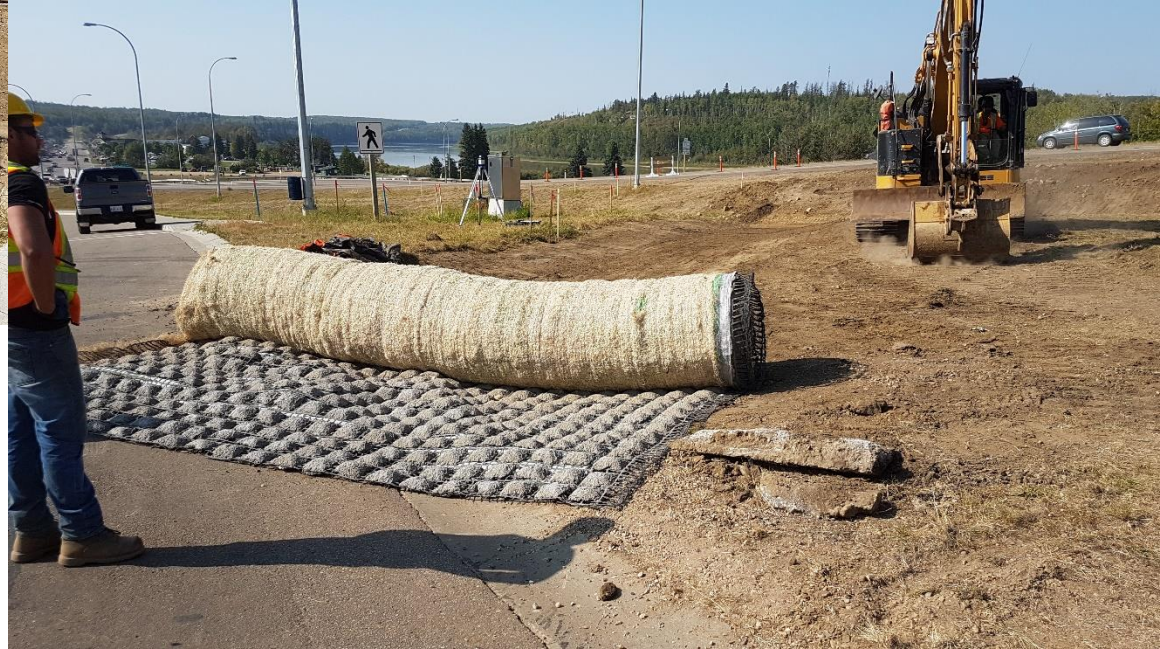
50 Ave: Flexamat placement

Flexamat Standard: beveled concrete blocks approx. 165 mm on each side and 57mm bonded to high-strength bi-axial geogrid with Curlex II ECB – up to 4.9m wide x 15m long

Flexamat Plus: adds Recyclex TRM-V on bottom side for additional erosion protection - \$75/m² installed v \$65/m² for RR

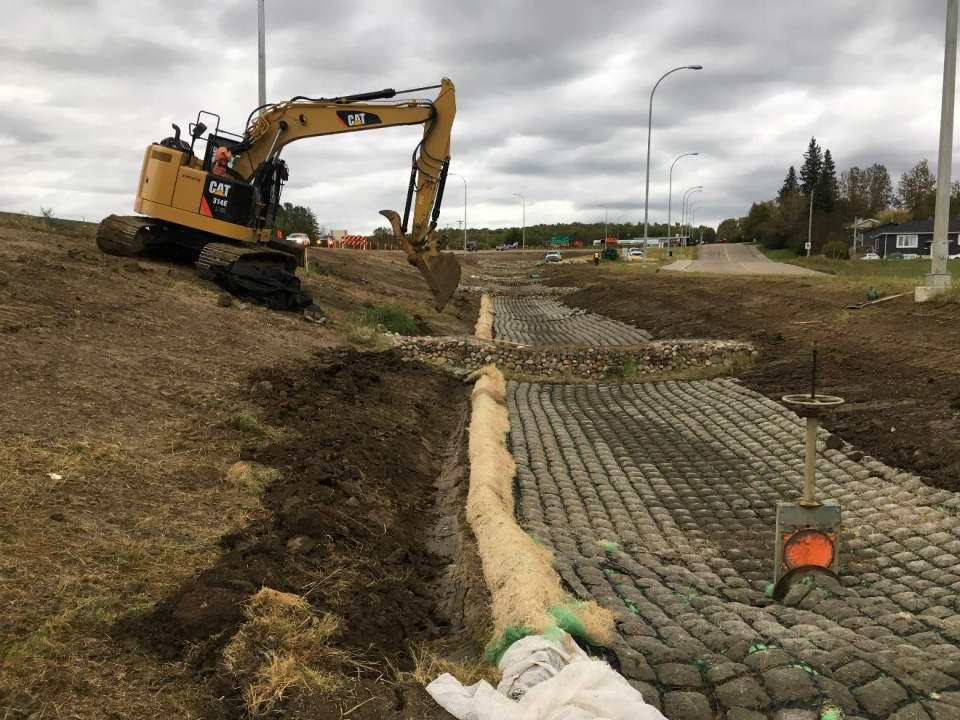
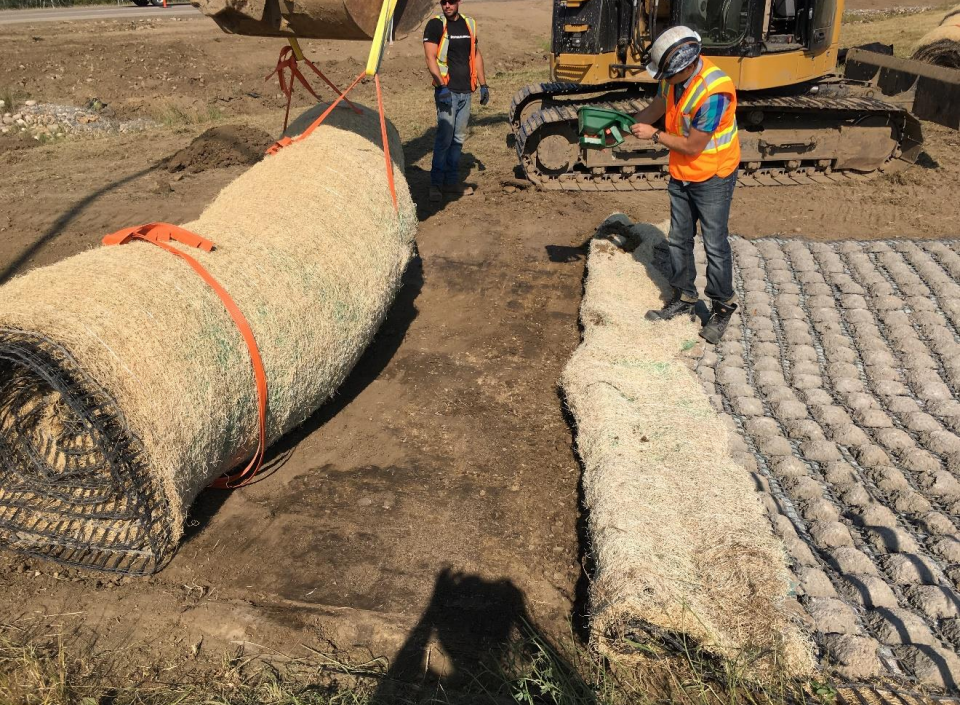
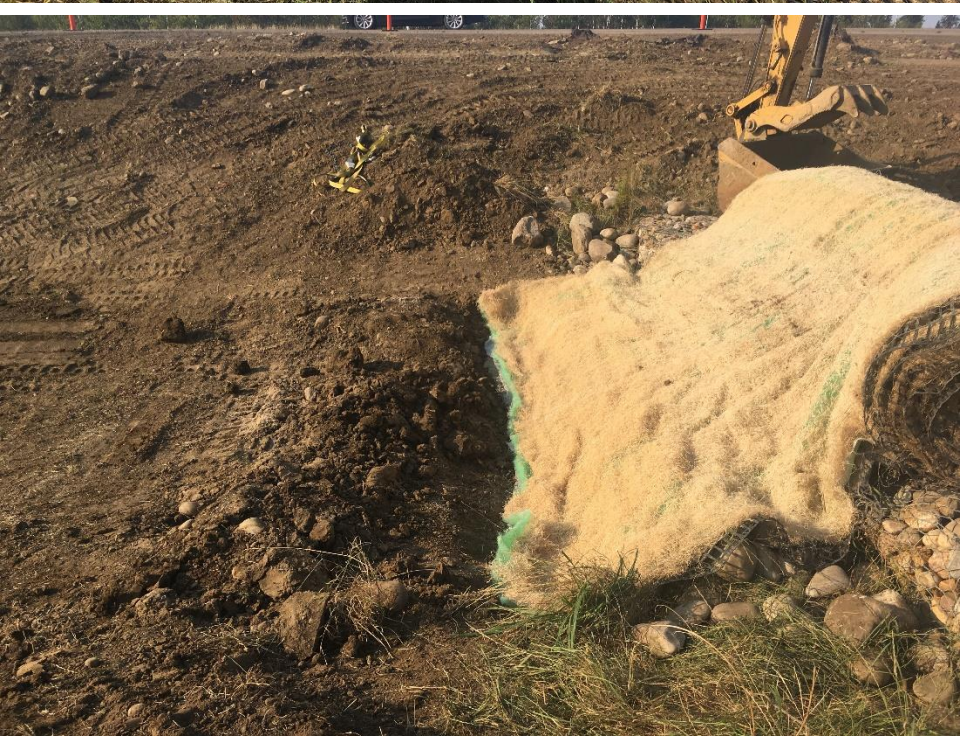
Anchoring and overlapping Flexamat
