July 15, 2025

**CON0022160 Central Region GRMP Instrumentation Monitoring
Site C062; H41:02, km 2.889 Vermillion Backslope
Section C – 2025 Spring Readings**

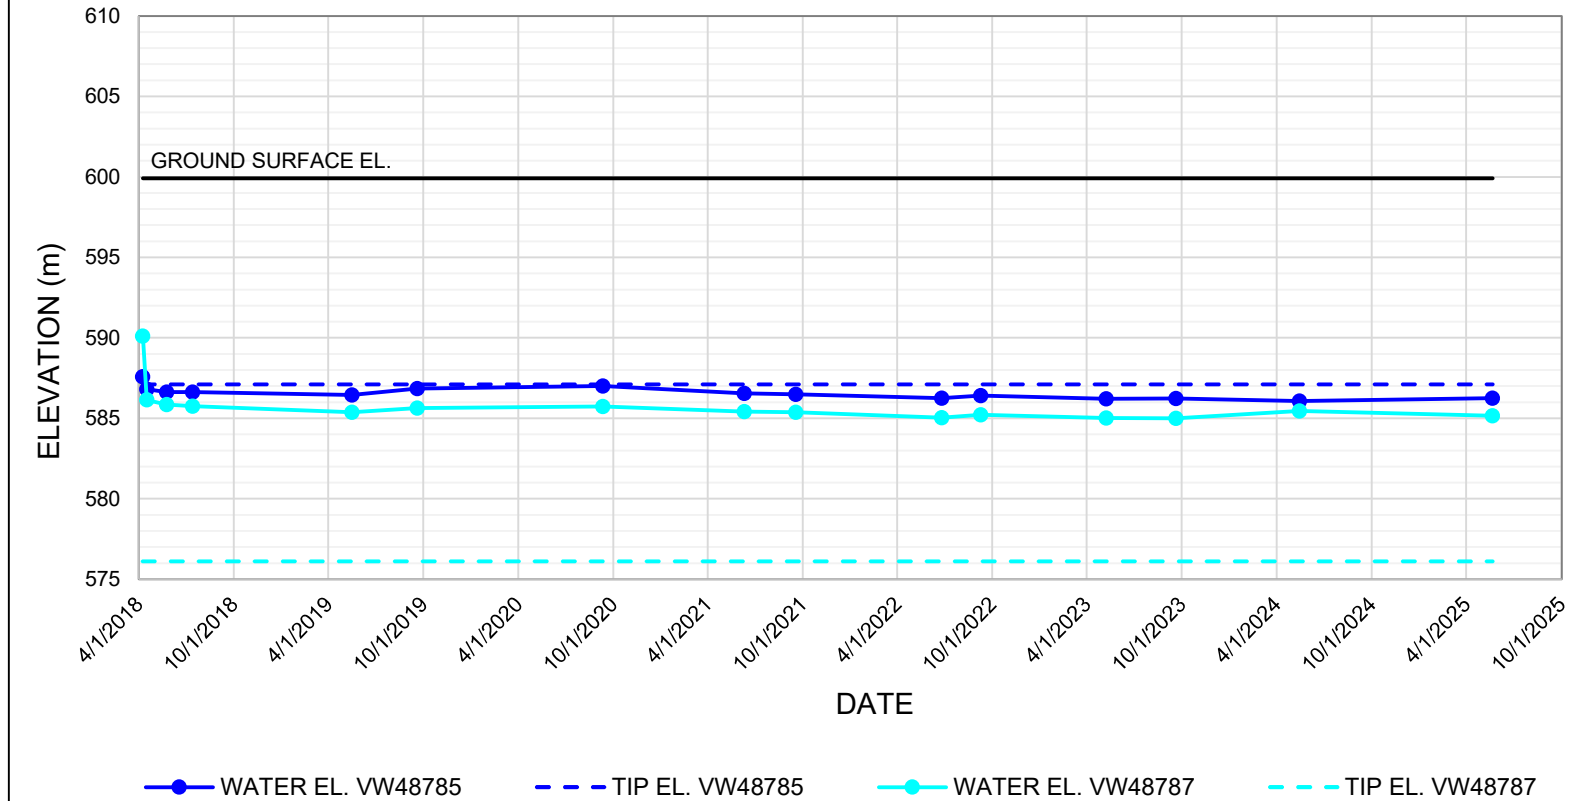
VW48785 AND VW48787 (MIDSLOPE)

The piezometers have been either relatively steady (± 1.5 m) or dry since installation. The May 2025 readings were consistent with historical trends observed in these instruments, except for VW48783 at the crest of the slope, where a 1.1 m increase was recorded between May 2024 and May 2025, despite lower-than-average precipitation recorded by the Vermillion ADGM weather station in the winter and spring months.
