July 15, 2025

**CON0022160 Central Region GRMP Instrumentation Monitoring
Site C042; H579:02 km 36.540 West of Water Valley Slide
Section C – 2025 Spring Readings**

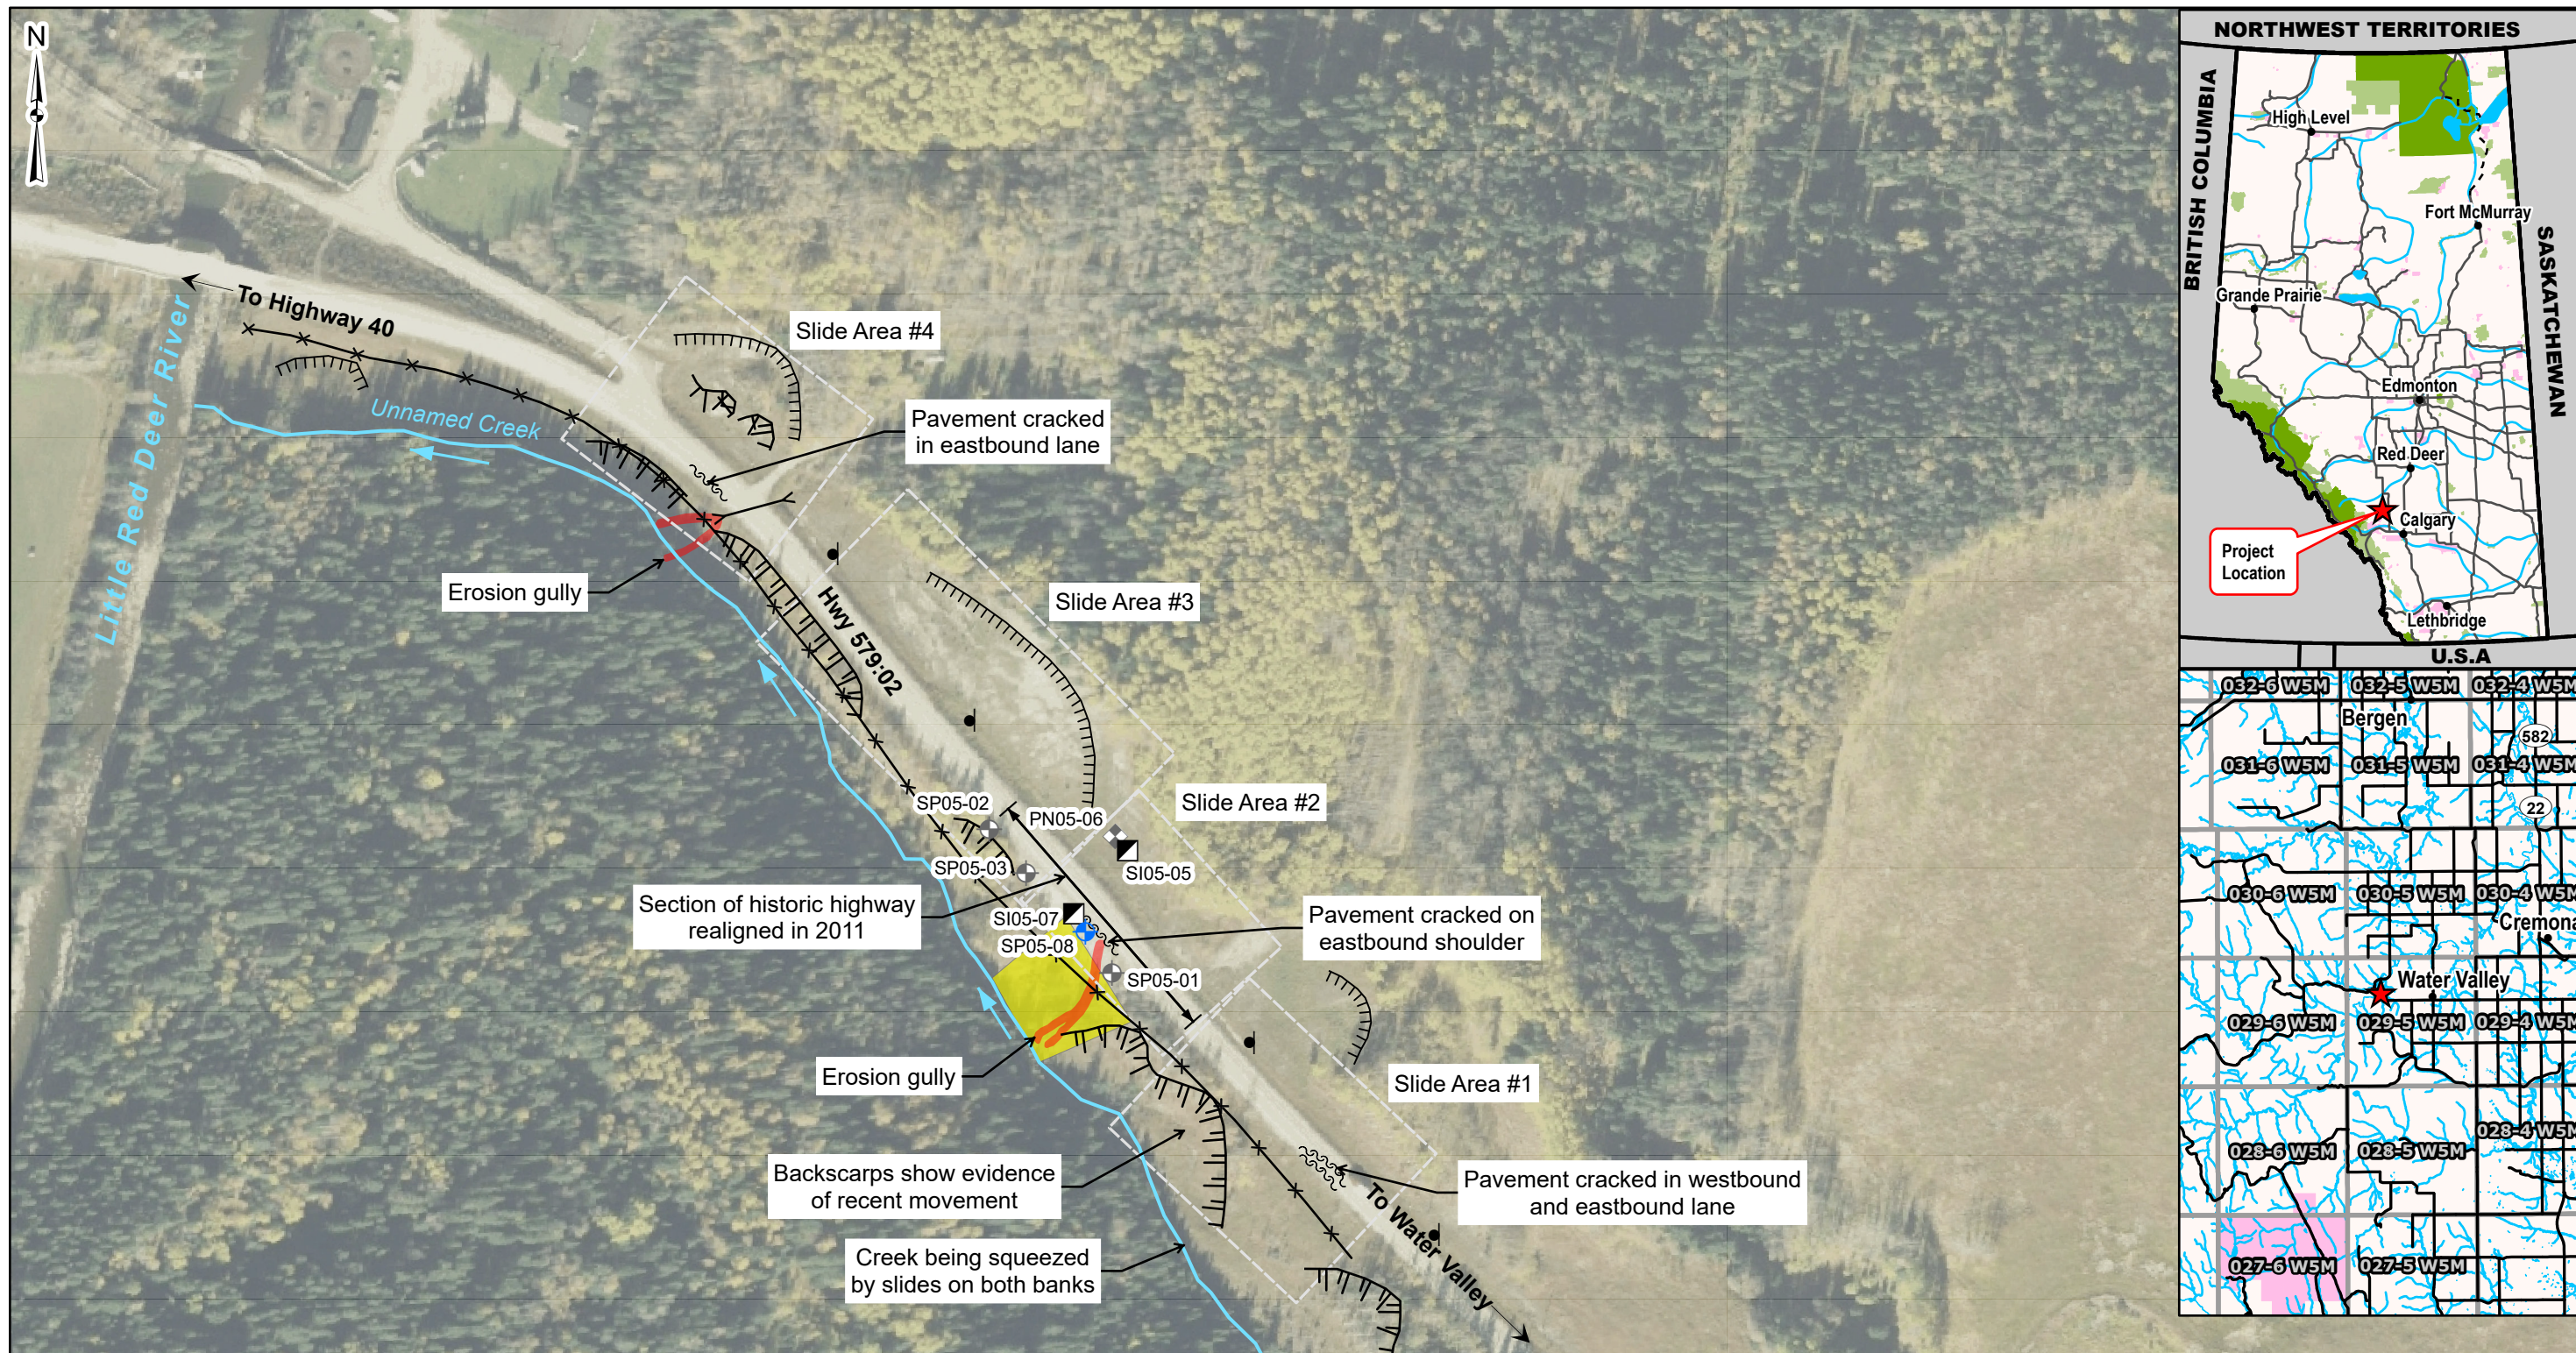
PROJECT CENTRAL REGION GEOHAZARD RISK MANAGEMENT PROGRAM		
TITLE Site Plan C042 - West of Water Valley Slide H579:02, km 36.540		
SCALE 1:2,500	PROJECT No. A05116A02	FIG No. 1

The geohazard at the C042 site consists of a series of valley slope and embankment fill slides along Hwy 579:02 that predominately impact the south side (eastbound lane) of the highway. Following a slide in 1995, a portion of the slope was excavated and backfilled with granular fill. A drainage blanket was placed at the base of the excavation, and a drain was placed in a groundwater spring. In 2011, a section of Hwy 579:02 was realigned north (upslope) towards the backslope.

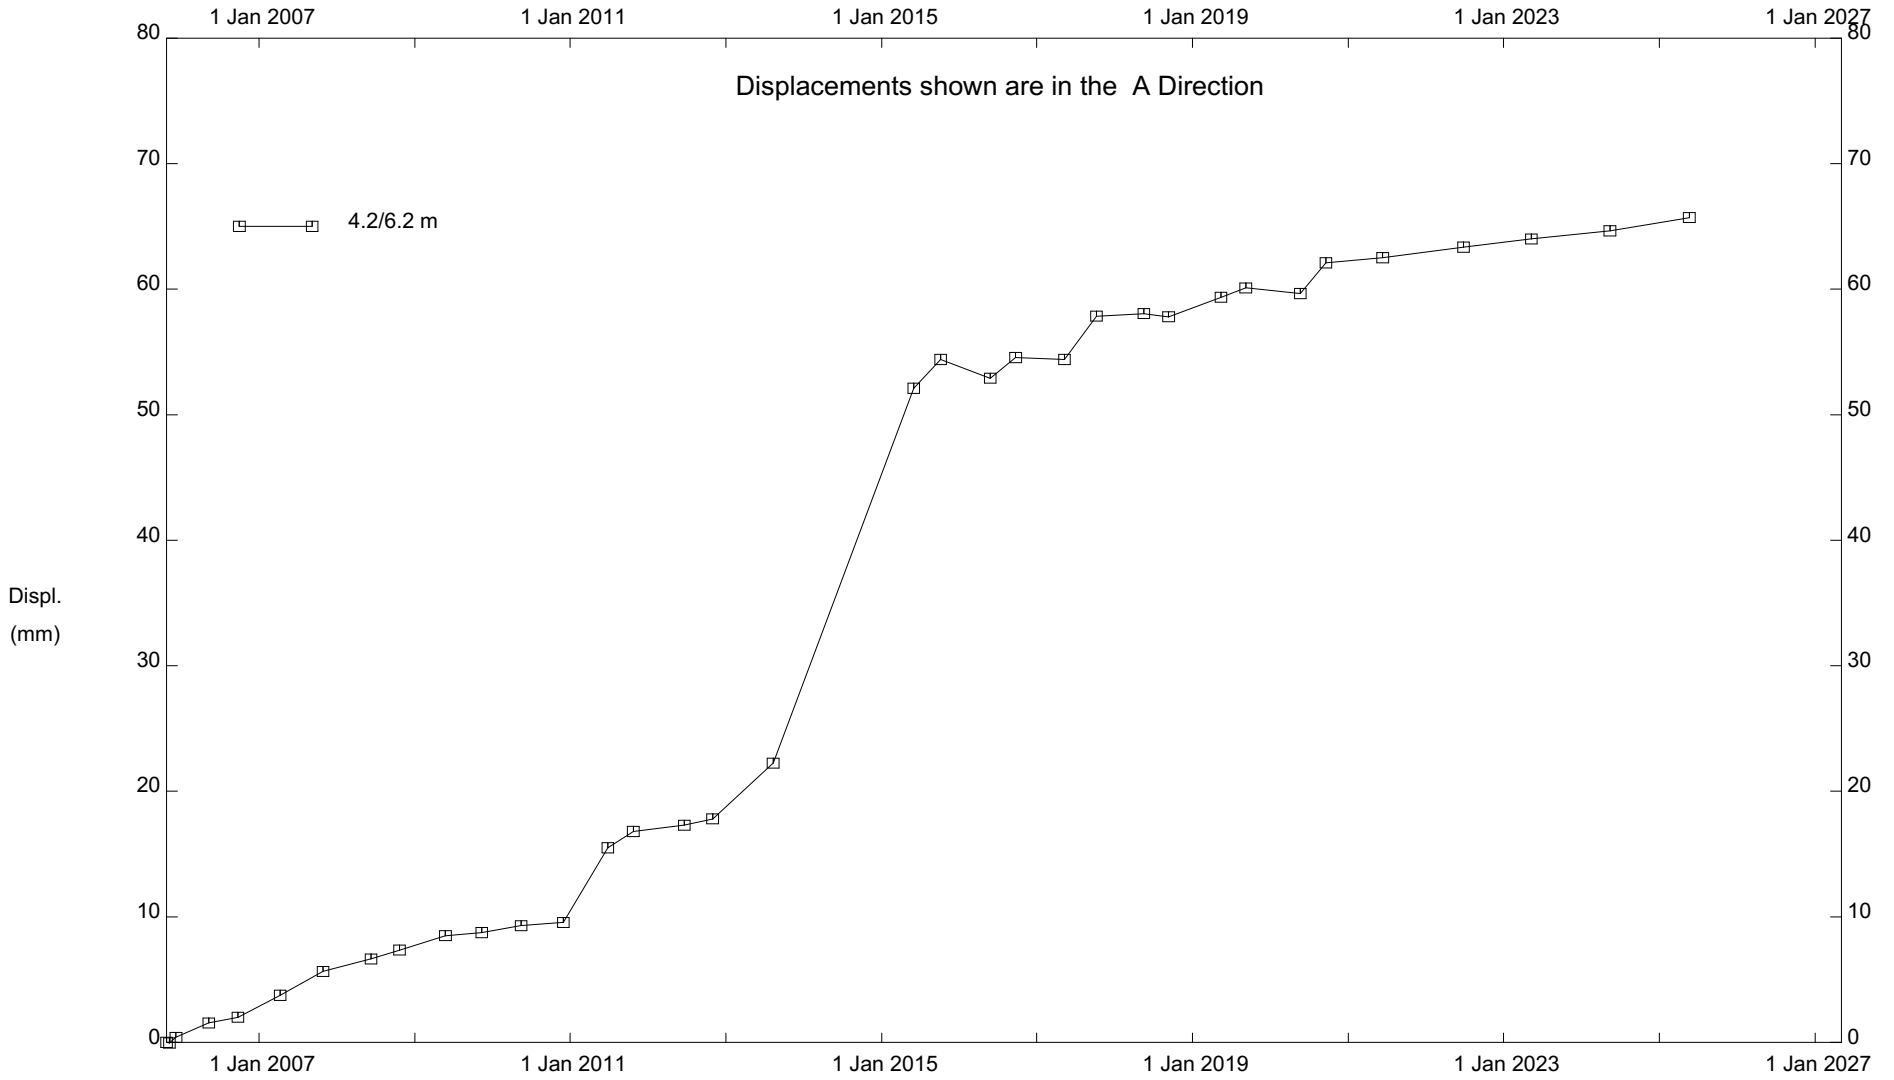
C042; H579:02, West of Water Valley Slide, Inclinometer SI05-07
 Alberta Transportation

The rate of movement recorded since spring 2021 has been slow (less than 1 mm/year). This was likely due to relatively dry weather throughout the past four years (excluding June and July 2022, see the precipitation data plotted on the piezometer plots). For comparison, the rate of movement in the previous wet year (2020) was approximately 7 mm/year. Increased movement may occur in response to periods of heavy or prolonged rainfall, resulting in higher groundwater conditions.

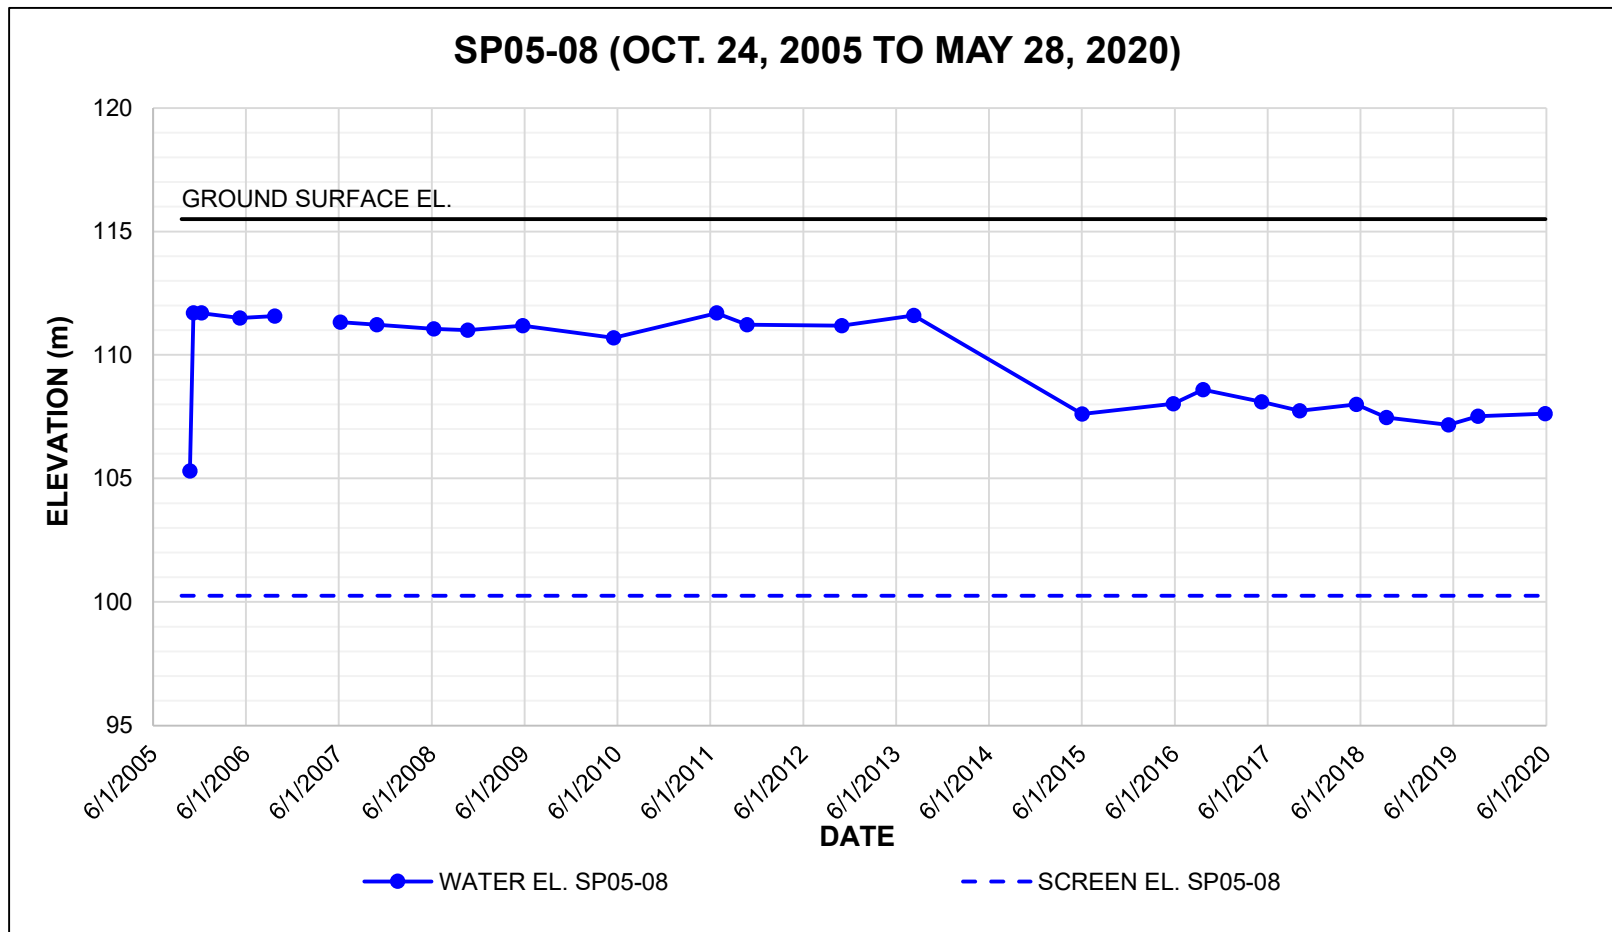
C042; H579:02, West of Water Valley Slide, Inclinator SI05-07

Upon review of the data obtained from the Heron data logger between May 2020 and May 2024, there appears to be a relatively strong relationship between precipitation and water level response (e.g., water level increases in response to increased rainfall in fall 2021). There are multiple precipitation events where there is no response recorded in SP05-08. However, these events were during winter months when the ground was frozen and there was no infiltration. It also appears that increases in the groundwater table in response to precipitation events were short-lived. However, these increases in groundwater could lead to increased rates of movement, before decreasing as the groundwater table decreases.

A manual reading was taken in spring 2025 for SP05-08 since the data logger was removed. The recorded water level increased (approximately by 3.8 m) between spring 2024 and 2025 and was within 0.3 of ground surface. KCB suspects the instrument casing may have cracked between the 2024 and 2025 readings, leading to infiltration into the casing, as the rainfall for April and May 2025 were similar to historic averages and do not support such a large increase.
