**ALBERTA TRANSPORTATION AND
ECONOMIC CORRIDORS
GEOHAZARD RISK MANAGEMENT PROGRAM
PEACE REGION (PEACE RIVER DISTRICT)
2025 INSPECTION**

Site Number	Location	Name	Hwy	km
SH010-1	Little Smoky River West Valley Slope	Little Smoky River Valley, South Hill – Site #1	744:02	14.4-14.7
Legal Description		UTM Co-ordinates		
NE-13-76-23-W5		11U E 473,759	N	6,160,016

SH010: HWY 744:02 LITTLE SMOKY RIVER VALLEY (SITE #1)

2025 SITE INSPECTION PLAN

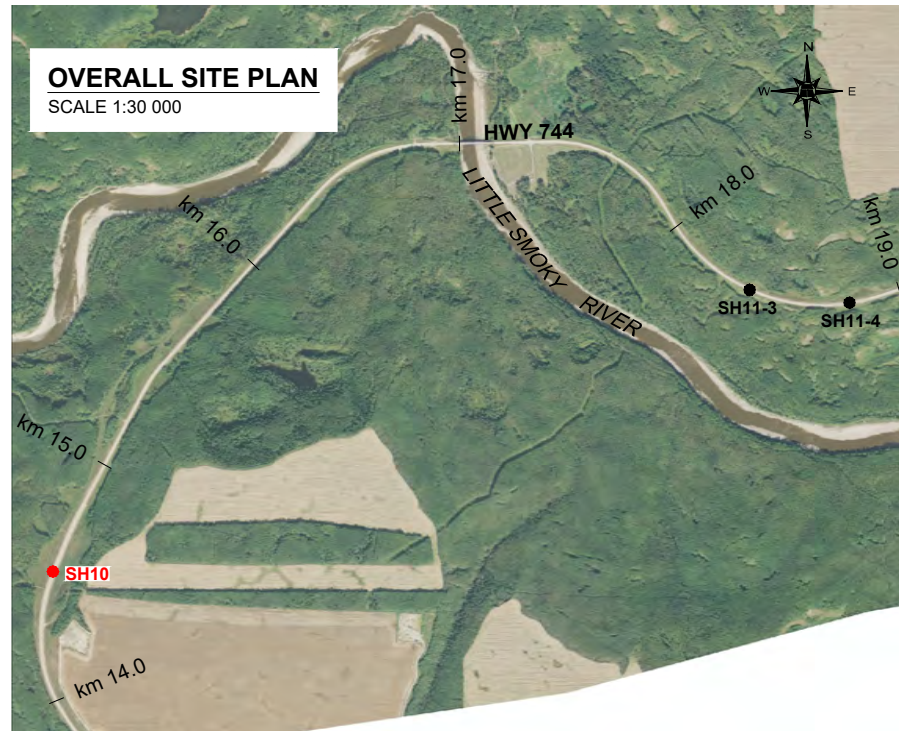
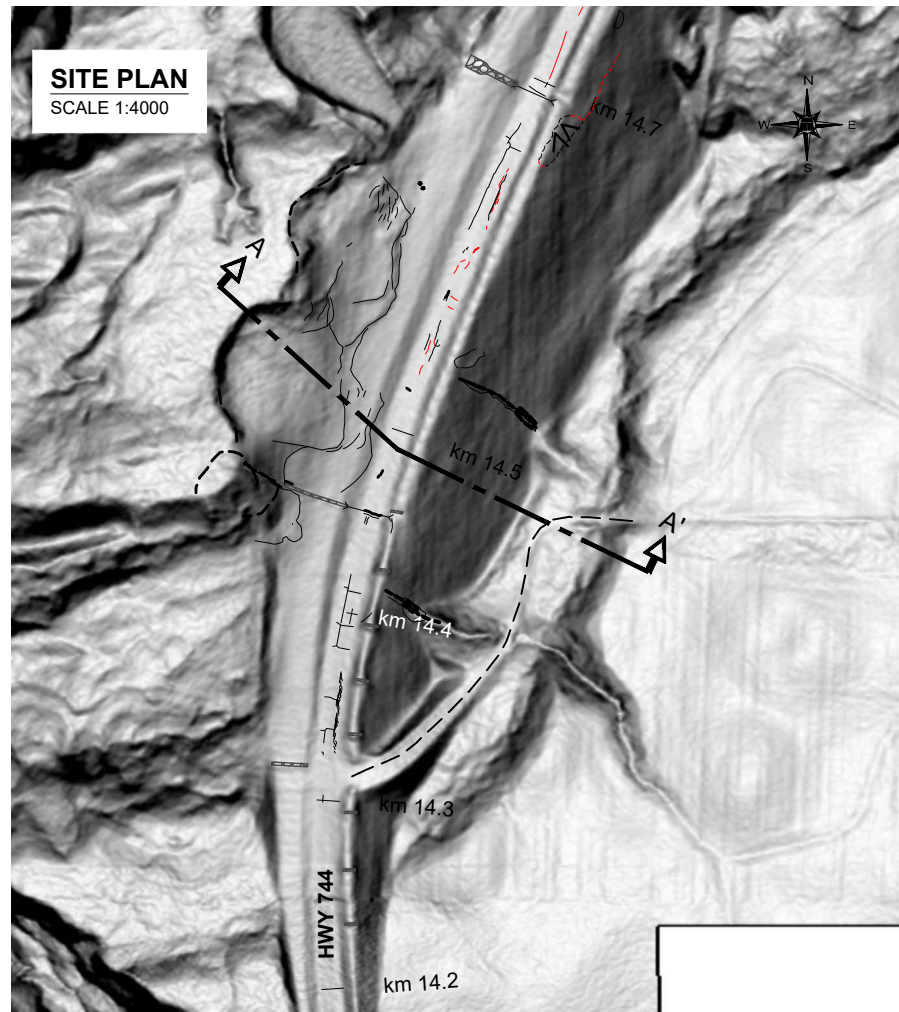
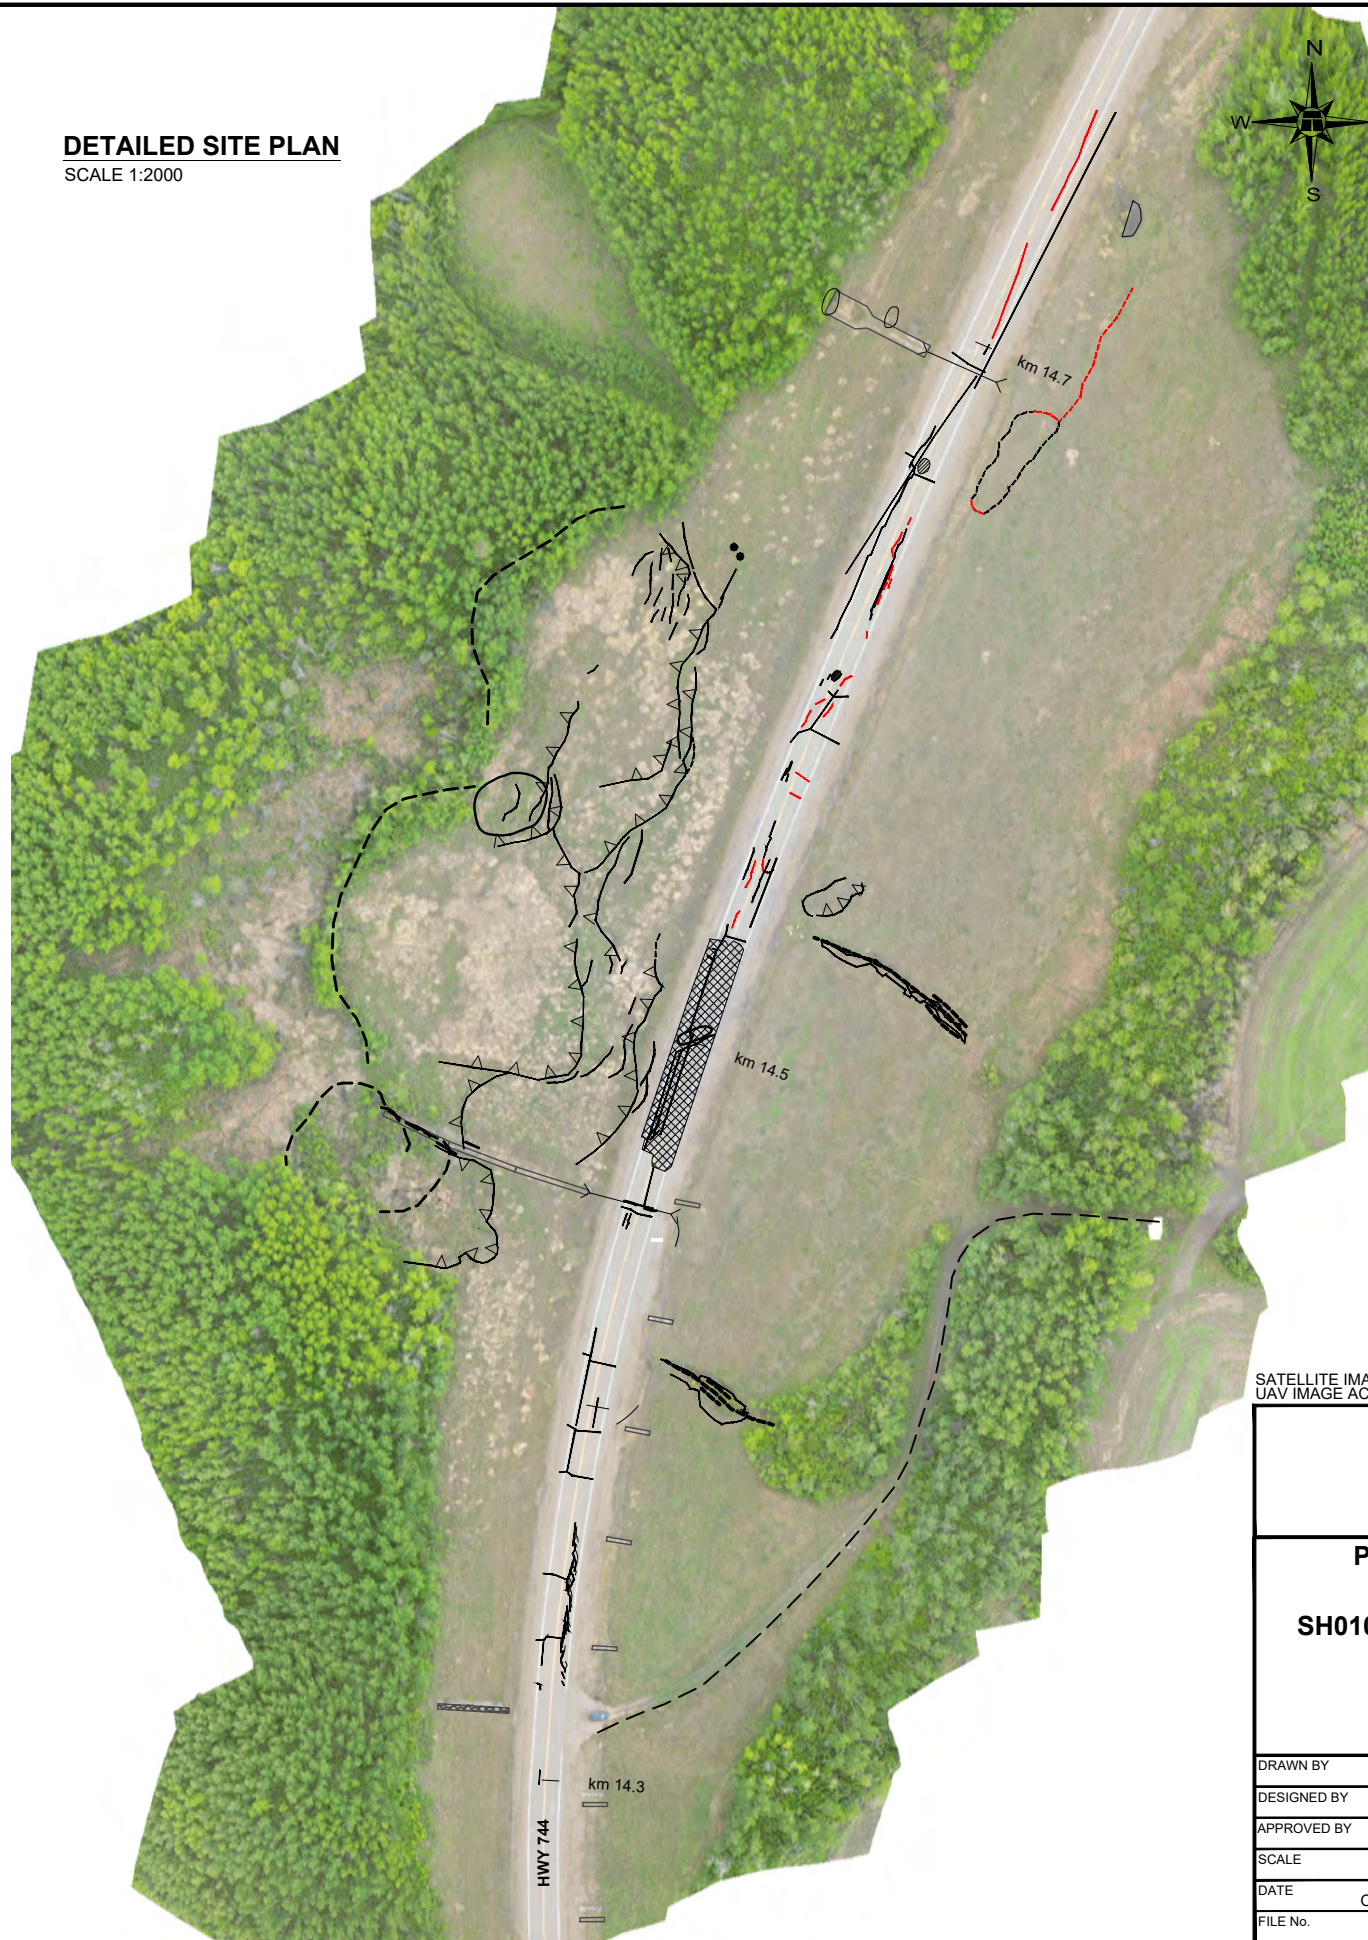
G:\32000\32121\AT GRMP Peace River District 2021-2025\CAD\2025 GEOHAZARD\IMG\32121\SH010-1.dwg - 1 - Oct. 01, 2025

CRACKS 10-20mm WIDE (2022)
CRACKS 10-30mm WIDE, 0mm DIFF (2024)
5-40mm WIDE, 0mm DIFF (2025)

SCARP CRACK, 300mm HIGH
ALONG FLANKS, 900mm HIGH
IN CENTER OF SLIDE (2025)

DIP, CRACKS

ALLIGATOR CRACKING
