8.0 CHAPTER 8 - TIMBER CORING

8.1 INTRODUCTION

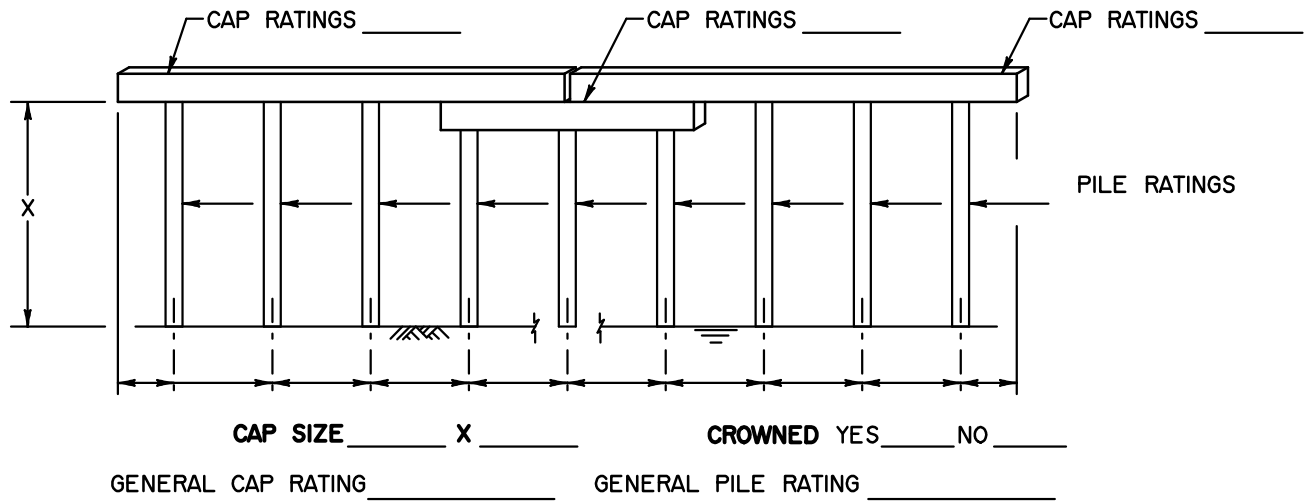
Each form has a sketch of a timber abutment or pier bent. Also each form has tables for recording the condition of the cores taken in timber caps/corbels and in timber piles. Each table has a number of thumbnails with descriptions into which each core location can be recorded. The form also has another table where other defects of timber piles can be recorded.

- In the tables provided record the identifying number of the timber cores that fit each thumbnail sketch description.
- For timber piles record location of any other defects noted.
