## 6.0 CHAPTER 6 - DECK JOINTS

### 6.1 PURPOSE OF DECK JOINTS

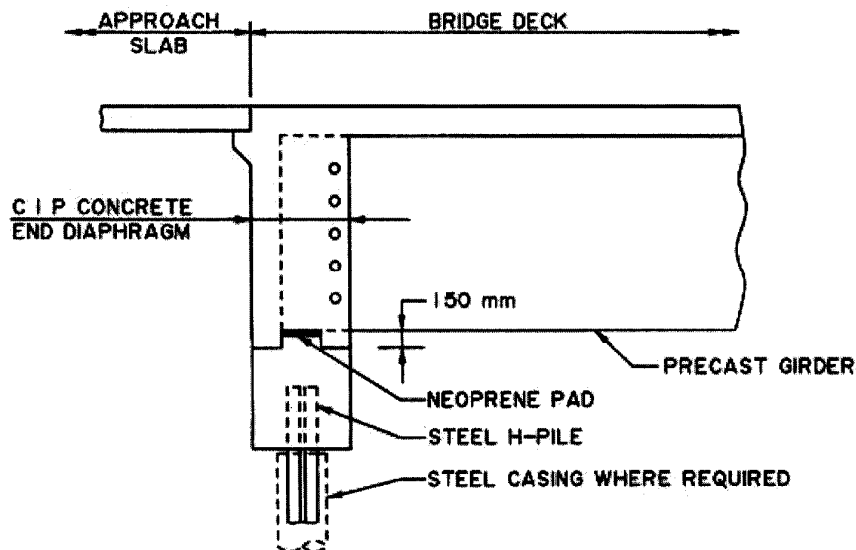
Figure 6-1 Full Integral Abutment

All types of deck joints require some type of maintenance and in recent years there has been a movement among bridge designers to design the shorter bridges without deck joints. The girders and deck are made continuous over the piers and the ends of the deck at the abutments are made integral with the abutment backwalls. Any thermal movements are accommodated by flexing of the abutments and stresses in the superstructure. The Department now uses integral abutment design for all concrete girder bridges of total length of less than 50m and steel girder bridges of total length less than 40m and may in some cases use integral abutment design for longer structures. Sketches of an integral abutment can be seen in Figures 6.1 & 6.2.

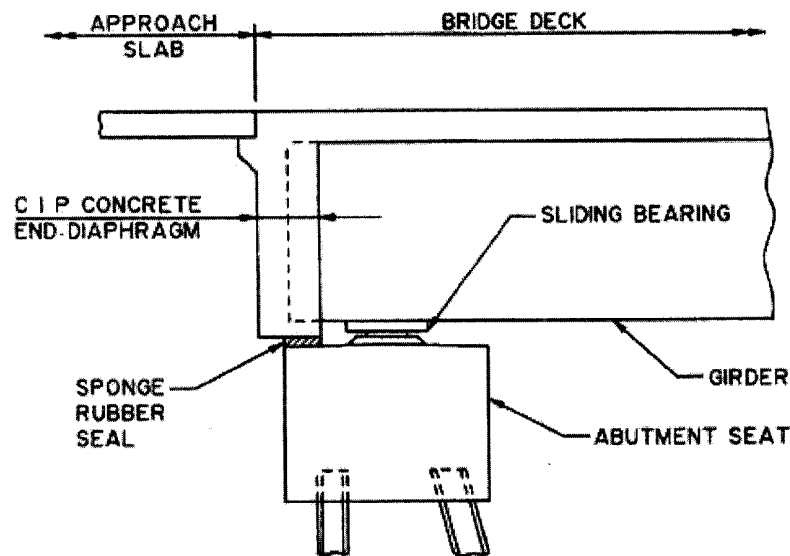
Figure 6-2 Semi-integral Abutment

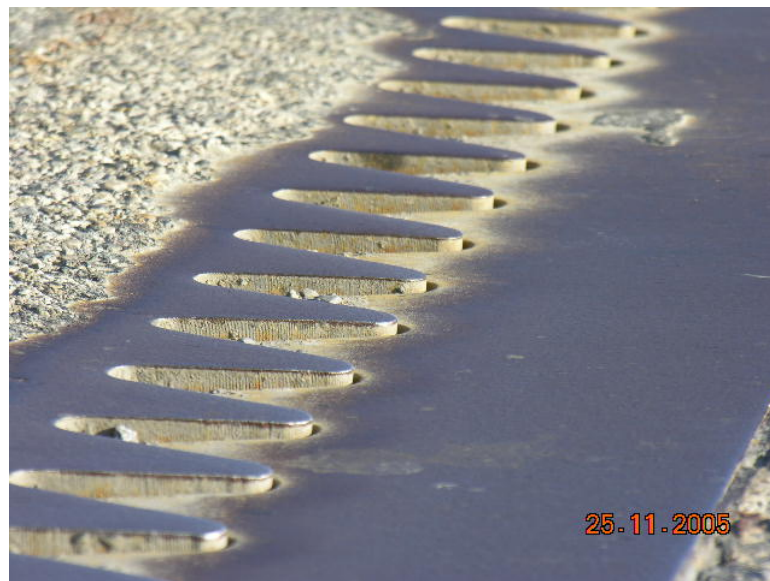
**Figure 6-3 Vertical misalignment of finger joint**

- A common defect with this type of joint is gaps between the finger plate and the plate it is sliding on (see picture Figure 6.3). This defect has a number of different causes. Deflection of the girders from the dead weight of the deck can cause the one side of the joint to rotate. To prevent this, these joints are generally now placed after the concrete deck has been cast and this rotation has taken place. Another cause of this gap can be settlement or rotation of the abutment. Distortion of the plates due to welding during the manufacture or improper installation can also cause this problem. If not fixed, stresses in the finger plate due to heavy truck traffic can cause cracking of the welds and the plates. Also, the ends of a sticking up finger can be caught by snow plows which can cause damage to the joint and plow and create a potential hazard. This defect can be difficult to solve. Heating and bending of the fingers is sometimes used. Shims are sometimes placed under the finger plate. In some cases the joint must be removed and reset.

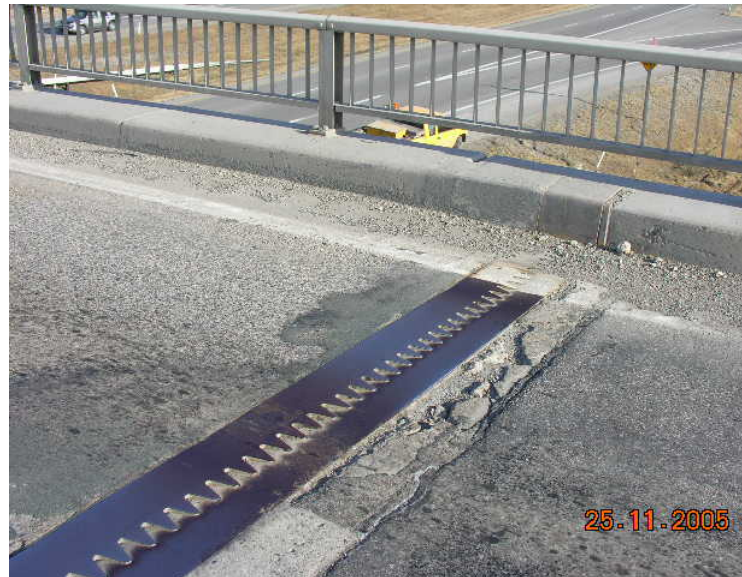
**Figure 6-4 Deterioration of concrete paving lip**

- Deterioration of the concrete paving lips at the finger joint is another common defect (see picture Figure 6.4). The concrete around these joints often does not get properly compacted and the joint generally creates somewhat of a bump where there is a pounding of this concrete by heavy traffic.

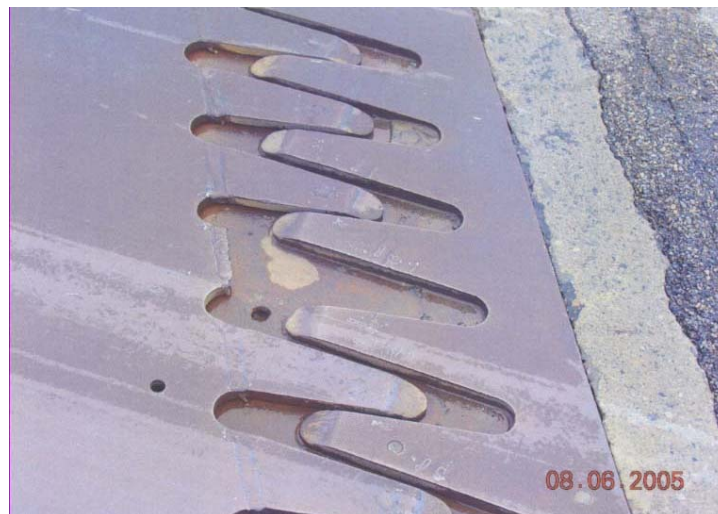
**Figure 6-5 Fingers not properly aligned and broken finger**

- The steel fingers are sometimes not aligned properly so that the finger surface on one side will close before the other (see picture Figure 6.5). This can be an indication of some transverse movement of the bridge or abutment. However, it can also be caused by improper manufacture or installation of the joint.

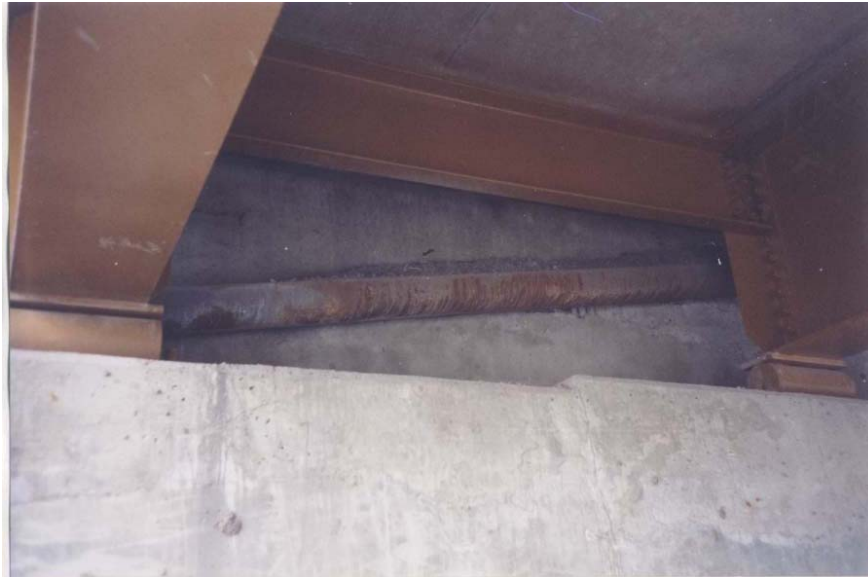
**Figure 6-6 Drain filled with sand and starting to corrode**

- Problems with the drainage system are common for these joints (see picture Figure 6.6). Sand and debris often fill the trough drains blocking the flow of any water. Also in some cases there is leakage between the trough drains and the backwall to which it is attached. On older structures the trough drains may be heavily corroded with numerous perforations.

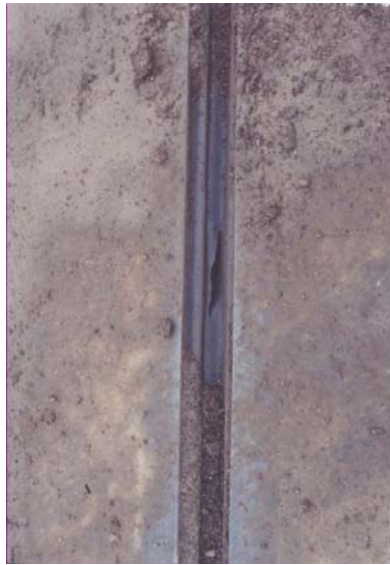
**Figure 6-7 Torn seal**

- A common defect with this type of joint is torn or dislodged seals (see pictures Figure 6.7 & 6.8). Minor tears in a seal can sometimes be repaired but replacement of the seal is normally required for this defect. If the seal has been dislodged out of the extrusion it can sometimes be placed back in the extrusion if there is no other damage to the seal.

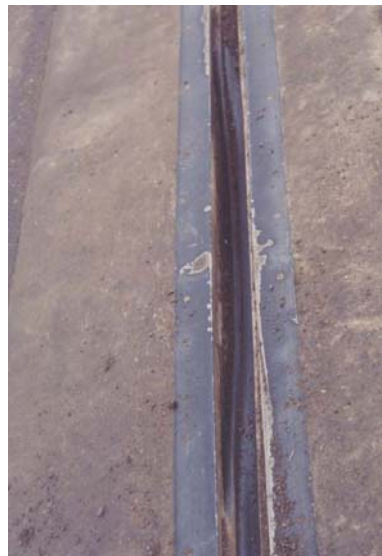
**Figure 6-8 Dislodged seal**

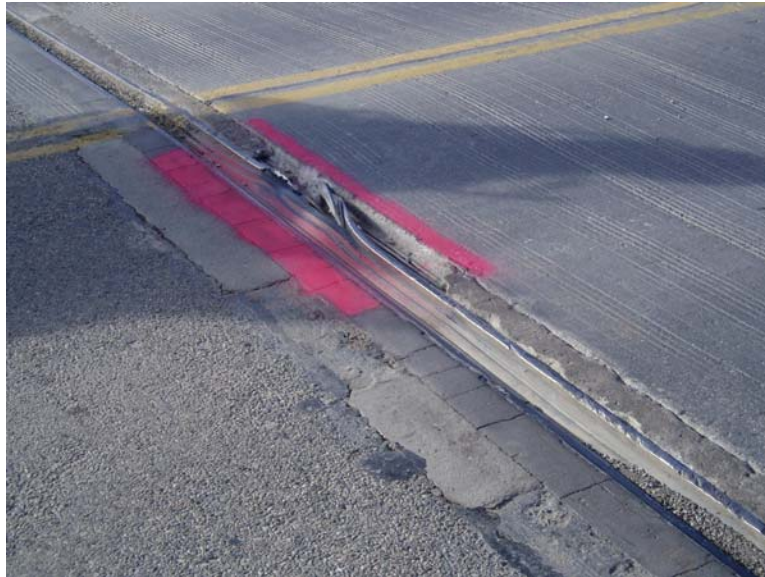
**Figure 6.9** Damage to metal extrusion

- Damage to the metal extrusions from snow plows is another problem with this type of joint (see picture Figure 6.9). Repair of this problem involves removal and replacement of the damaged section of the extrusion. It will also normally require the replacement of the seal. The present practice for these joints is to recess the joint extrusion slightly below the deck surface to help prevent this problem.

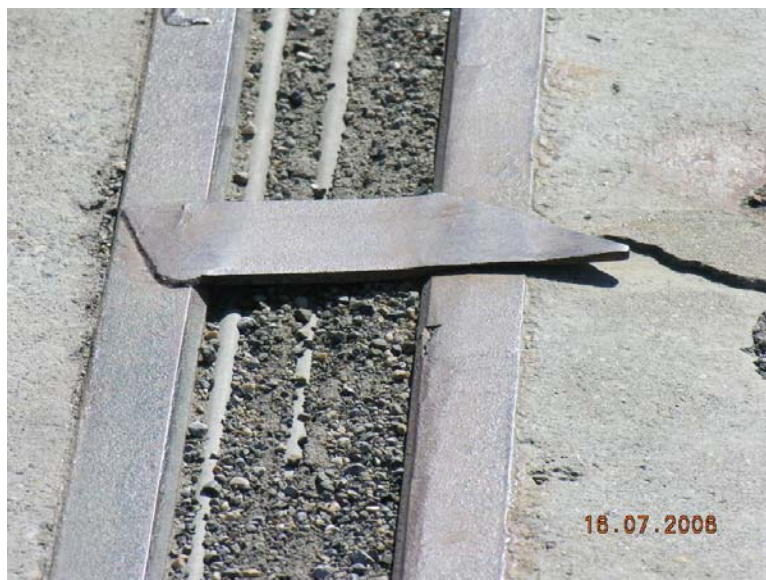
**Figure 6.10** Damaged snow plow guard

joint causing damage to the joint and plow. Generally, this is only a concern on bridges having a skew of 20 to 45 degrees. To prevent this problem metal straps, called snow plow guards, are welded to one side of the extrusion extending across the joint opening (see picture Figure 6.10). However, due to heavy truck traffic, these straps can be a maintenance problem with the welds anchoring the straps or the straps themselves breaking and requiring replacement.

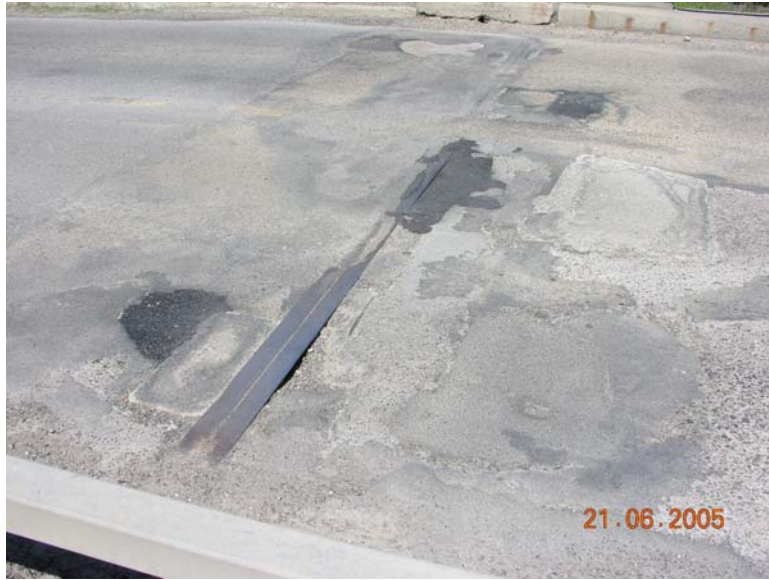
**Figure 6.11 Deterioration of concrete at buffer angles**

- The buffer angles can sometimes be damaged by snow plows especially if they protrude above the deck surface.
- The blockout concrete at the buffer angles can be deteriorated (see picture Figure 6.11).
- There can be vertical misalignment between the angles in different spans. This can be a sign of failure of a bearing or timber cap, but can also be caused by improper placement of the girders.
