S3 Cochrane

PROJECT: **SOUTHERN REGION LANDSLIDE MONITORING**

TITLE: **INSTRUMENTATION SITE PLAN
HWY 22:00
COCHRANE SLIDE AREA**

CLIENT: **ALBERTA TRANSPORTATION**

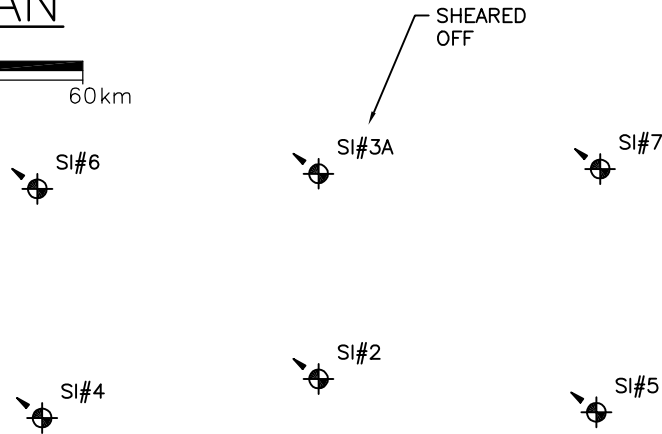
DATE: JUNE 2002	JOB No.: CG25132	CAD FILE: 25132R03.DWG	FIGURE No.: FIGURE I-S3	REV. A
-----------------	------------------	------------------------	-------------------------	--------

SI#5 SLOPE INCLINOMETER WITH A-GROOVE ORIENTATION RELATIVE TO MAGNETIC NORTH.

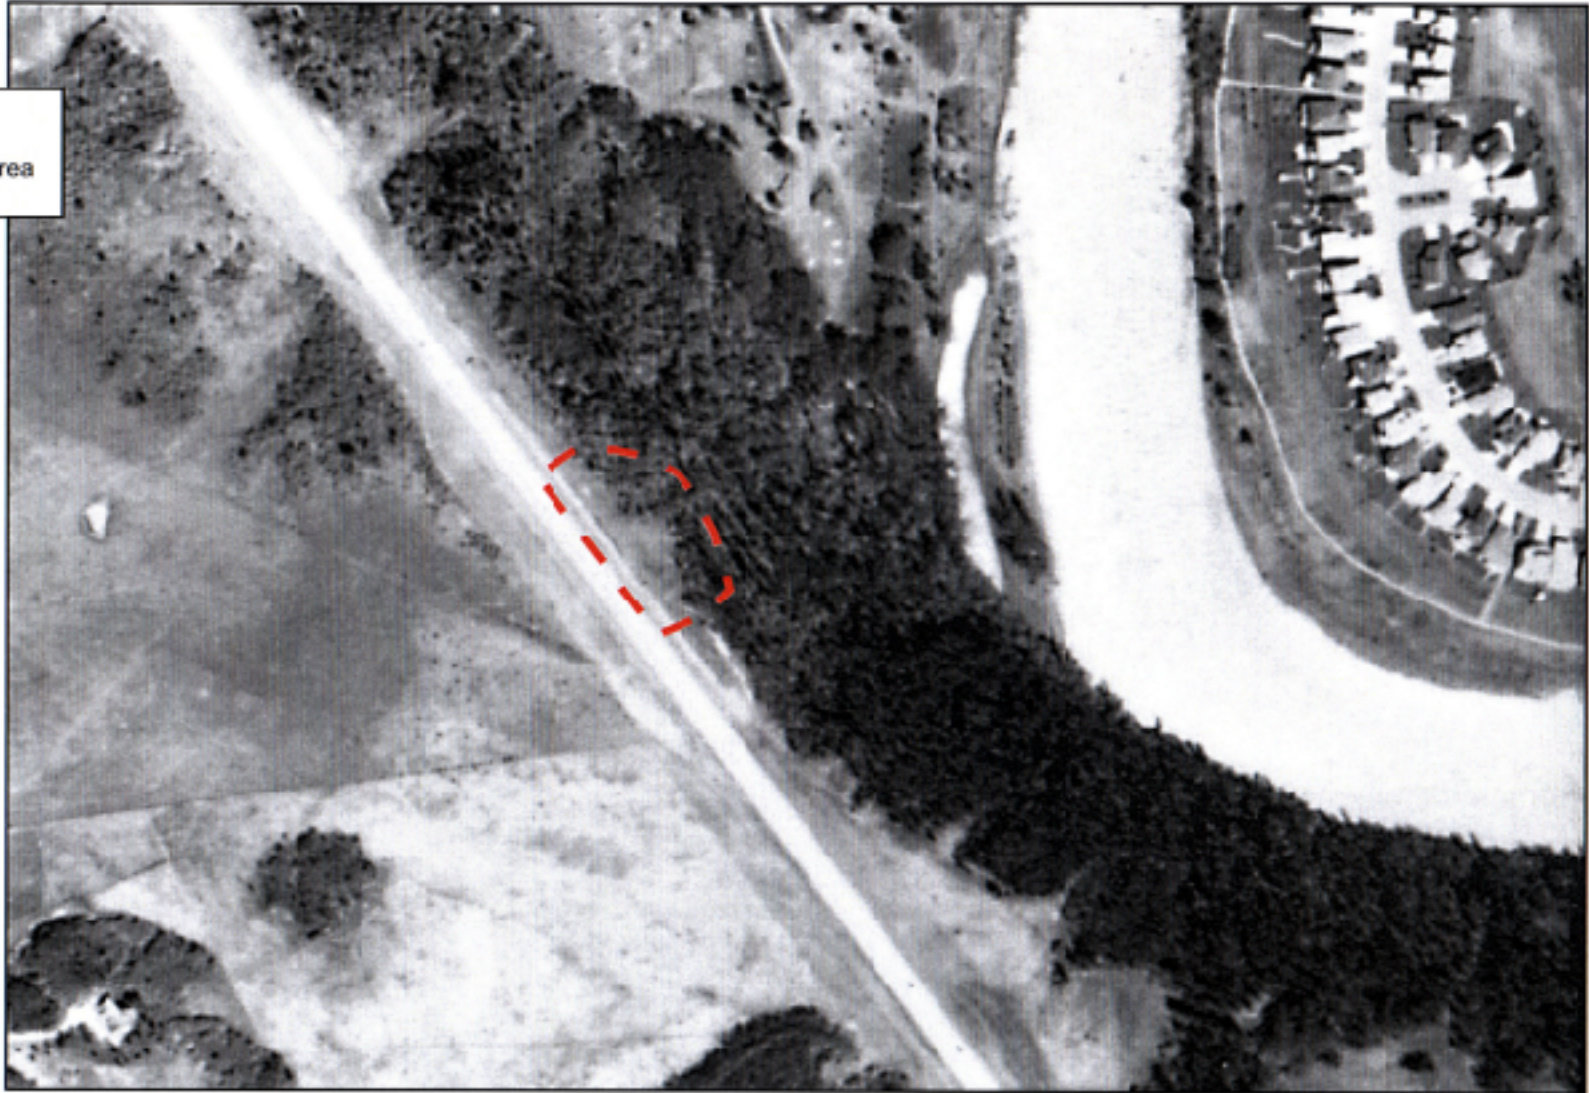
Slide Area

Enlarged View from Airphoto
AP AS4958 LN-7 296
 May 31/98

Approx Scale: 1:3100

The Cochrane site was visited on 29 May 2002. Photographs from this site visit are included in Appendix S3, along with a site plan, air photograph, and a detailed discussion of the visit. This discussion has also been submitted in separate unbound sheets for inclusion in Appendix B of the Cochrane binder. The following is a brief summary of the assessment.
