Slide Name: (GP 15b) SH 727:02 Ksituan River
Inspection Date: N/A
Inspection By: Alberta Transportation Staff (see attached list of attendees)
EBA Staff (Karl Li and Tony Ruban)

1.0 BACKGROUND

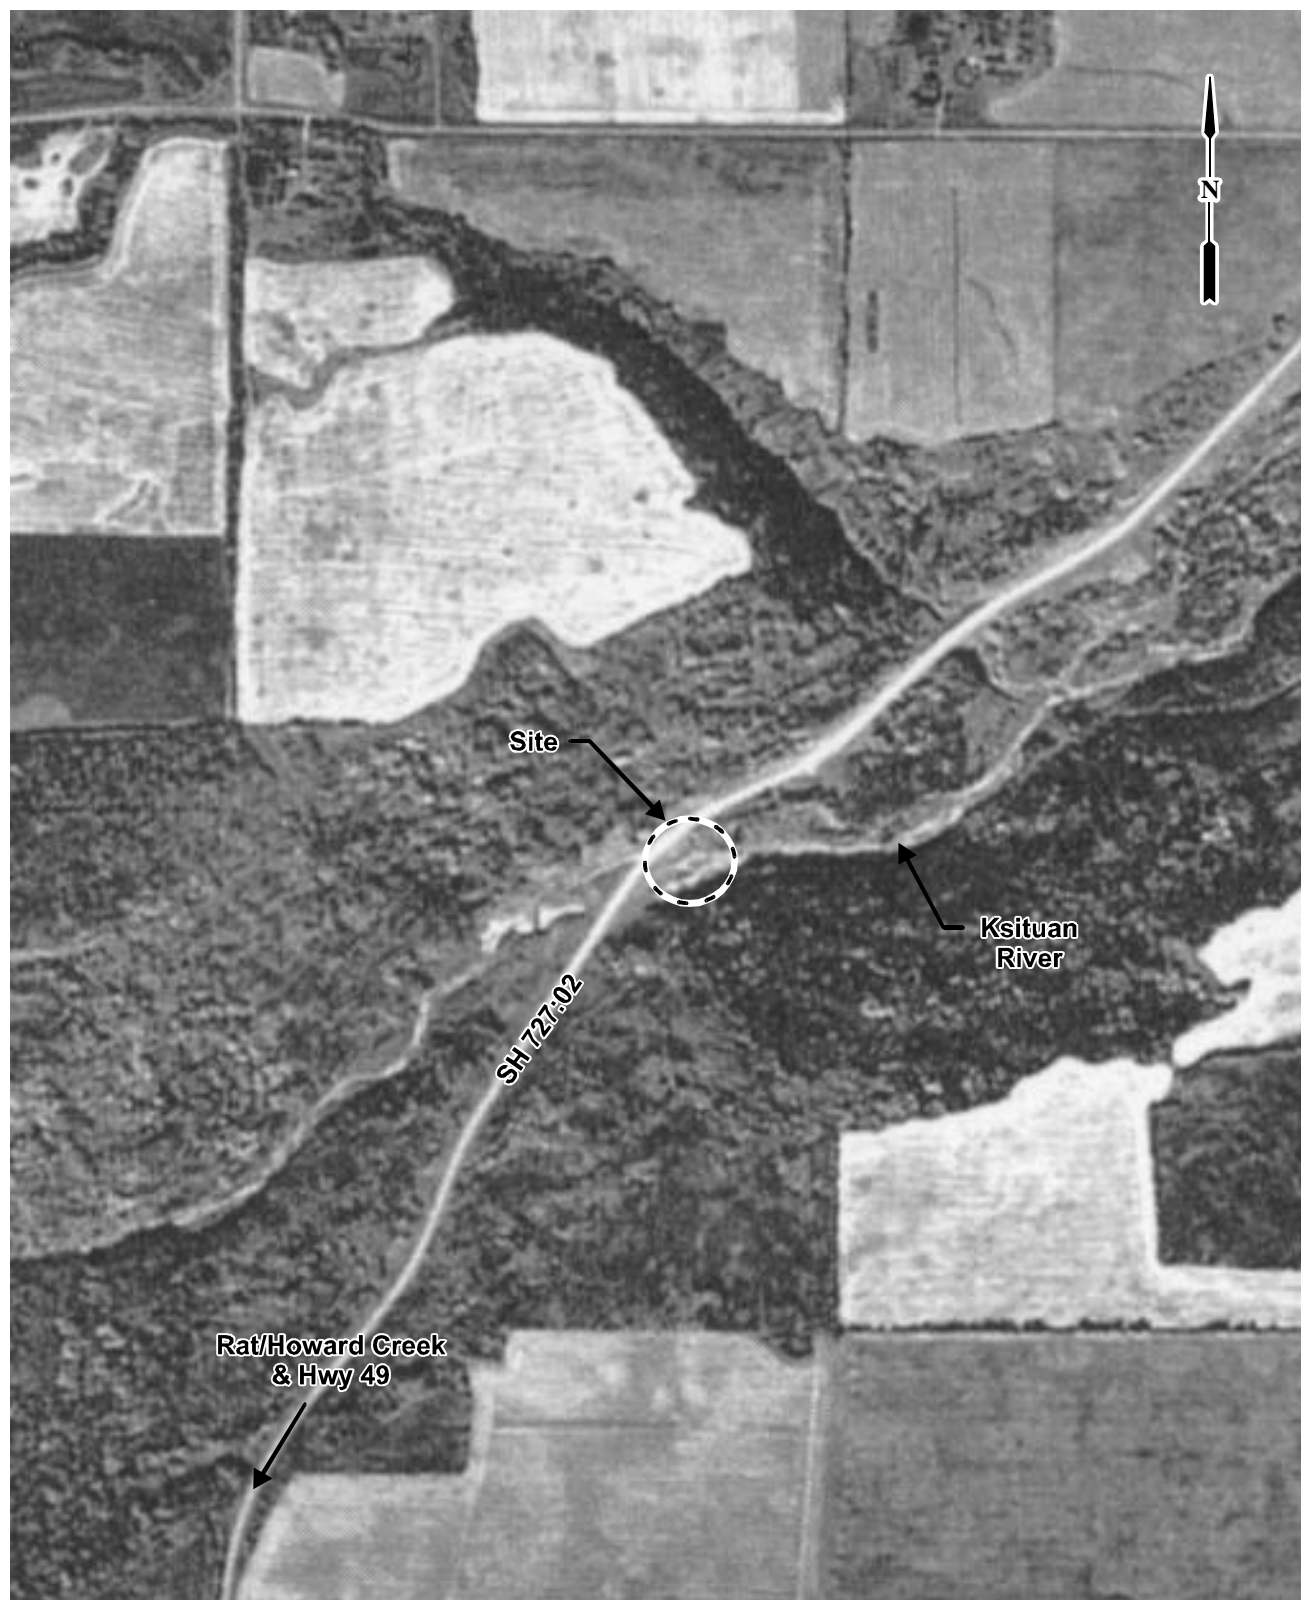
Figure 1
Site Plan

Based on 1995 Aerial Photograph

0 400
SCALE (metres)

Refer to EBA 2000 Report for site conditions and details of risk assessment. SH 727:02 is a gravel road parallel to the Ksituan River with a setback of approximately 20 m from the riverbank at this location. The location was adjoining to the approach fill to a bridge culvert. It was reported by AT in the 2000 inspection that settlement of the road grade was noted after completion of the widening (around 1999) and, thus, this site was enlisted for observation of road alignment stability.
