Central Region Landslide Assessment Site C1
H27:10 Ghostpine Creek Slide
2002 Annual Inspection Report

This report was prepared by Klohn Crippen Consultants Ltd. for Alberta Transportation Central Region under Contract No. CE053/2000.

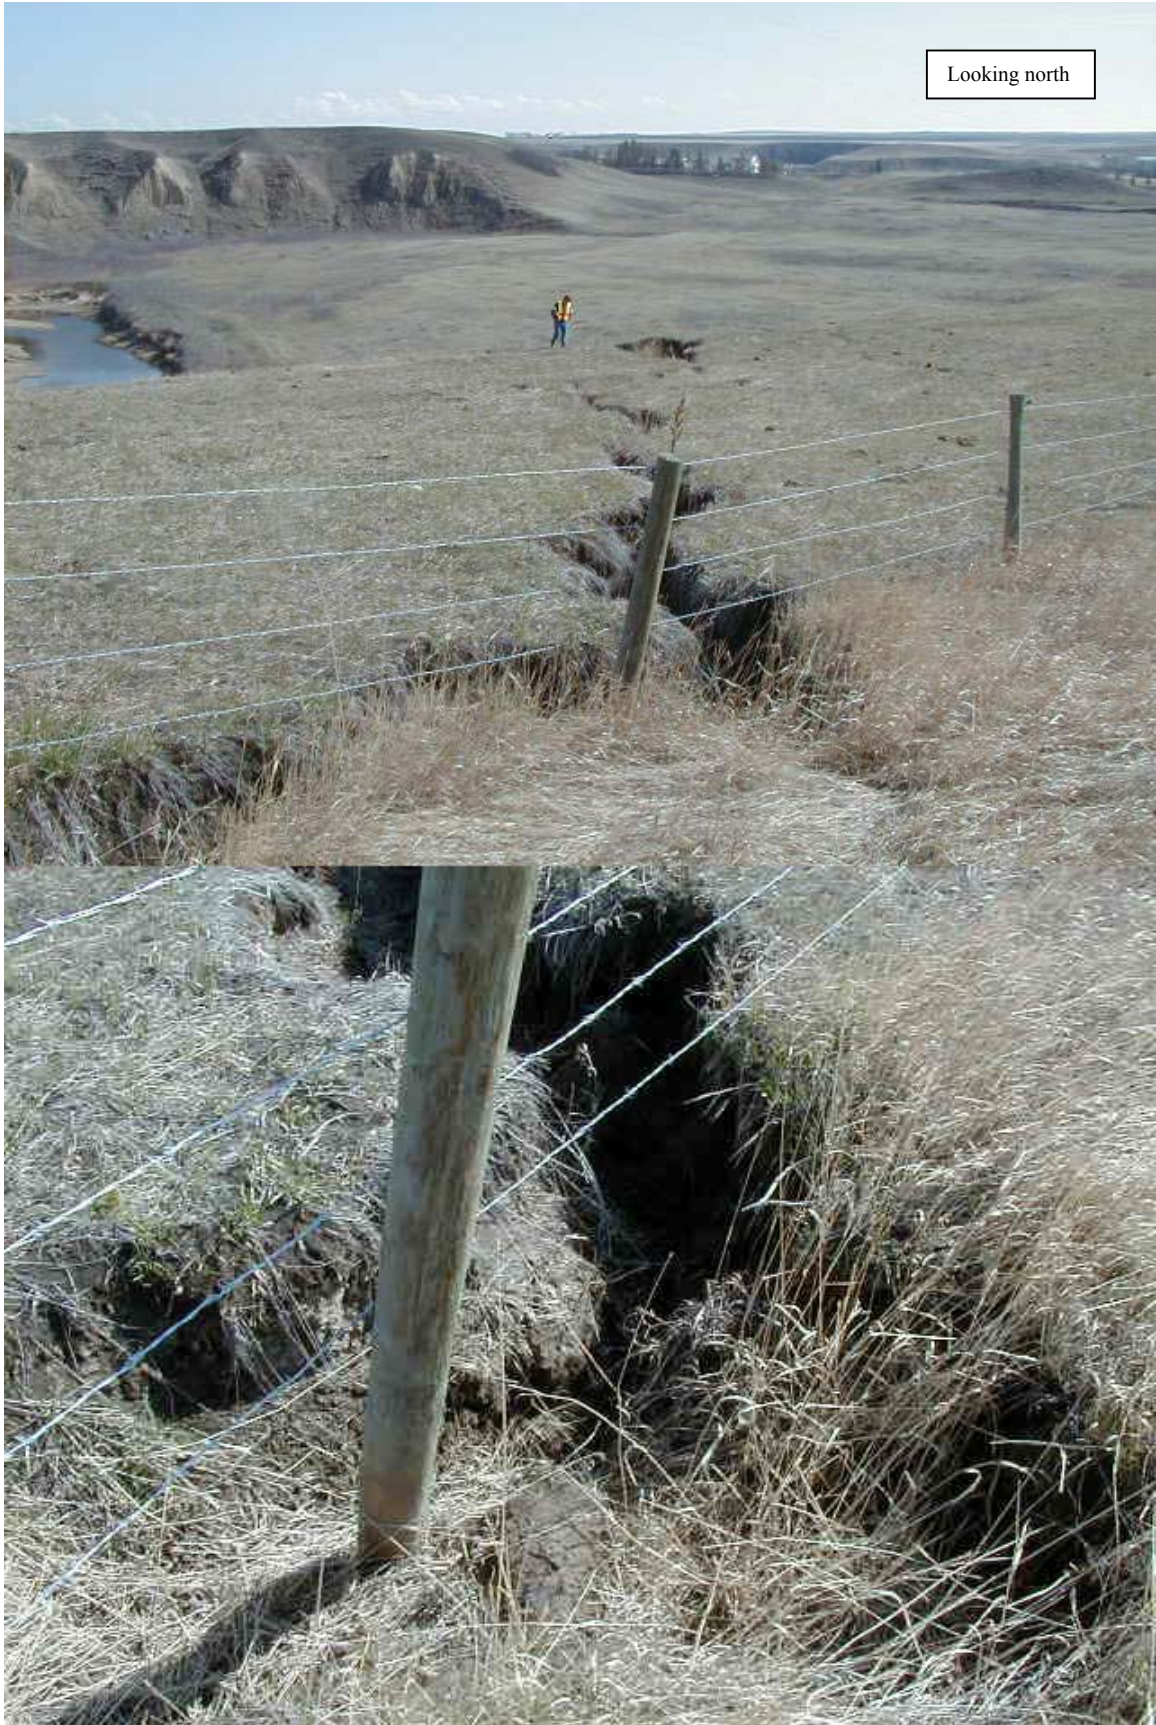
Three slope inclinometers are operational at this site with locations as shown on Figure 1. The instruments were read on June 4, 2002 and the following observations were noted:
