SITE NUMBER AND NAME C10A H53:04 Erosion		HIGHWAY & KM 5 km east of H22	PREVIOUS INSPECTION DATE June 26, 2007	INSPECTION DATE May 20, 2014
LEGAL DESCRIPTION SW 10-43-6-W5	NAD 83 COORDINATES N 5840057 E 648688		RISK ASSESMENT PF: 1 CF: 1 TOTAL: 1

LAST READING DATE:	
PRIMARY SITE ISSUE: Ditch Erosion & Instability	
APPROXIMATE DIMENSIONS:	
DATE OF ANY REMEDIAL ACTION: "Living Wall" (compost filled tubes) and rip rap installed September 2006

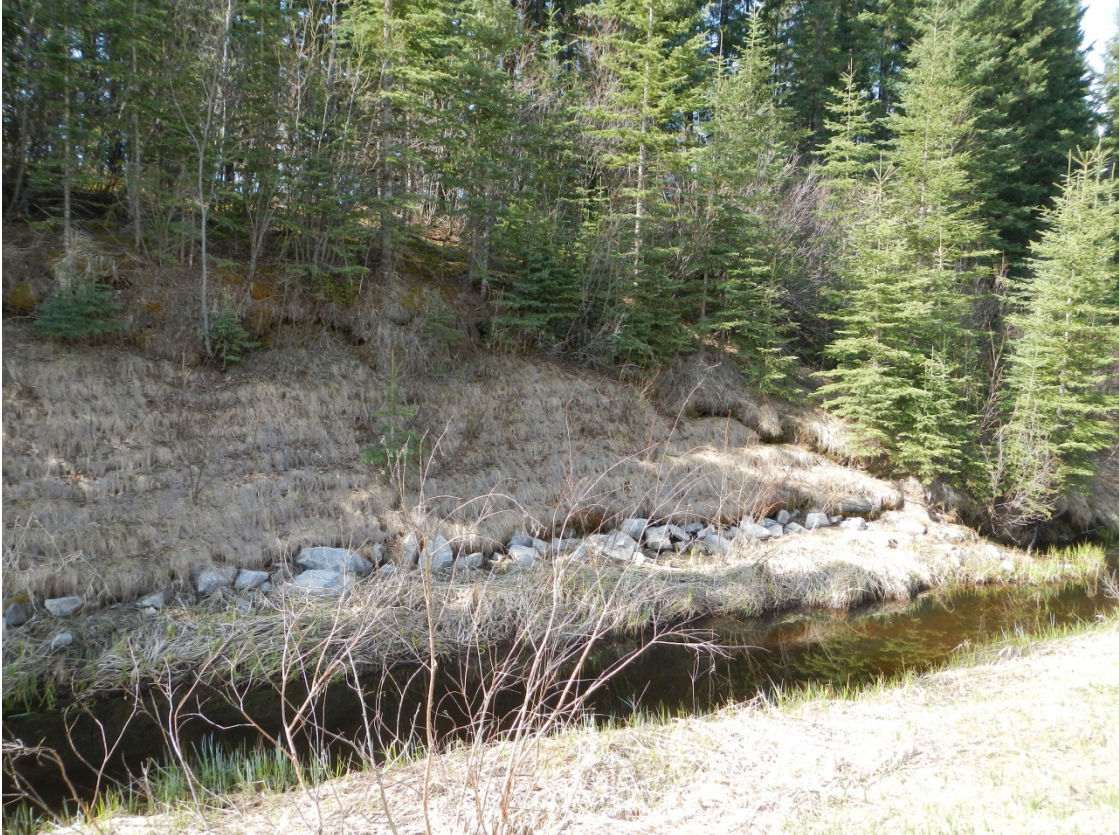
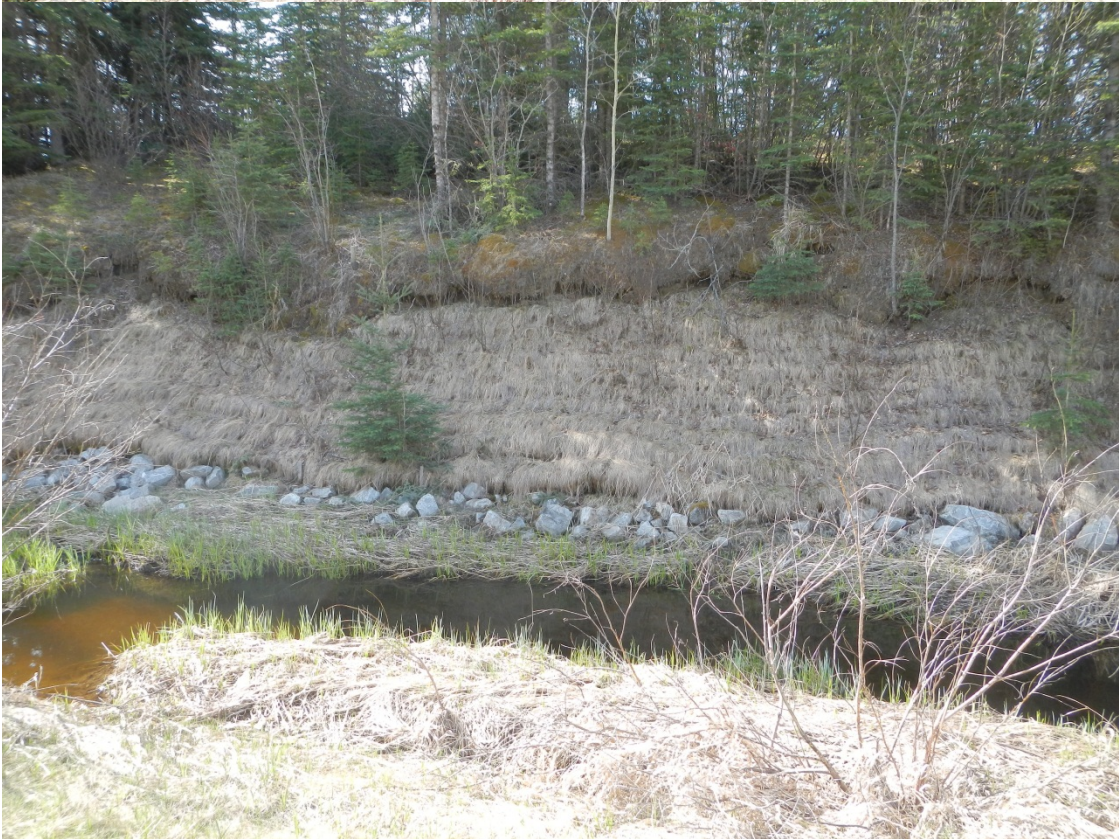
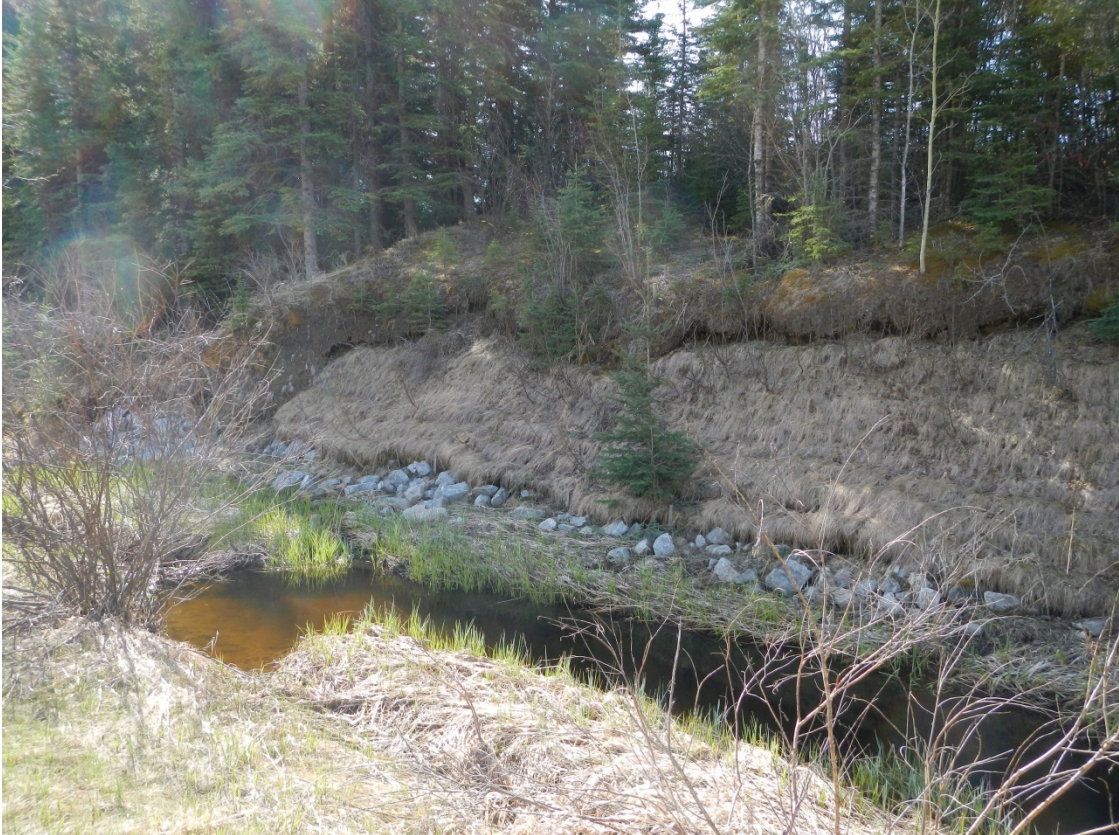
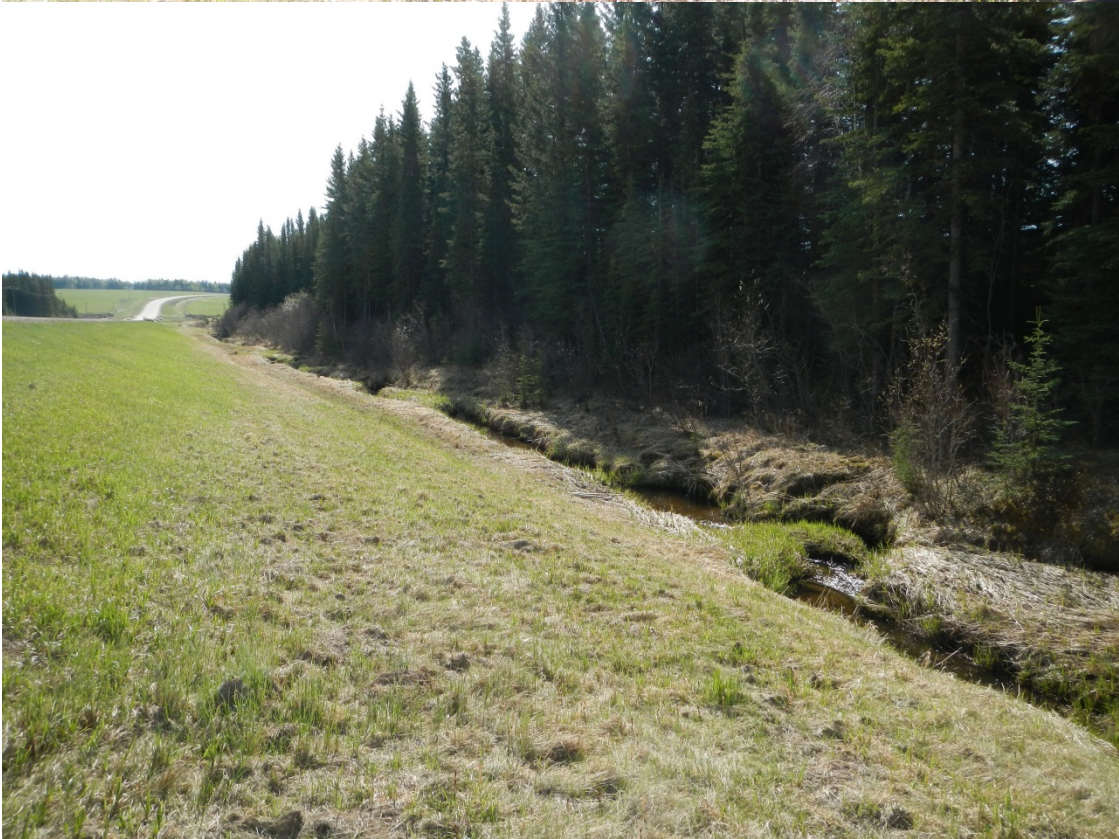
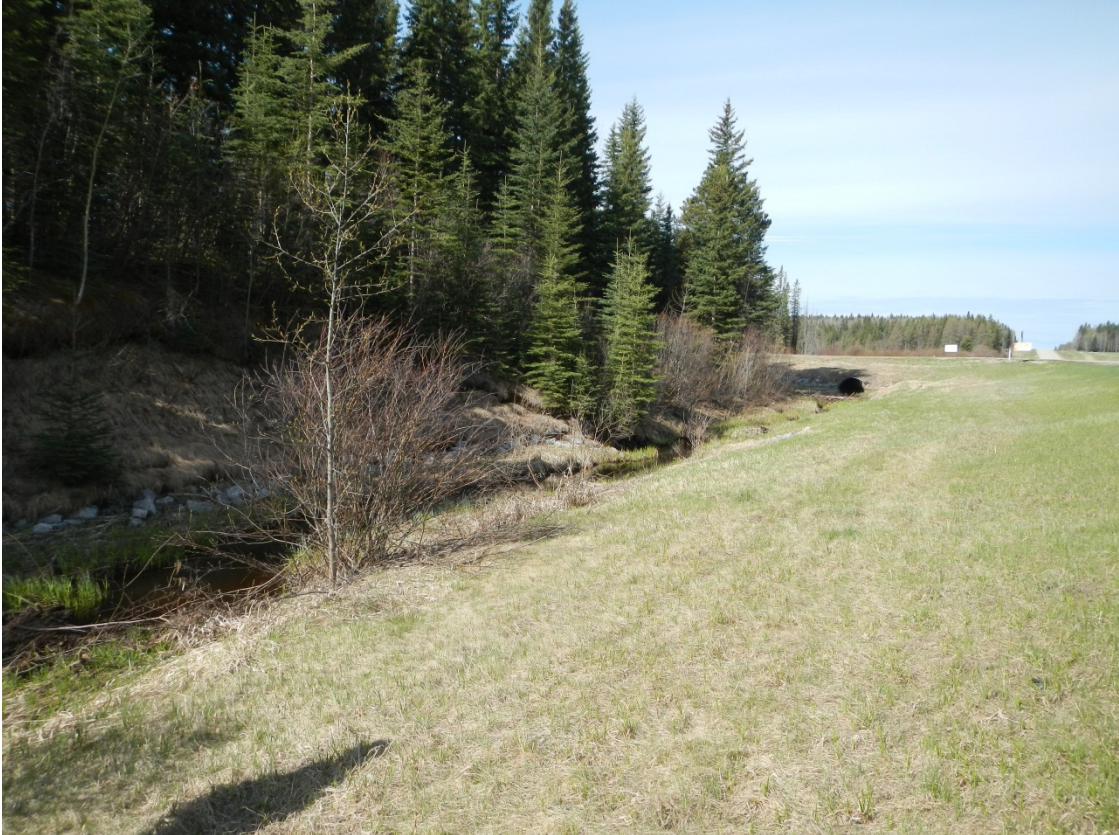
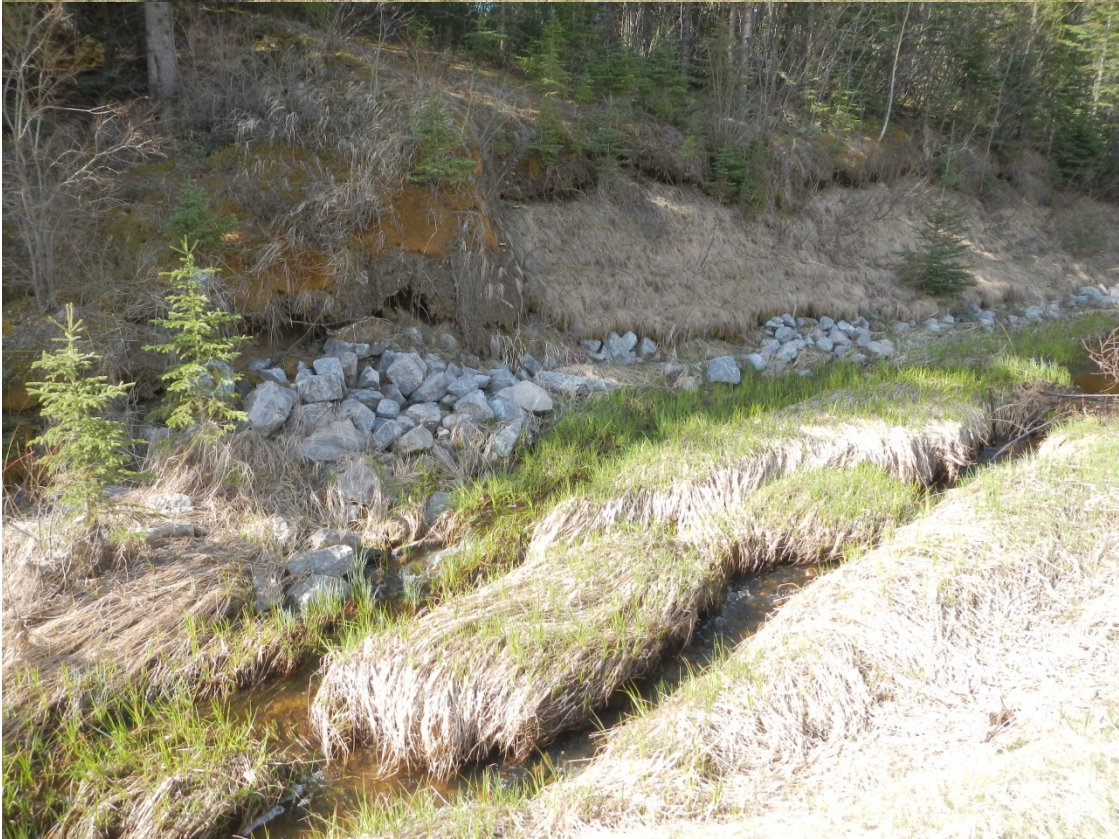
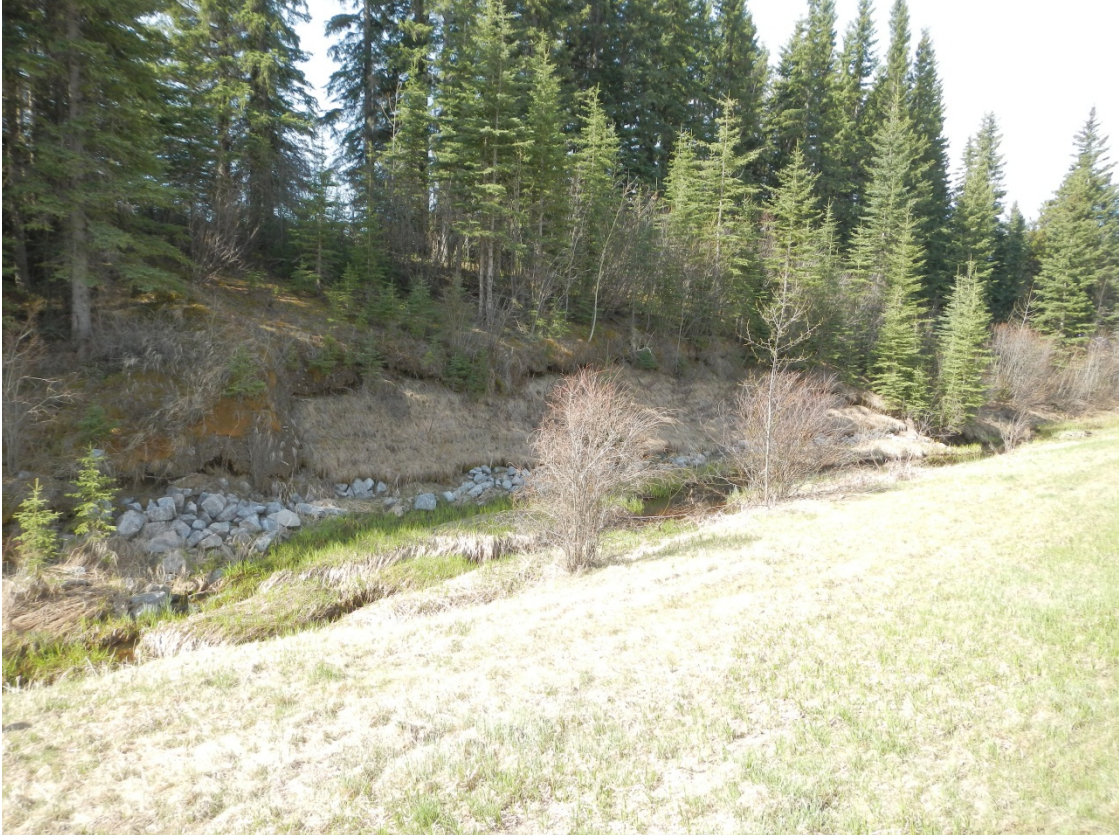
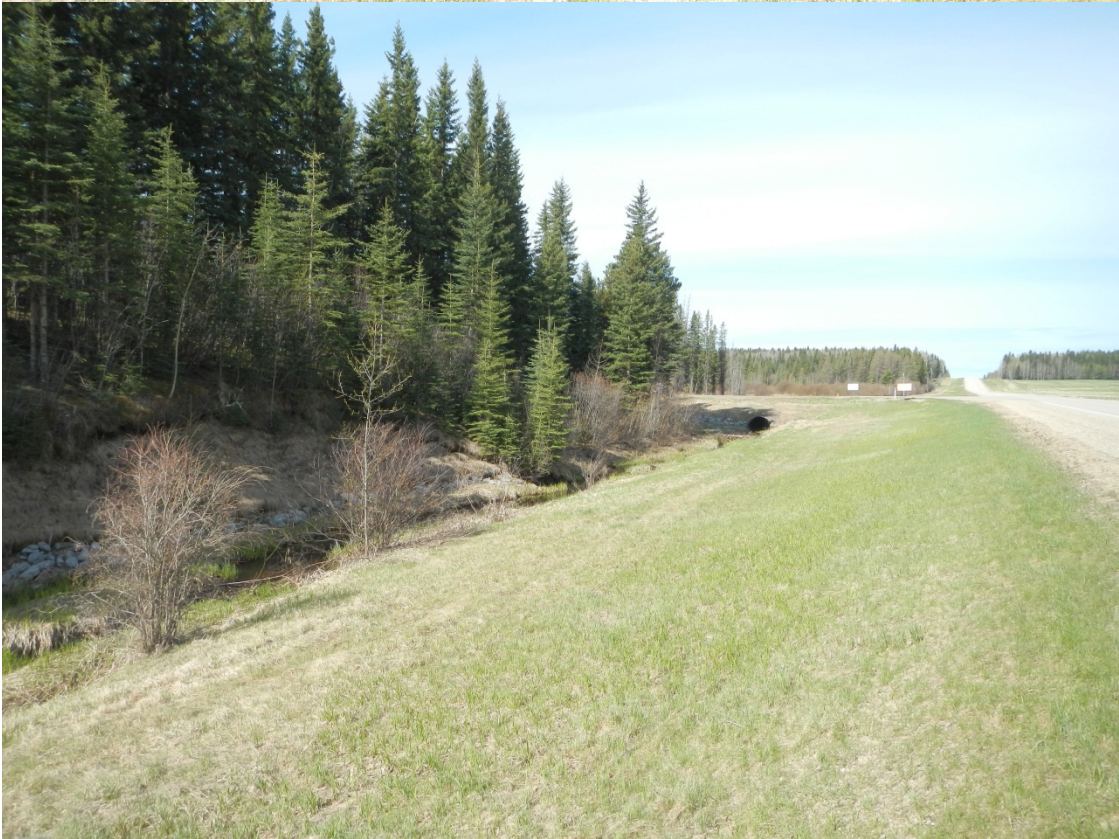
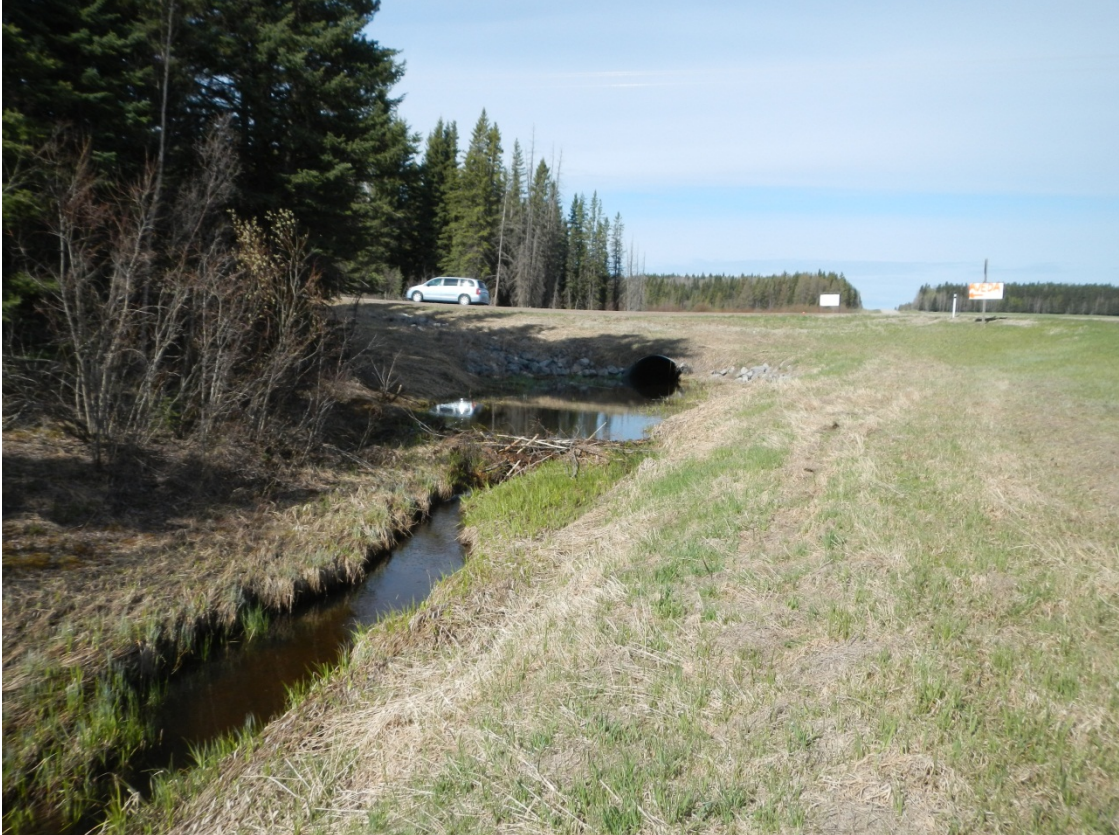
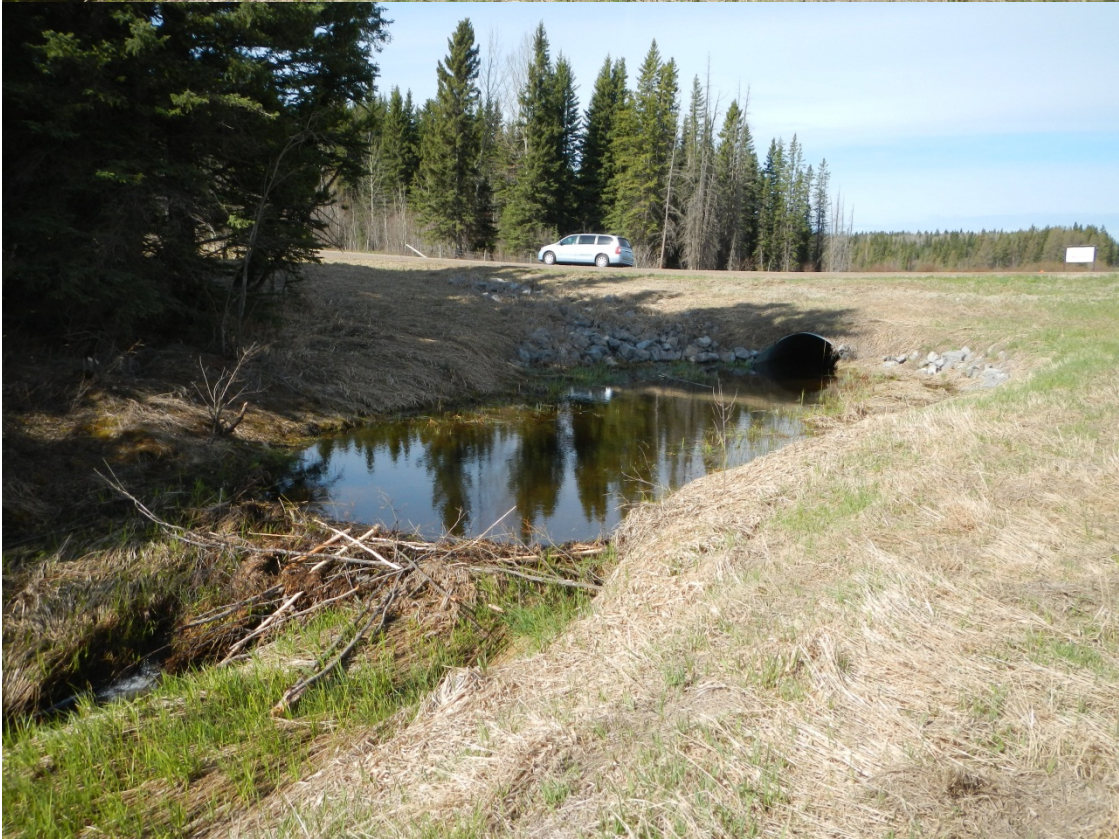
COMMENTS
Refer to previous reports and attached photos
Culvert was replaced in 2005 and rip rap installed in 2006.
Bank is now well vegetated. Beaver dam located downstream of culvert.

ITEM	CONDITION EXISTS		DESCRIPTION AND LOCATION	NOTICABLE CHANGE FROM LAST INSPECTION	
	YES	NO		YES	NO
Pavement Distress					
Slope Movement		X	Instability in bank slopes due to toe erosion repaired with rip rap and compost filled tubes.		X
Erosion		X	Toe and bank erosion occurring due to flows from culverts over a length of about 100 m.		X
Seepage					
Culvert Distress
