SITE NUMBER AND NAME C39 H576:02 Slide		HIGHWAY & KM 2.5	PREVIOUS INSPECTION DATE August 11, 2005	INSPECTION DATE May 15, 2006
LEGAL DESCRIPTION 13-29-20-W4	NAD 83 COORDINATES N 57004150 E 382250		RISK ASSESMENT PF: 9 CF: 4 TOTAL: 36

**Central Region GeoHazard Assessment
Site C39 H576:02 km 2.5
May 2006 Site Assessment Report**

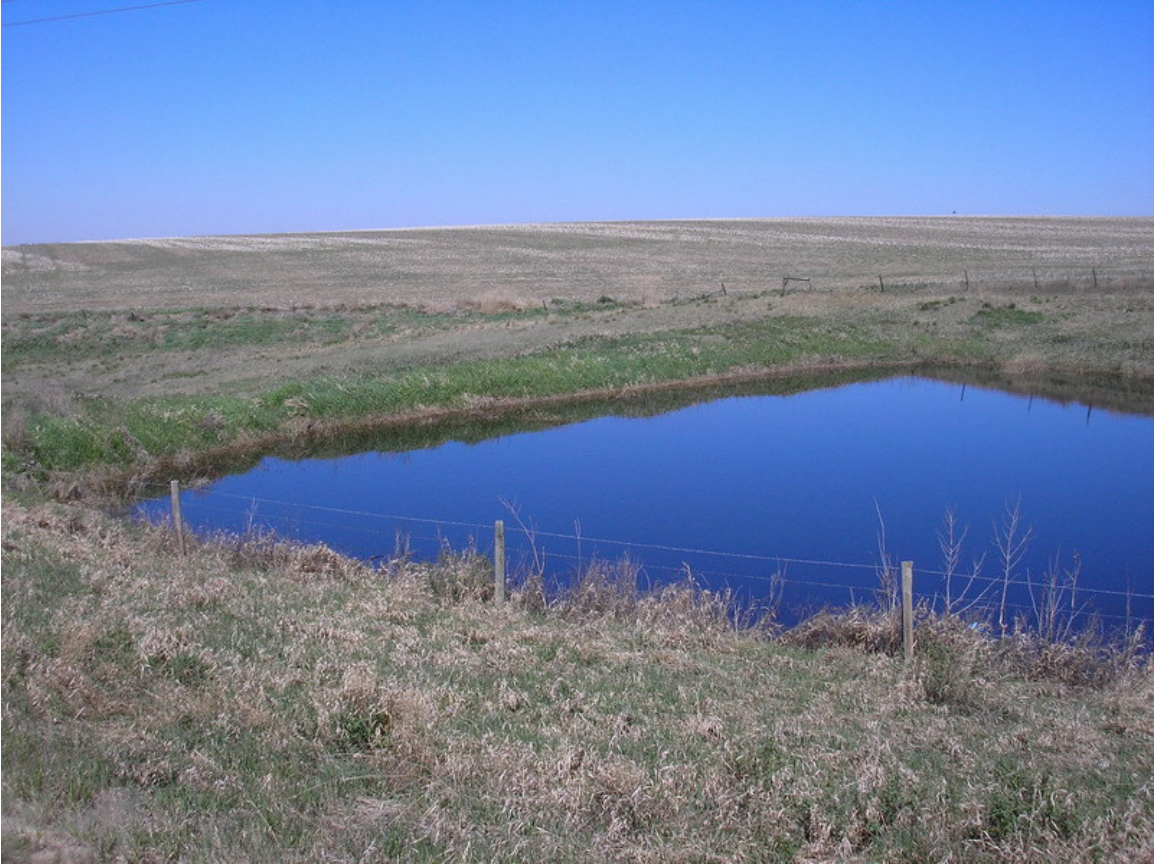
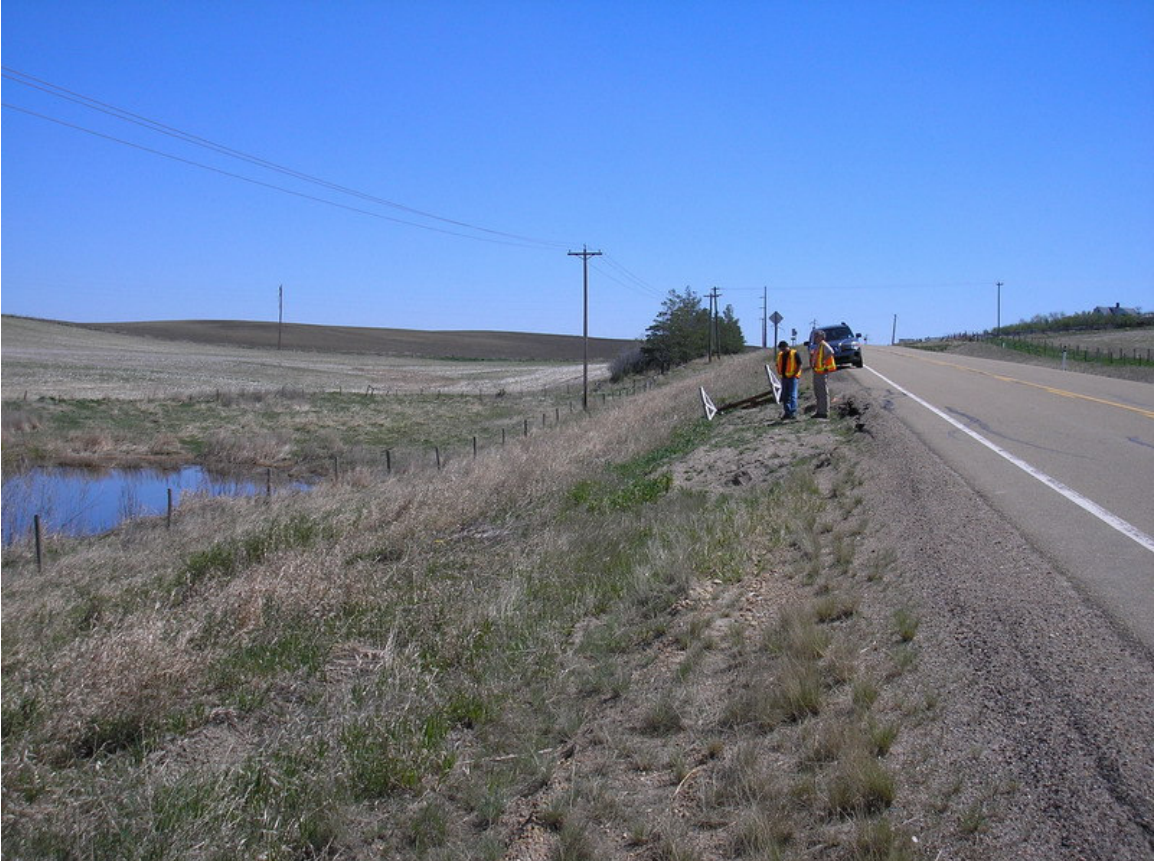
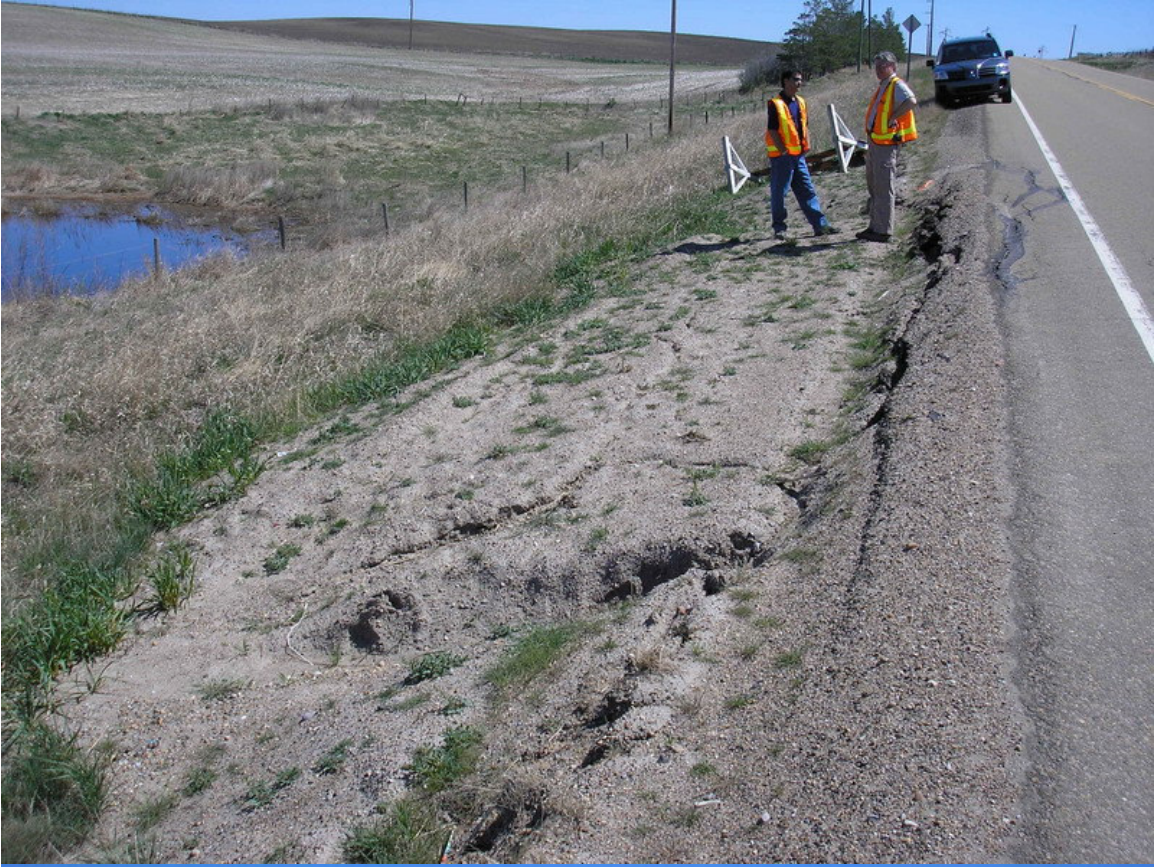
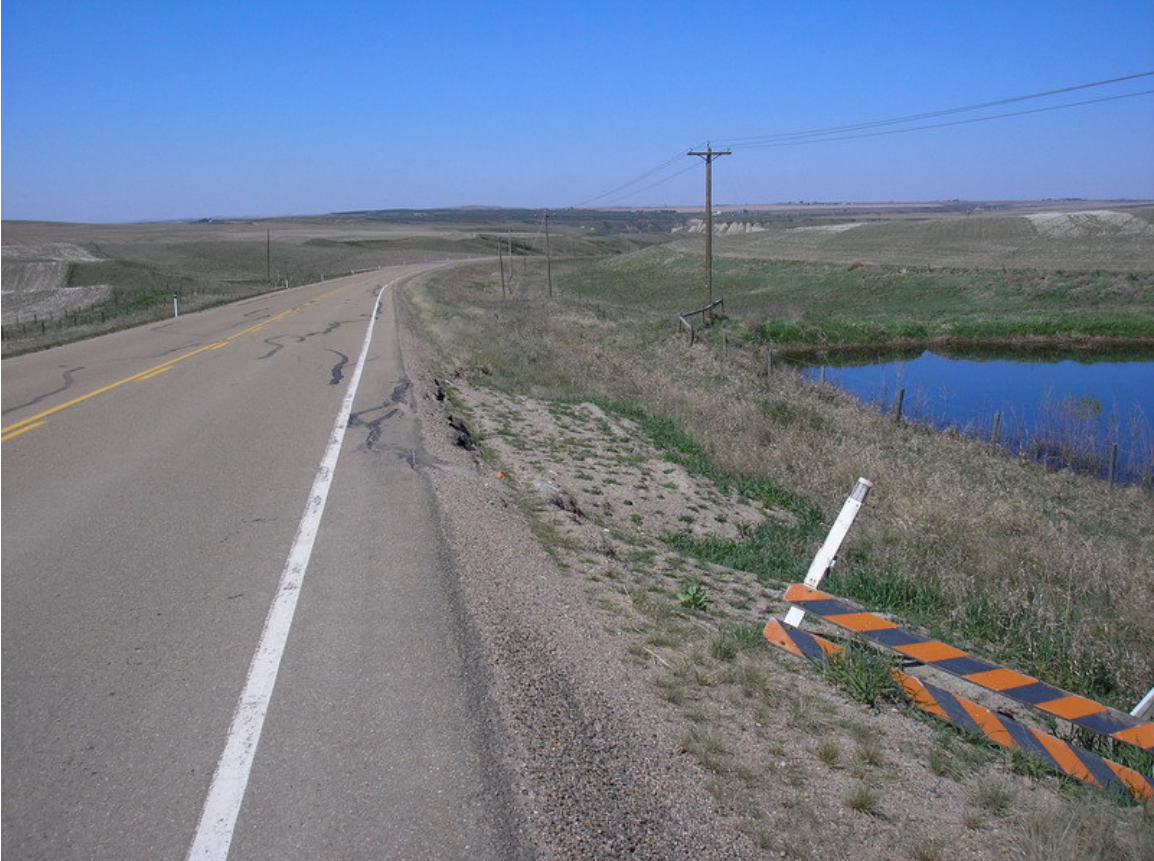
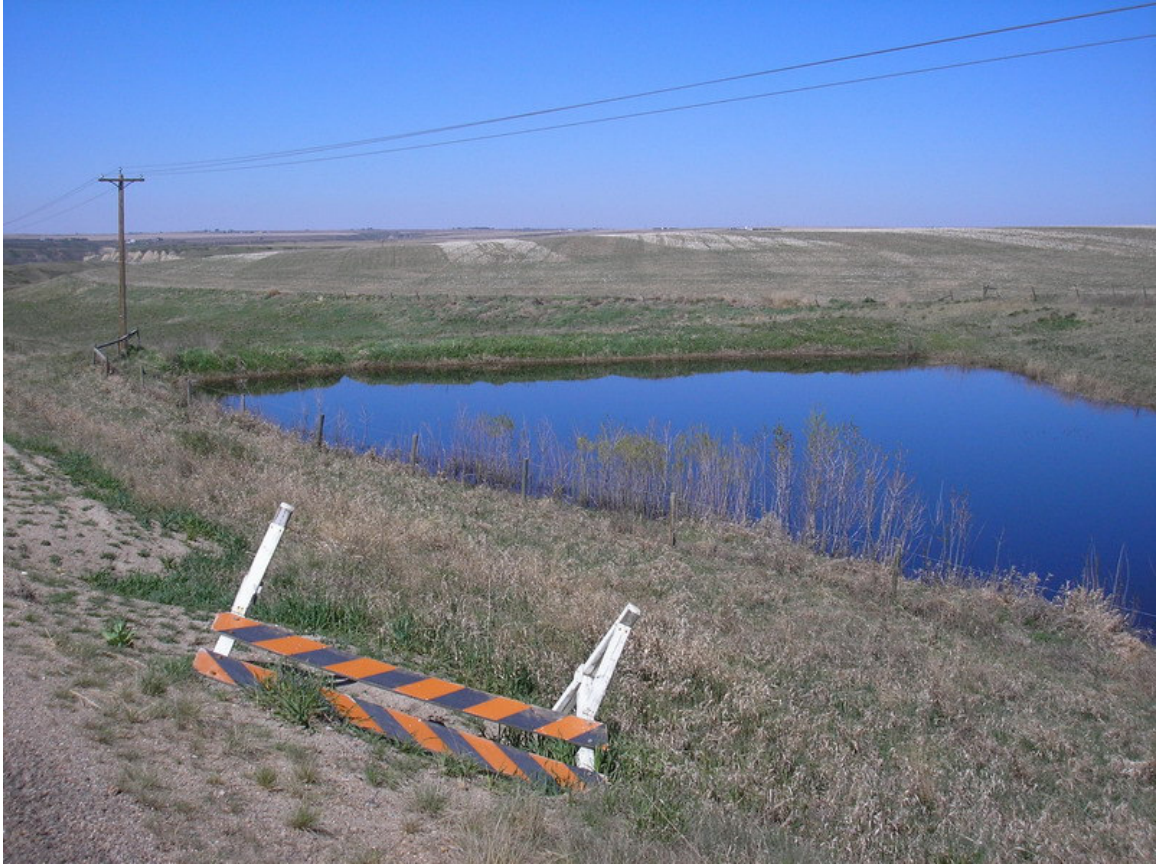
COMMENTS
Refer to previous callout report and attached photos

- The slide area appeared to be about 20 m wide. Based on pre-repair photographs, the scarp was about 1 m high. No distinct bulging of the toe area of the slide could be observed, however, the toe area was covered with long grass. A small deflection in the alignment of the fence at the toe of the slope was noted.

- The slope between the highway and the pond is estimated to be about 3H:1V.
- Loose sand has been placed at the top of the slope in the slide depression to reinstate the shoulder of the highway. Some minor cracking and settlement of the sand was observed.
