SITE NUMBER AND NAME C06 H881:10 Myrnam Spring		HIGHWAY & KM	PREVIOUS INSPECTION DATE May 19, 2004	INSPECTION DATE May 14, 2007
LEGAL DESCRIPTION 14-54-9-W4	NAD 83 COORDINATES N 5955328 E 485473		RISK ASSESMENT PF: 9 CF: 2 TOTAL: 18

LAST READING DATE:	
PRIMARY SITE ISSUE: Frost heave, Pavement distress	
APPROXIMATE DIMENSIONS:	
DATE OF ANY REMEDIAL ACTION: Subexcavation and gravel replacement / sub-drains in September 2005

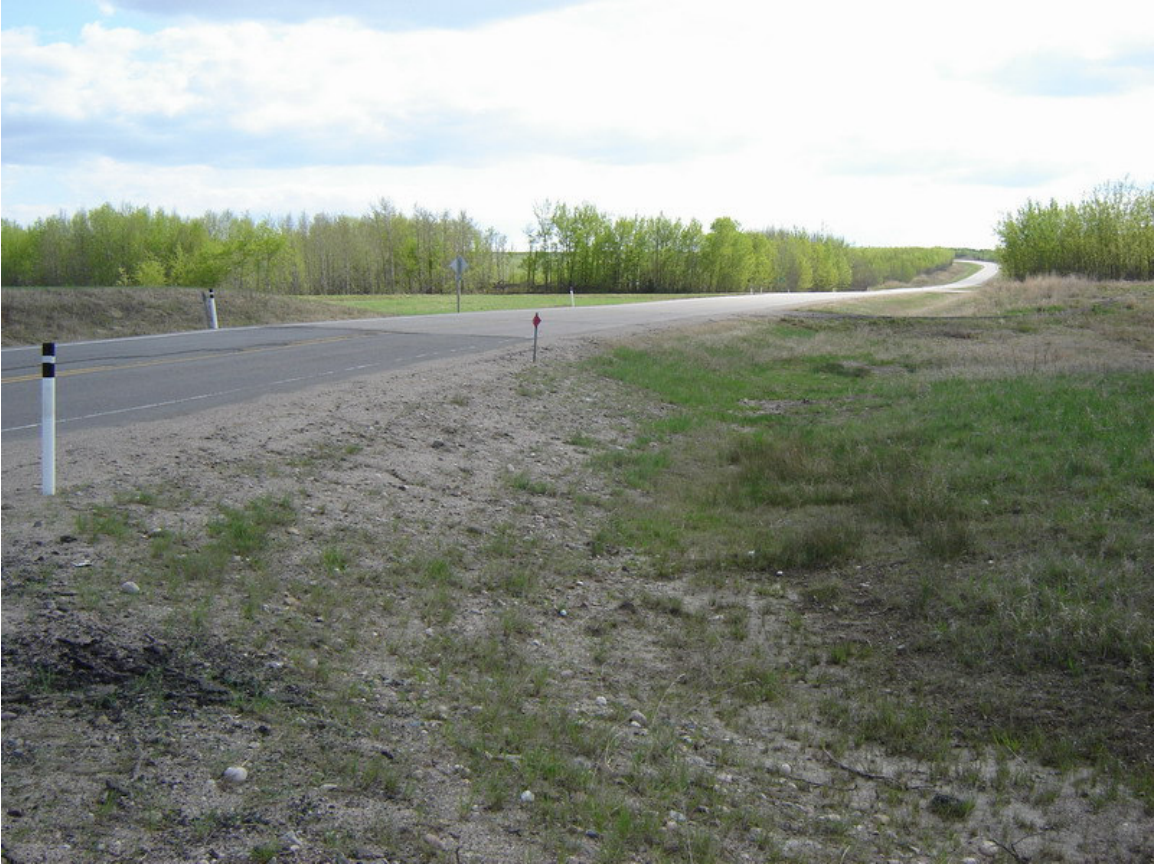
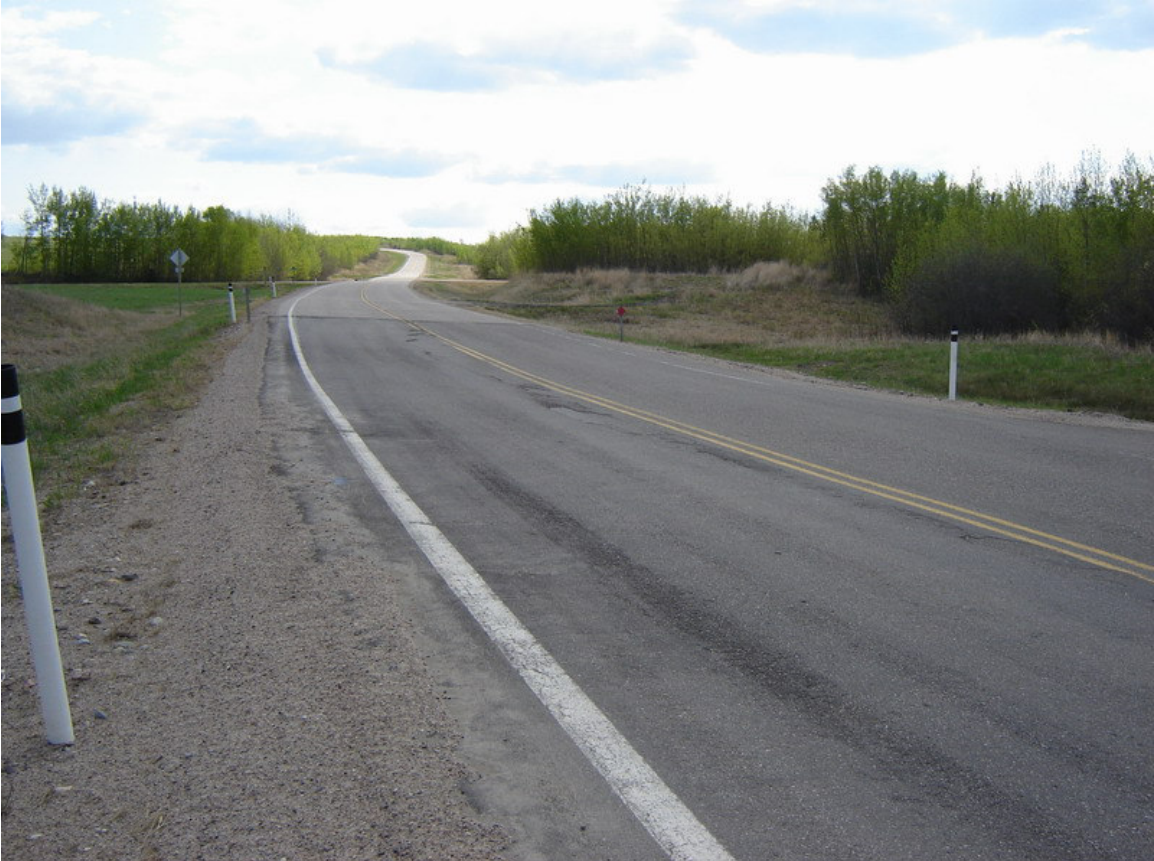
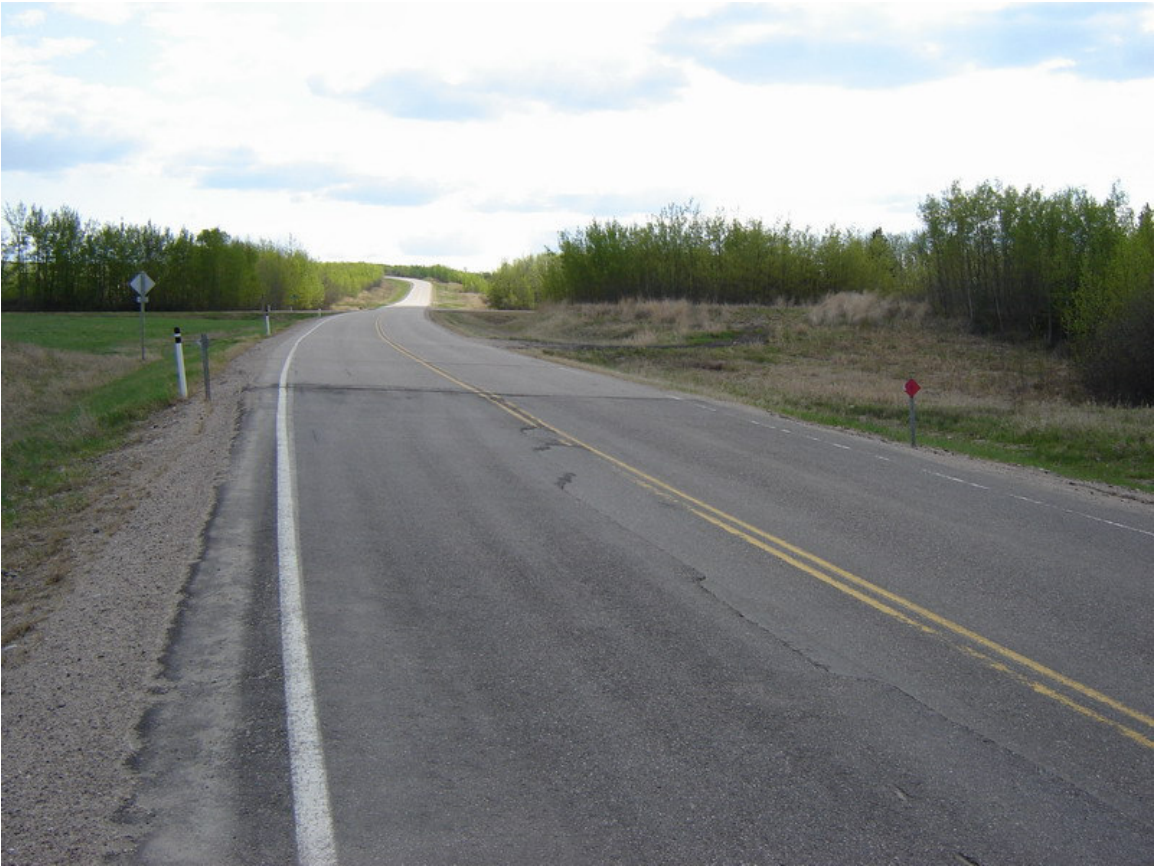
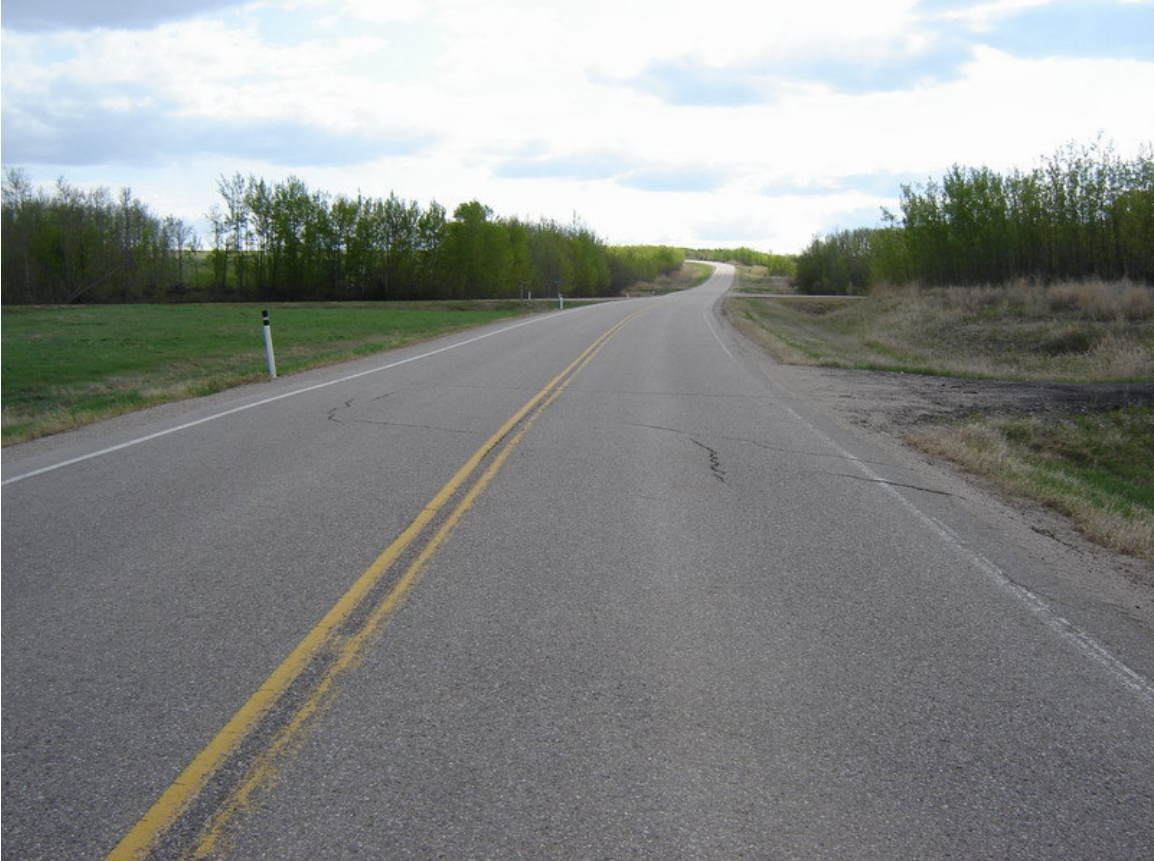
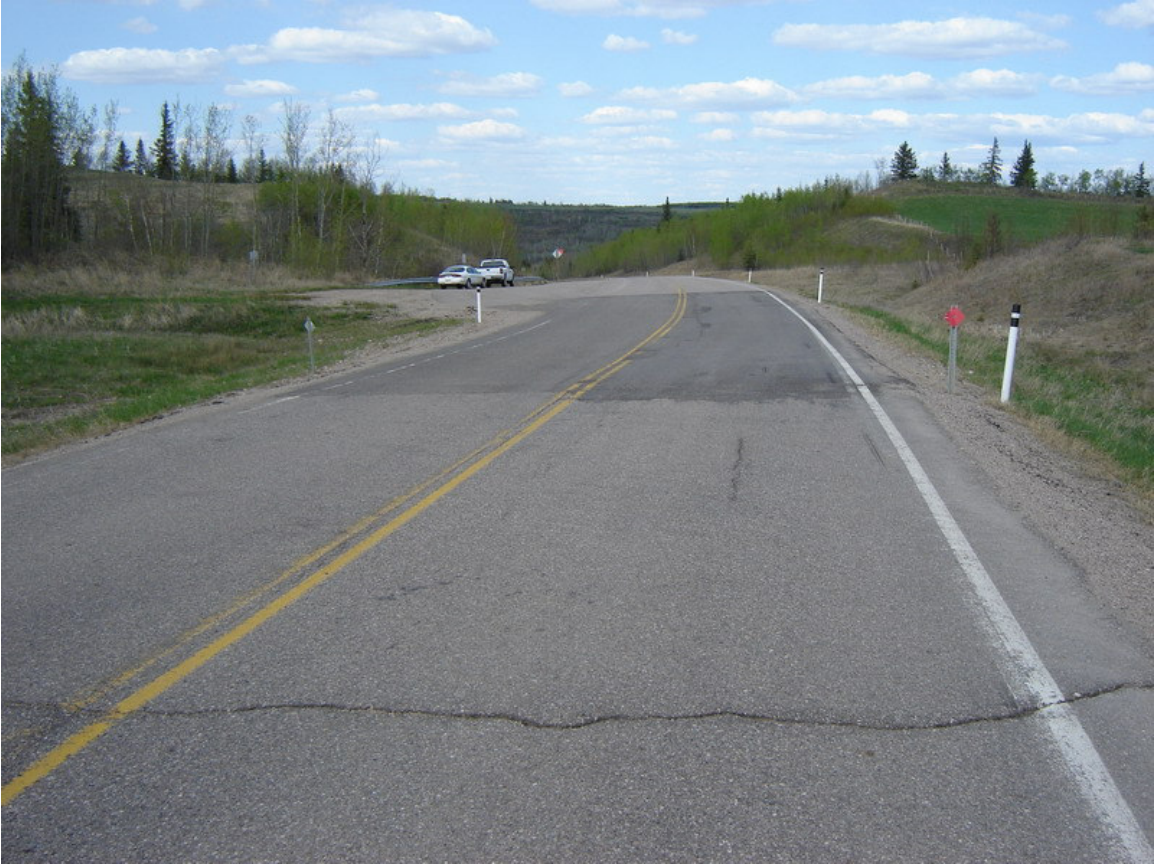
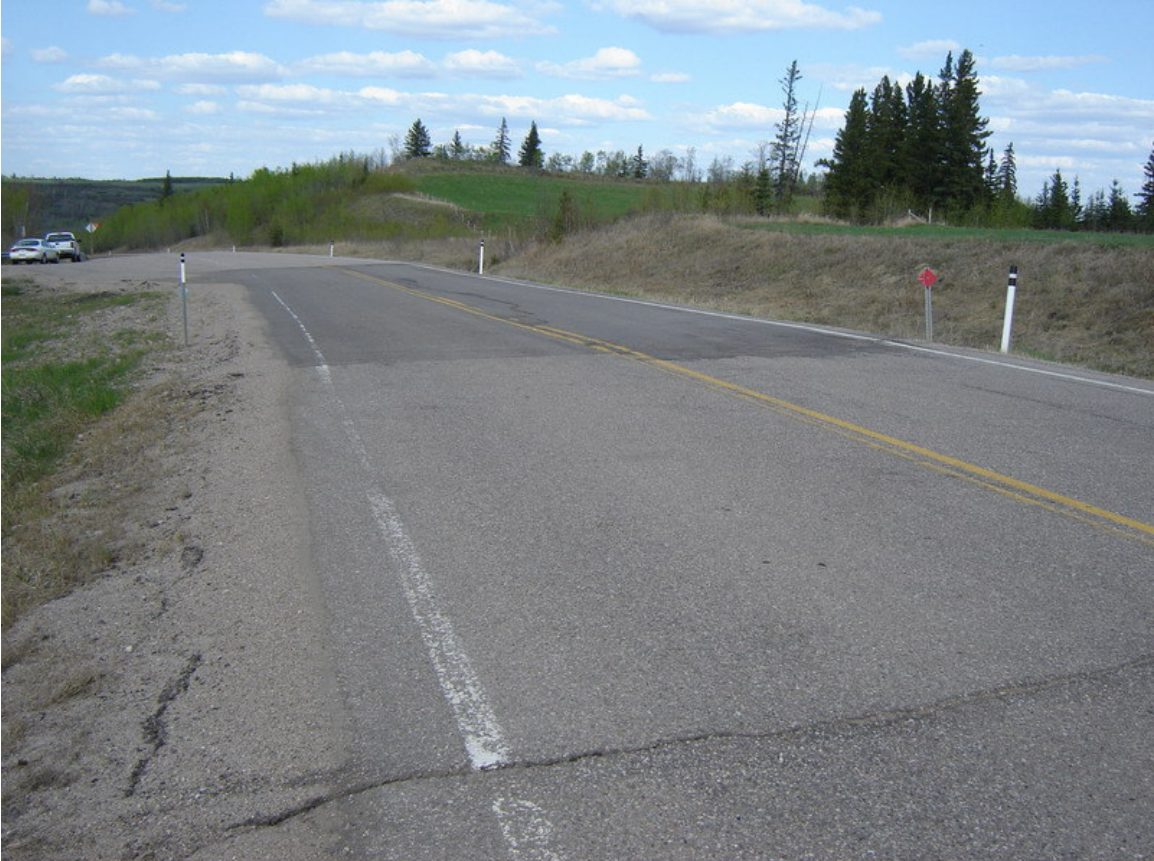
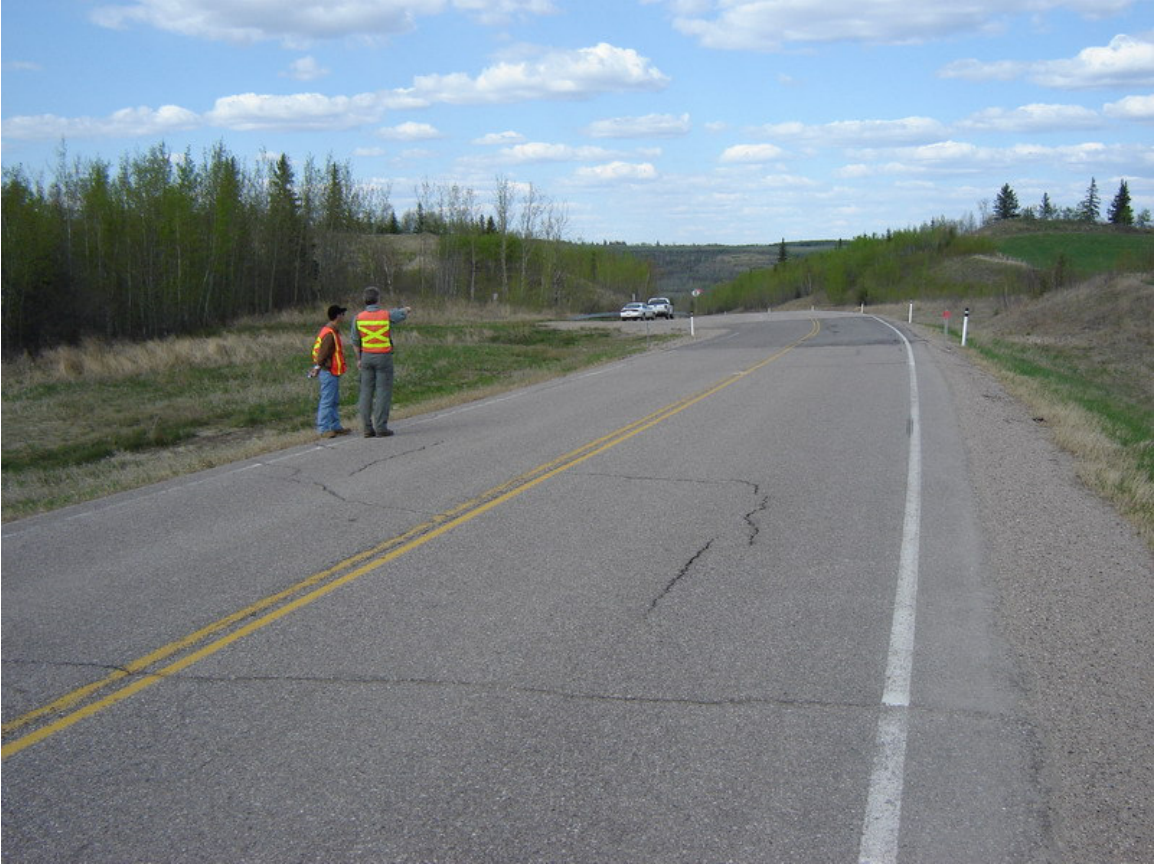
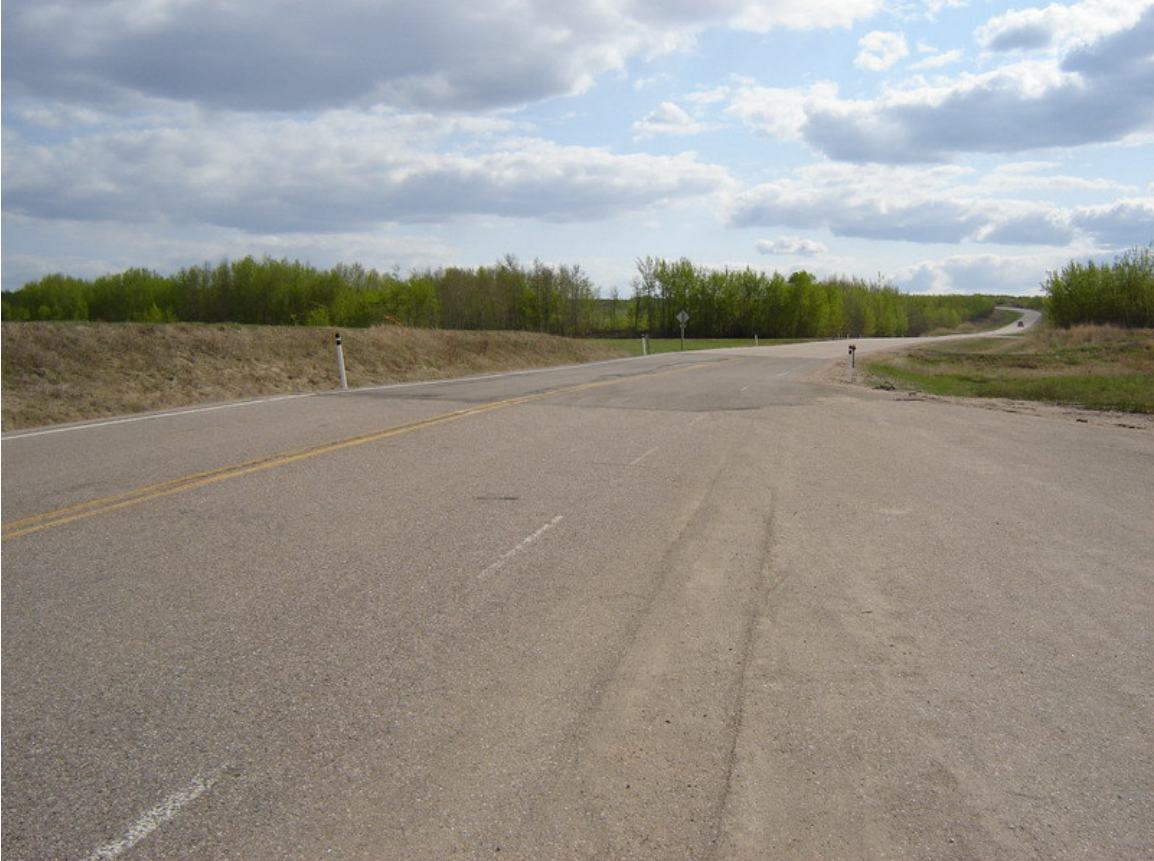
COMMENTS
Refer to previous reports and attached photographs.
A section of highway about 20 m long was subexcavated with gravel replacement / drains in 2005. This road section appears to be performing well and the new drain was observed to be flowing. The existing "Myrnam Spring" was unaffected by the construction. It is reported that the highway section to the south is heaving in winter months and the gravel replacement section should be extended. It is recommended that an inspection be undertaken in January/February 2008 to determine the extent of the section to be remediated.
