ALBERTA TRANSPORTATION GEOHAZARD ASSESSMENT PROGRAM PART A: FILE REVIEW

PEACE REGION – PEACE-HIGH LEVEL

PH32 JUDAH HILL – MAKEOUT SLIDE

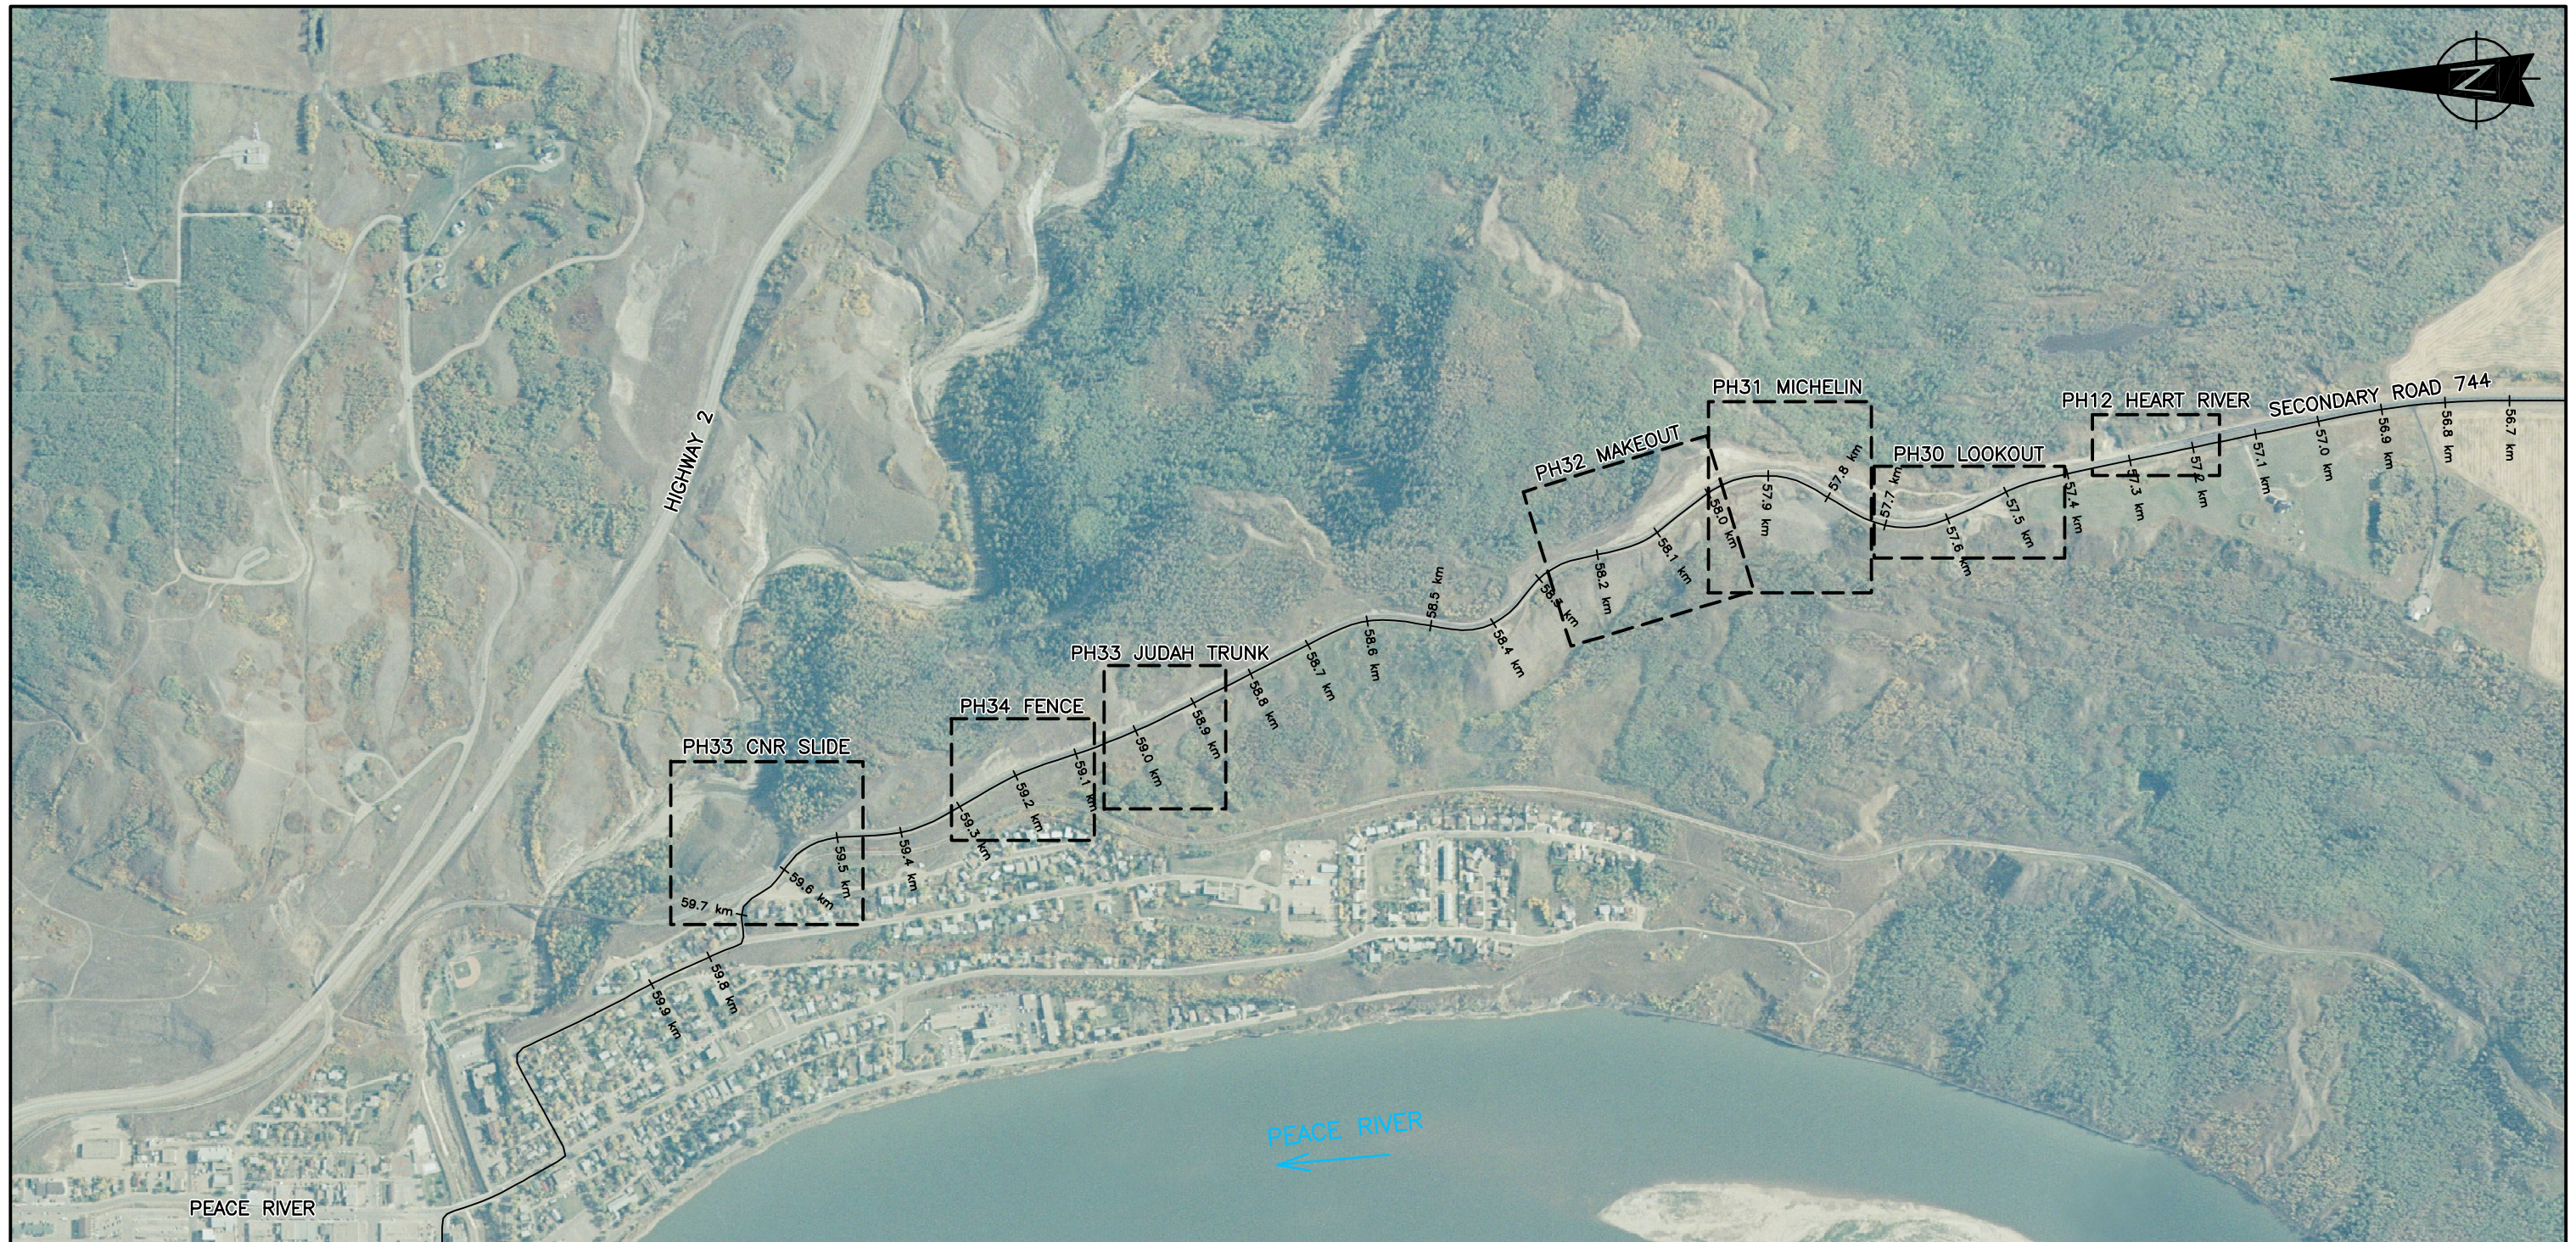
1 LOCATION DATA RECORDED USING HAND HELD GPS RECEIVER. ALL LOCATIONS ARE APPROXIMATE AND ARE FOR ILLUSTRATIVE PURPOSES ONLY.

The location of the site is shown on Figure 1, while site details are shown on Figure 2, based on the last inspection.
