SITE NUMBER AND NAME C31 H11:02 Debris Flow		HIGHWAY & KM 27.2	PREVIOUS INSPECTION DATE July 9, 2014	INSPECTION DATE June 23, 2015
LEGAL DESCRIPTION	NAD 83 COORDINATES		RISK ASSESMENT PF: 1 CF: 1 TOTAL: 1

PRIMARY SITE ISSUE: The site experienced a localized heavy rainfall and run off event in 2004 that triggered debris flow that resulted in 300 m³ to 500 m³ of mud and rock materials being deposited on the highway up to the centerline. The origin of the debris materials is believed to extend from near the highway to the upper elevations of the catchment on the nearby mountain side.

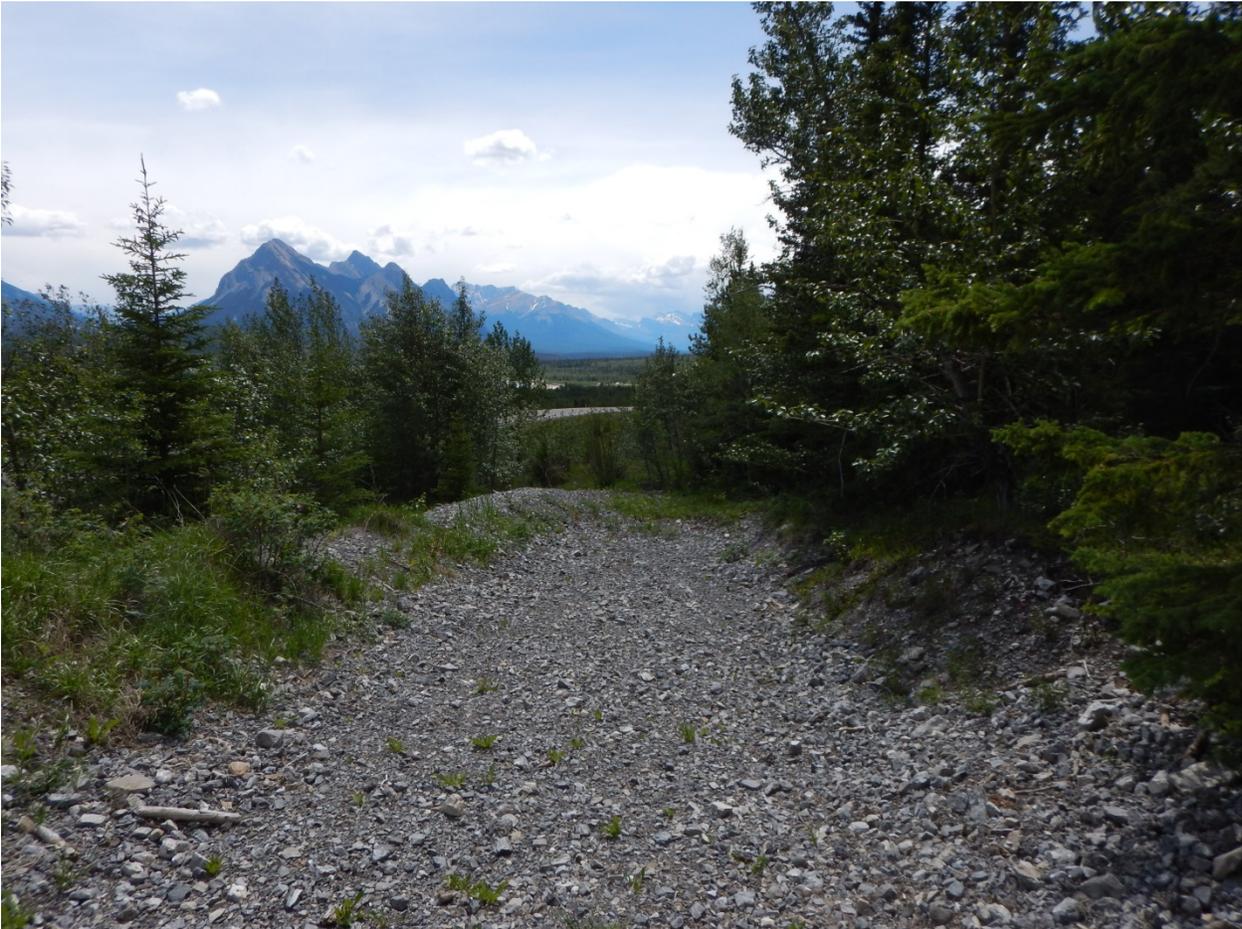
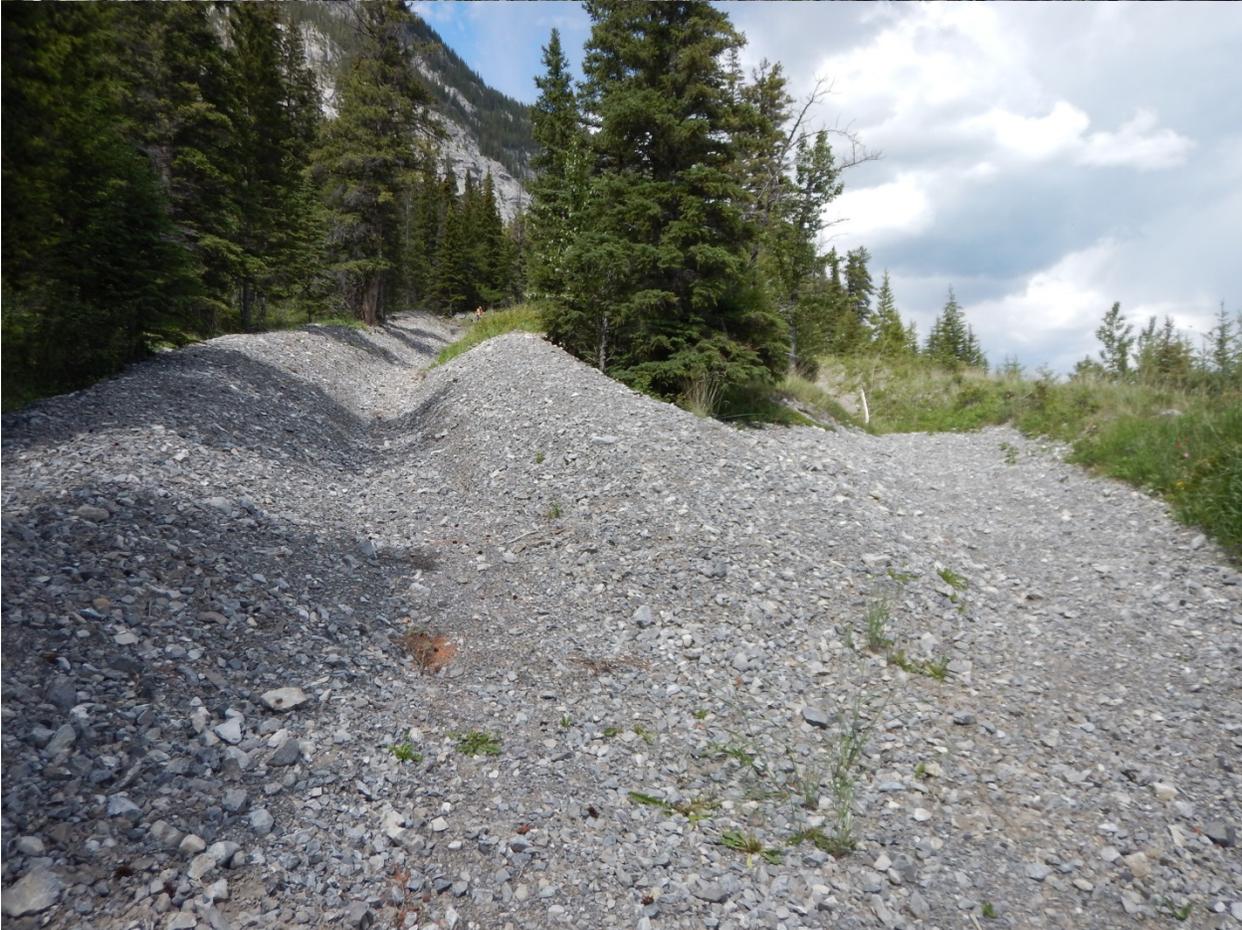
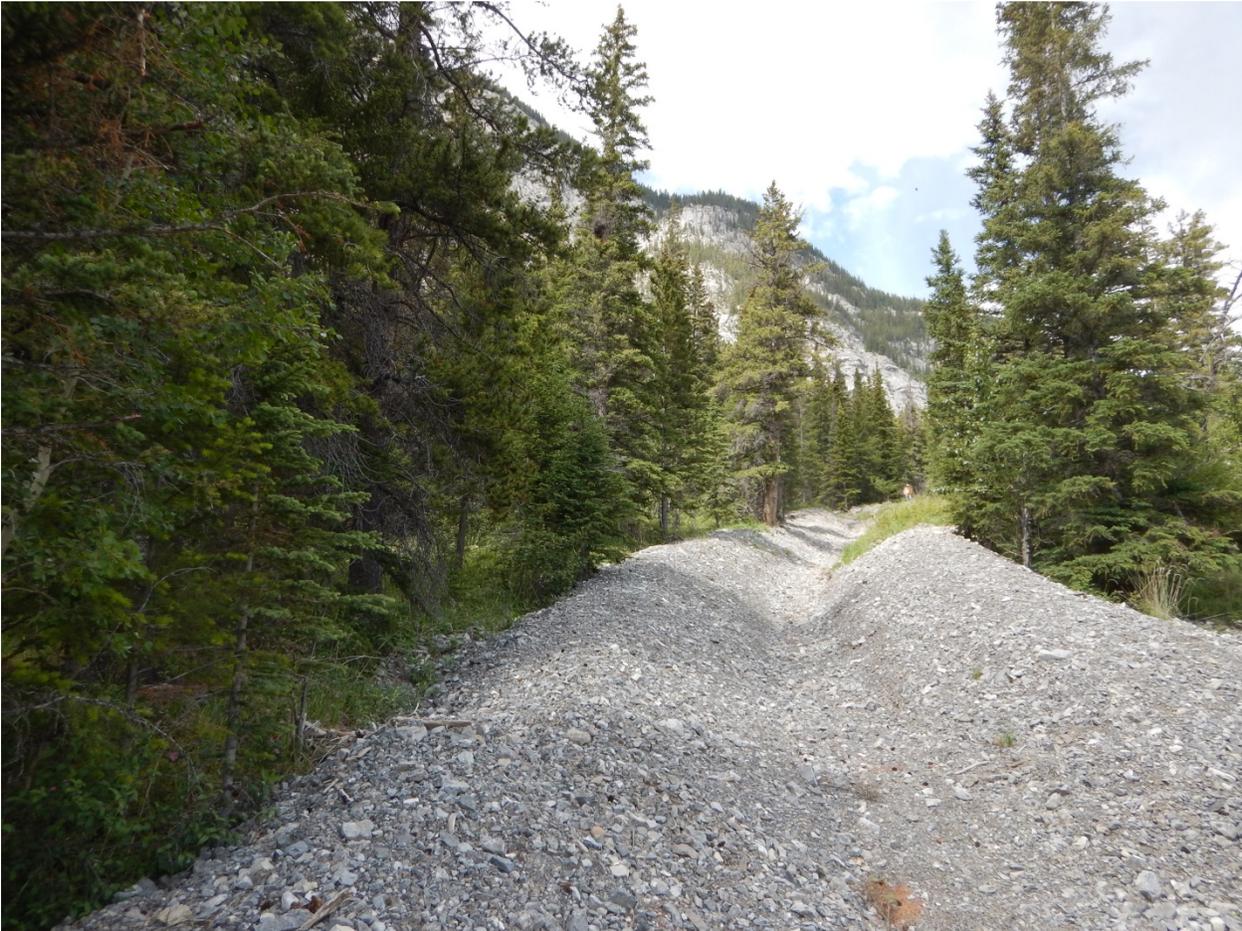
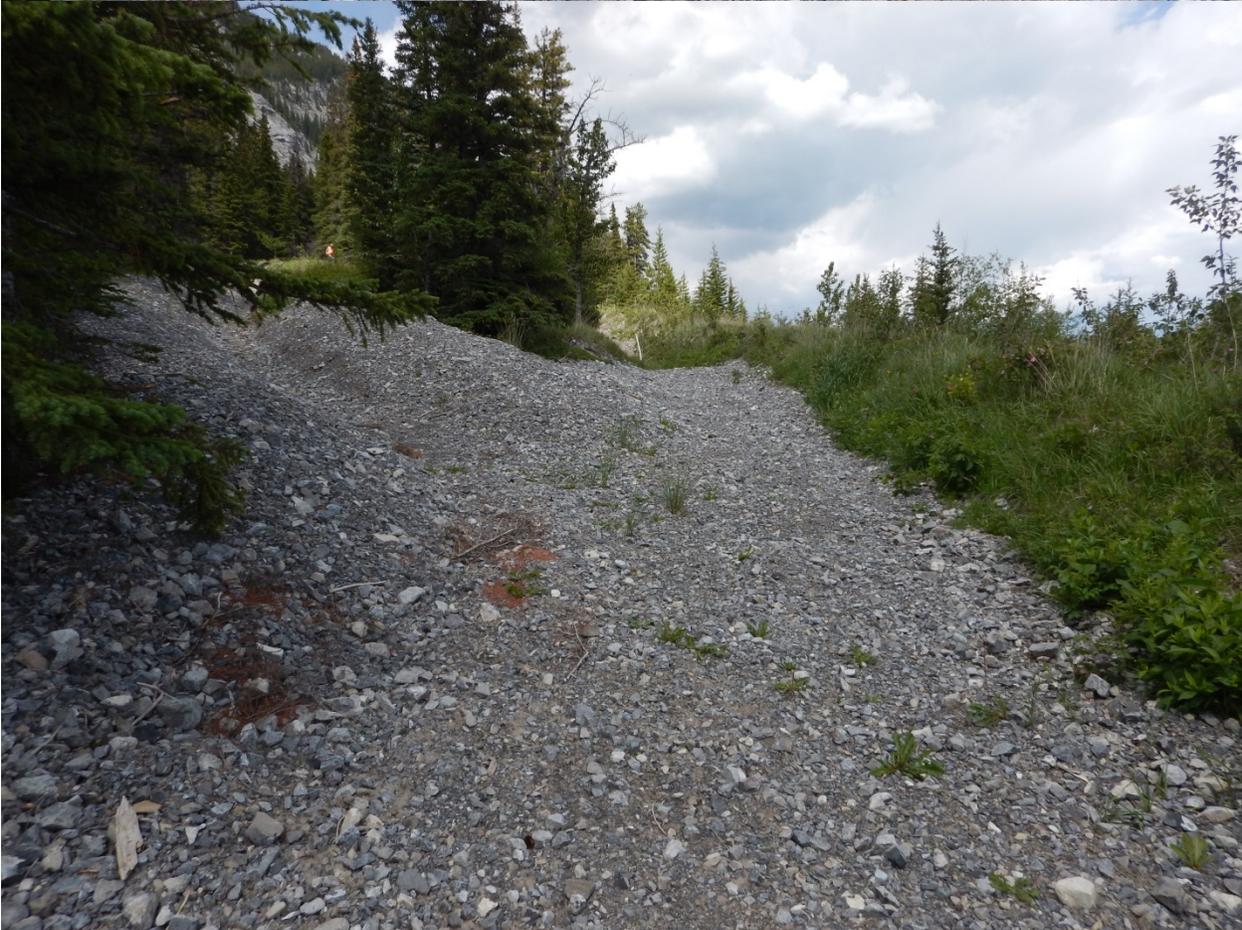
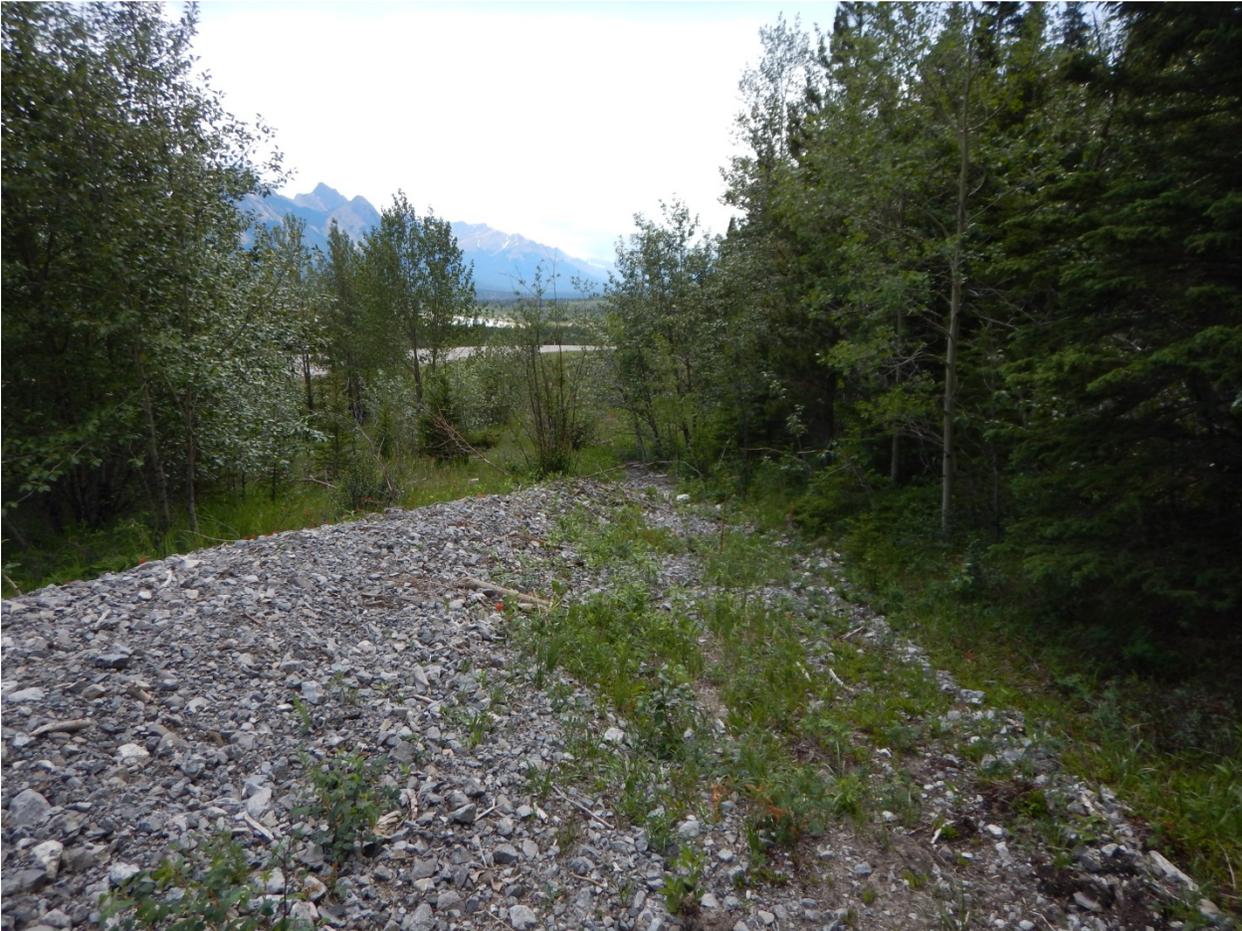
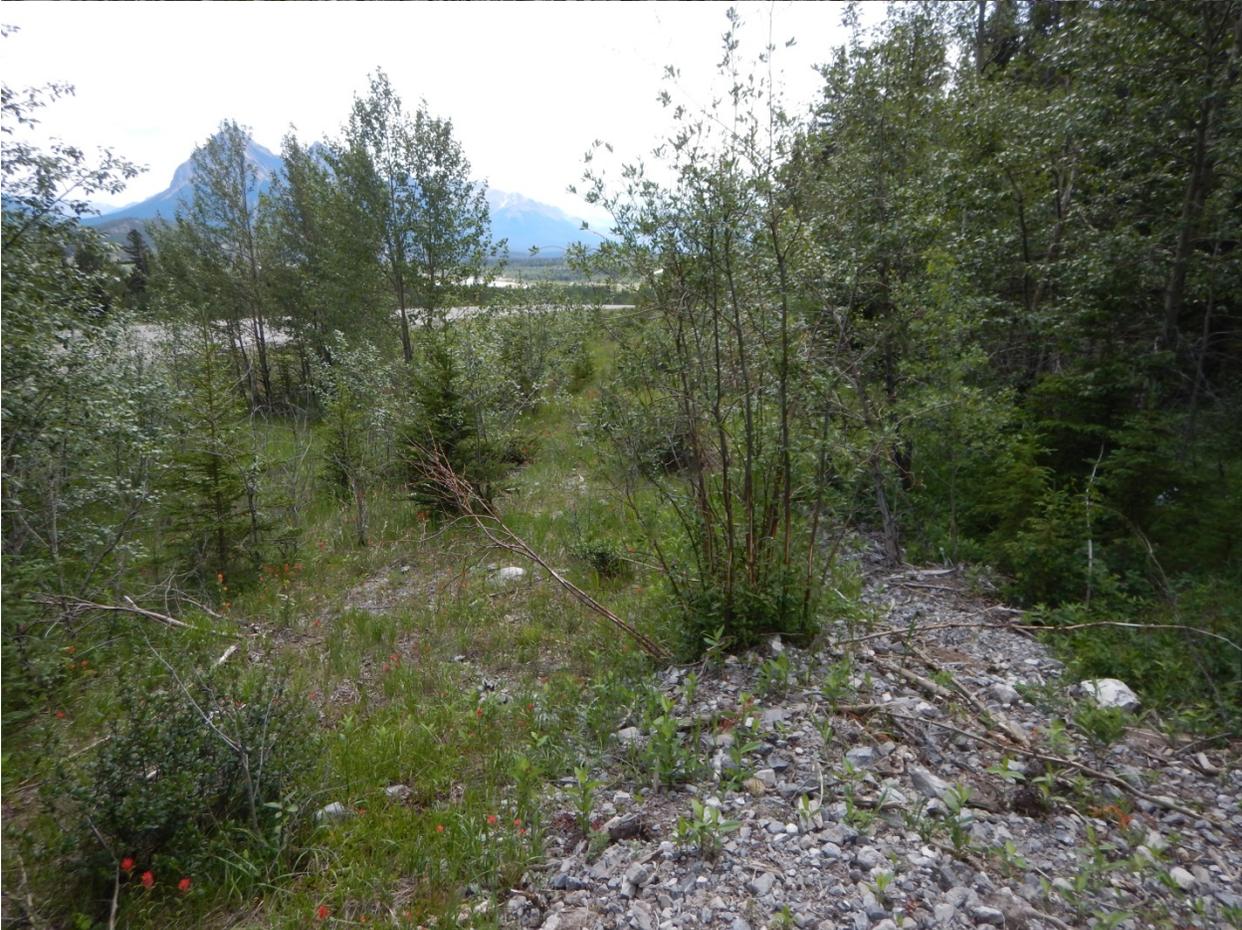
ITEM	CONDITION EXISTS		DESCRIPTION AND LOCATION	NOTICABLE CHANGE FROM LAST INSPECTION	
	YES	NO		YES	NO
COMMENTS					
<p>Upon assessment of the debris flow event in July 2004, KCB recommended that berms and channels be constructed to divert future water and debris flow events to the south along the ditch parallel to the highway. Two converging channels with training berms were constructed in the fall of 2004 above the highway on a natural bench. The berms were constructed with coarse gravel and cobbles with some sand that was derived from colluvial and debris flow materials. The channels are approximately 4 m wide across the bottom with 1.5H to 2H:1V side slopes. The berm height was approximately 1.5 m.</p> <p>Since completion of this work there have been no further debris flows that have impacted the highway surface at this area, including during the severe flood events of June 2005 and June 2013. KCB recommends that AT continue to maintain the existing channel and berm system which includes regular inspections and removal of accumulated debris materials and any vegetation growing in the channel system. Revisions to the width or depth of the channels are not required at this time.</p>

DATE OF ANY REMEDIAL ACTION: In the fall of 2004, AT constructed earthen diversion berms to direct flow to the south along the ditch to reduce the potential for debris flows impacting the highway. It is understood that there has been no change or debris flow activity at this site in the past 11 years, including during and immediately after the severe flood event of June 2013.
