PRODUCTS EVALUATION

Maccaferri Green Terramesh

By: Fred Cheng On: Aug 20, 2007

Project	Description	Application Date
Discovery Woods Villa, S.W. Calgary	Retaining wall	
Elbow River Pathway near Stampede Grounds	Retaining wall	2006

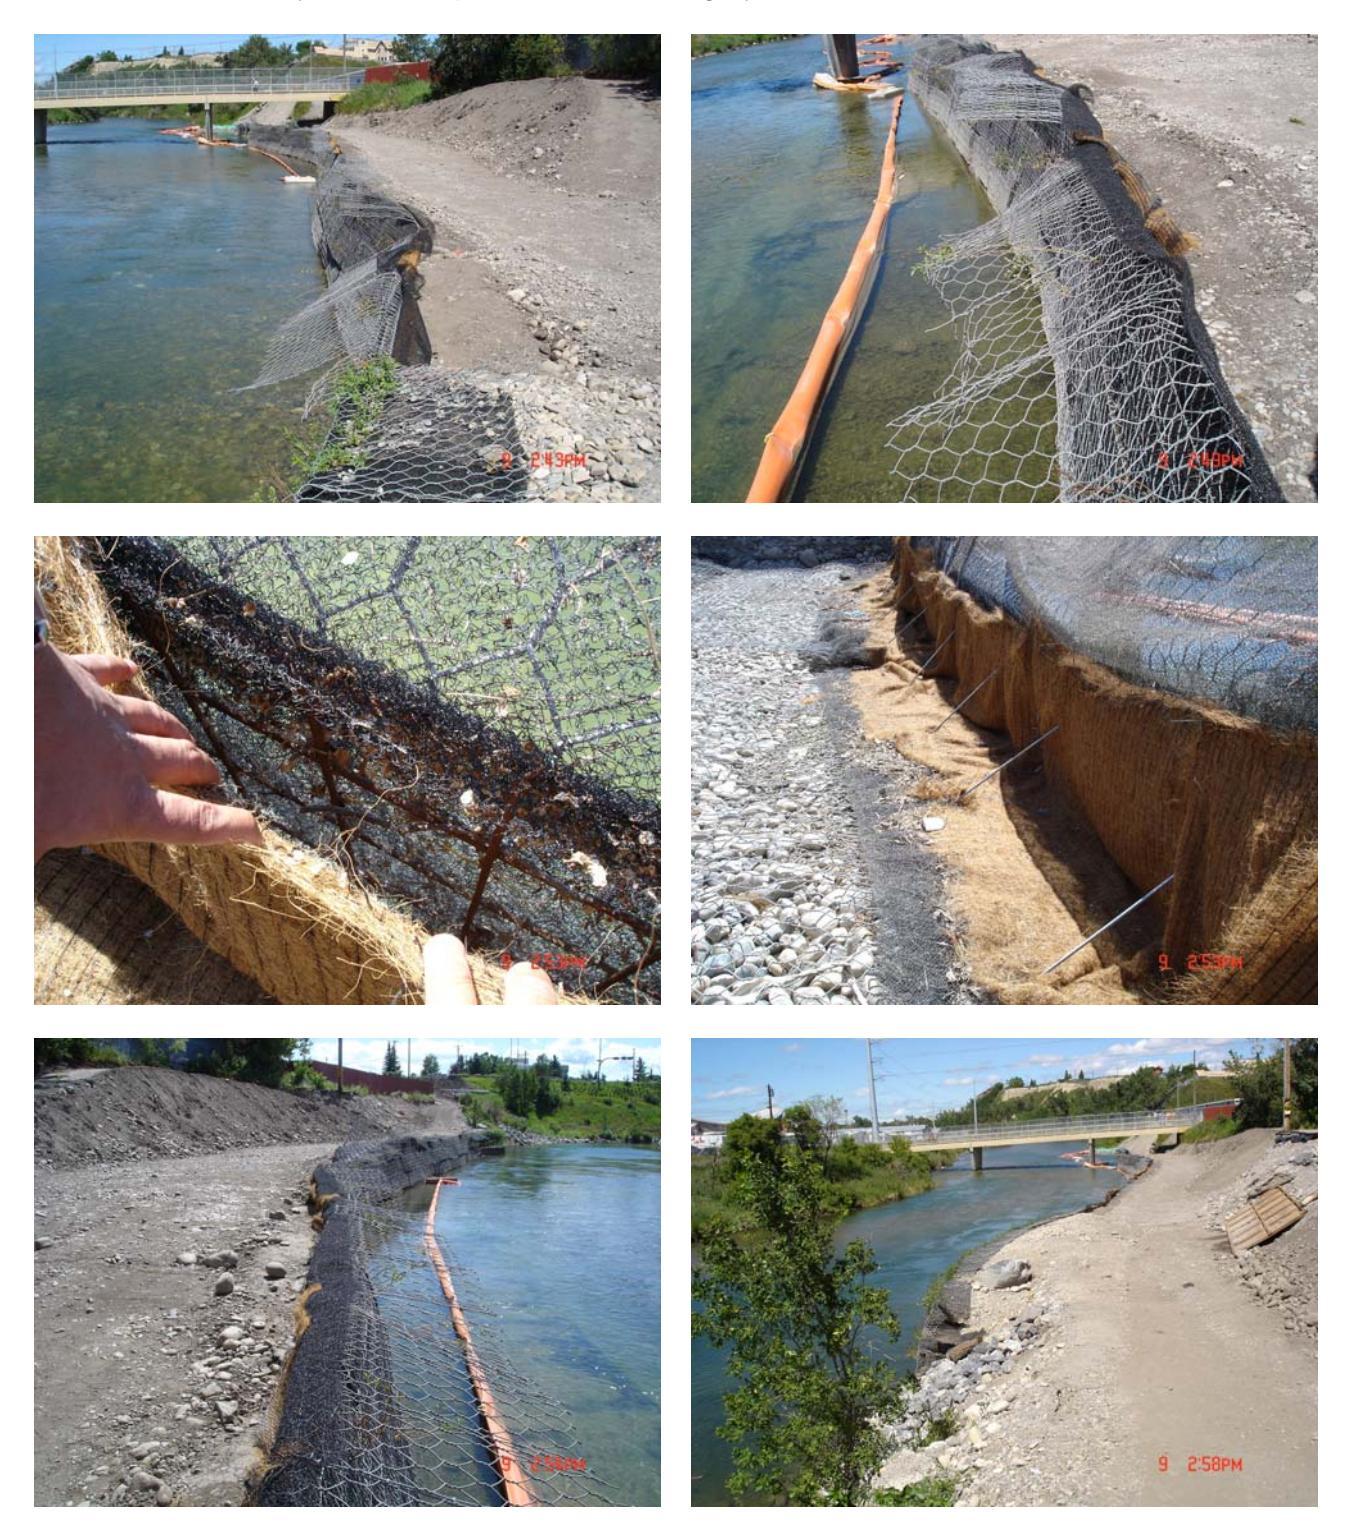
Elbow River Pathway near Stampede Grounds, Calgary:

- A Green Terramesh is built along the Elbow River bank to support a pathway along the river bank and provide natural look after it is fully vegetated
- Wall construction looks good

• The wall is near completion at time of inspection

Performance of the wall and vegetative catch is to be monitored regularly.

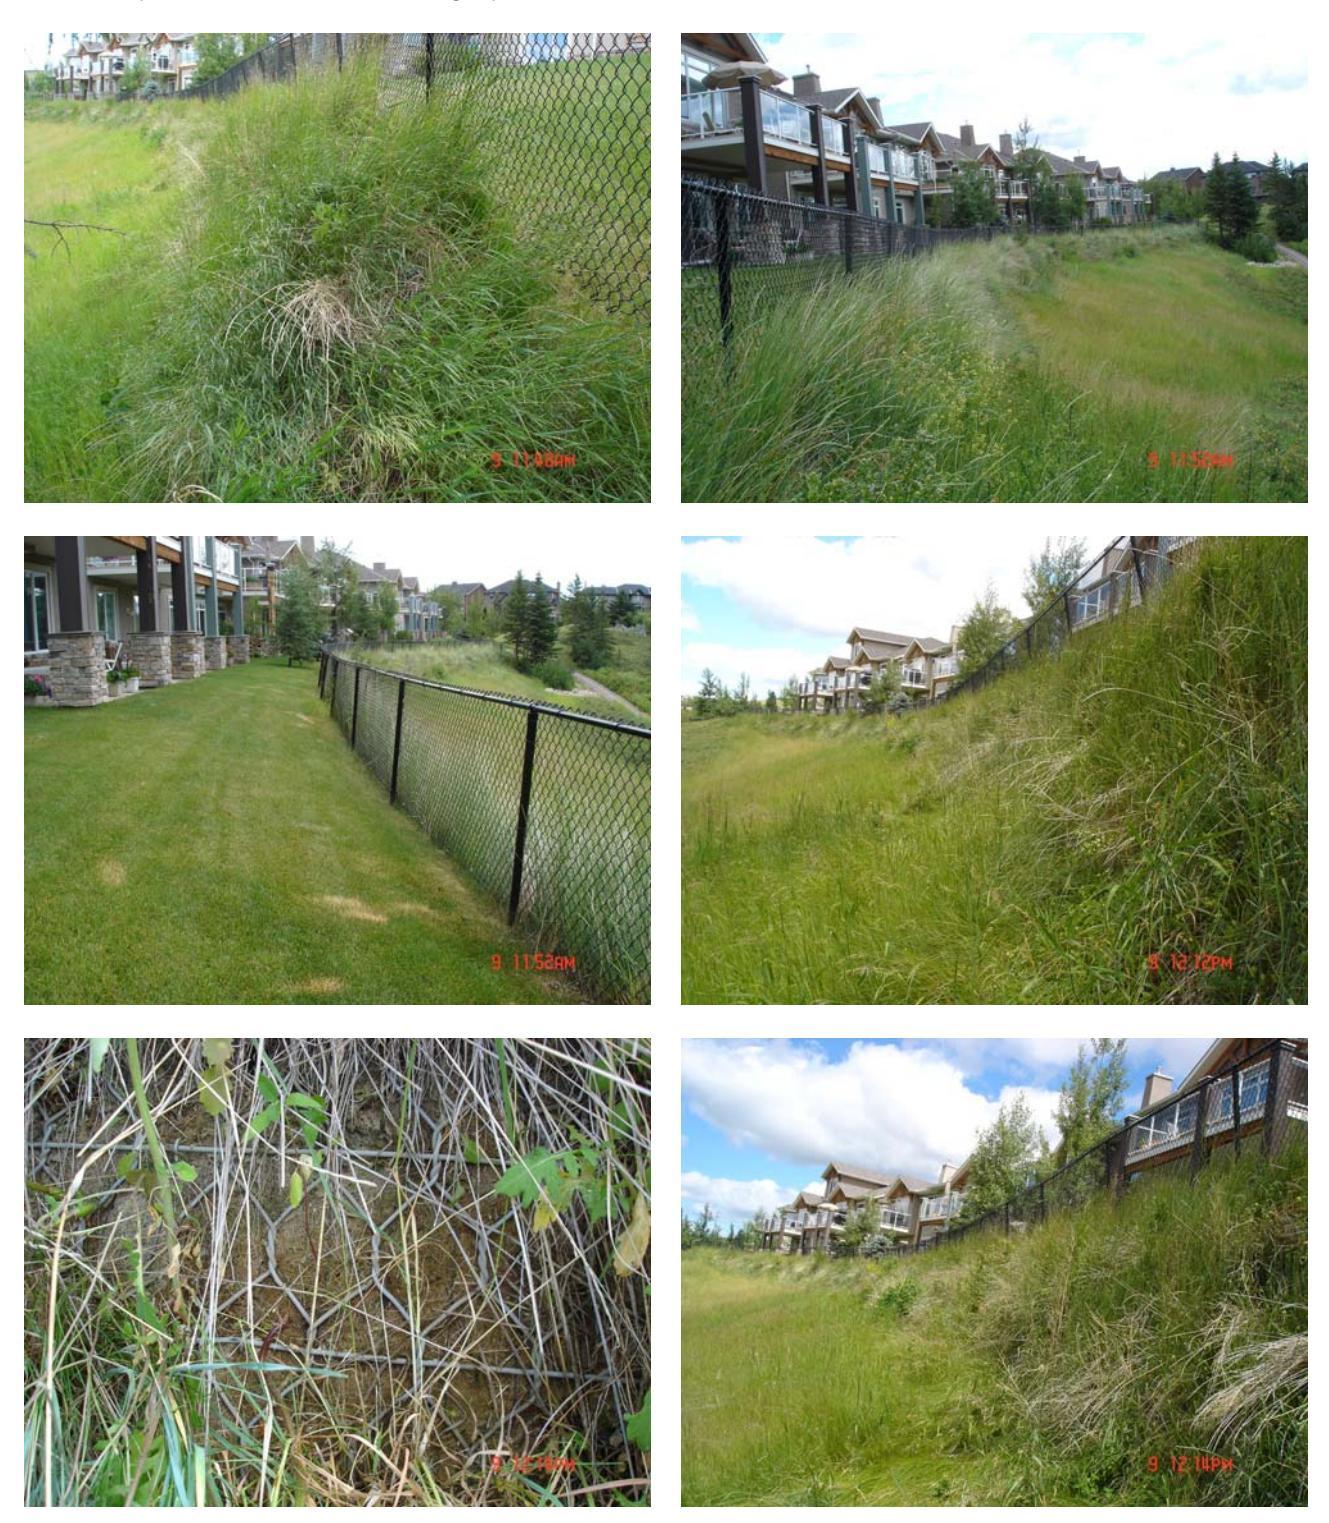
Discovery Woods Villa, S.W. Calgary:

- Retaining wall built along a slope
 - Houses are built behind it
 - Grass catches profusely on the wall surface
 - A chain link fence is built on top of the wall
 - The wall looks good and stands vertical
 - There are plans to extend the height of the wall
