| | <b>WILDLIFE CORRIDOR WARNING SIGN</b> | | <i>Issued: DEC 2015</i> |
| <b>RECOMMENDED PRACTICES</b> | PART | HIGHWAY SIGNS | |
| | SECTION | WARNING SIGNS | |

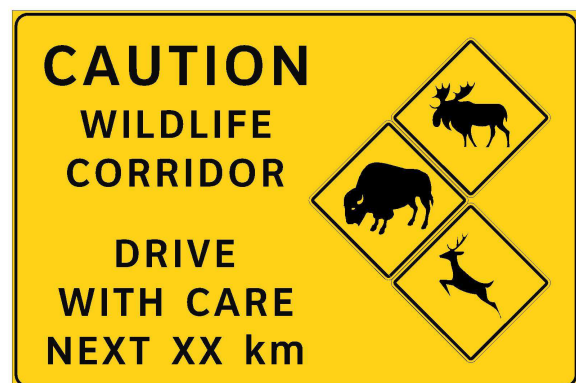
| <b>WC-18A</b> | <b>3660 mm x 2440 mm</b> | |

| <b>Colour</b> | Message and Border Background | Black Yellow |
| <b>Sheeting</b> | ASTM D4956 Type IX or XI | |

The standard sizes of Wildlife Corridor Warning signs are 3660 mm x 2440 mm for WC-18A with three wildlife symbols, and 3350 mm x 2440 mm for WC-18B with two wildlife symbols.

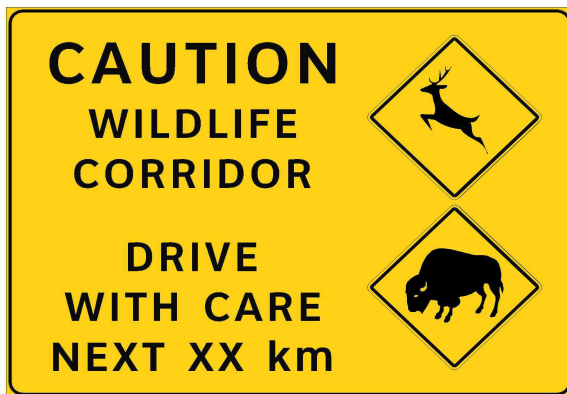
| <b>WC-18B</b> | <b>3350 mm x 2440 mm</b> | |

| <b>Colour</b> | Message and Border Background | Black Yellow |
| <b>Sheeting</b> | ASTM D4956 Type IX or XI | |
