Title: Intersection Type, Hwy 59:02/ Hwy 723:02 / Rge Rd. 100 km 21.349, Valhalla Centre

Design Exception Request Date: December 7, 2012

Region: Peace

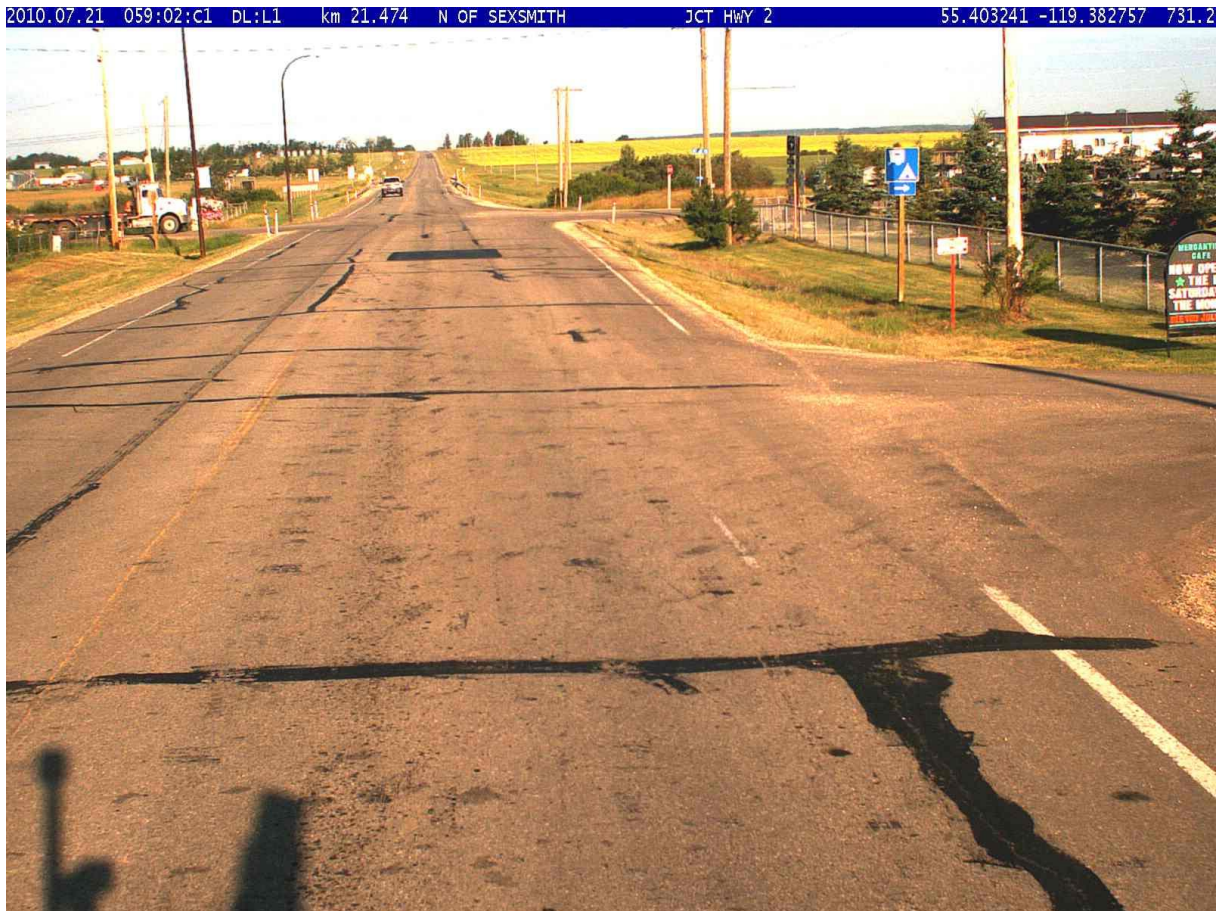
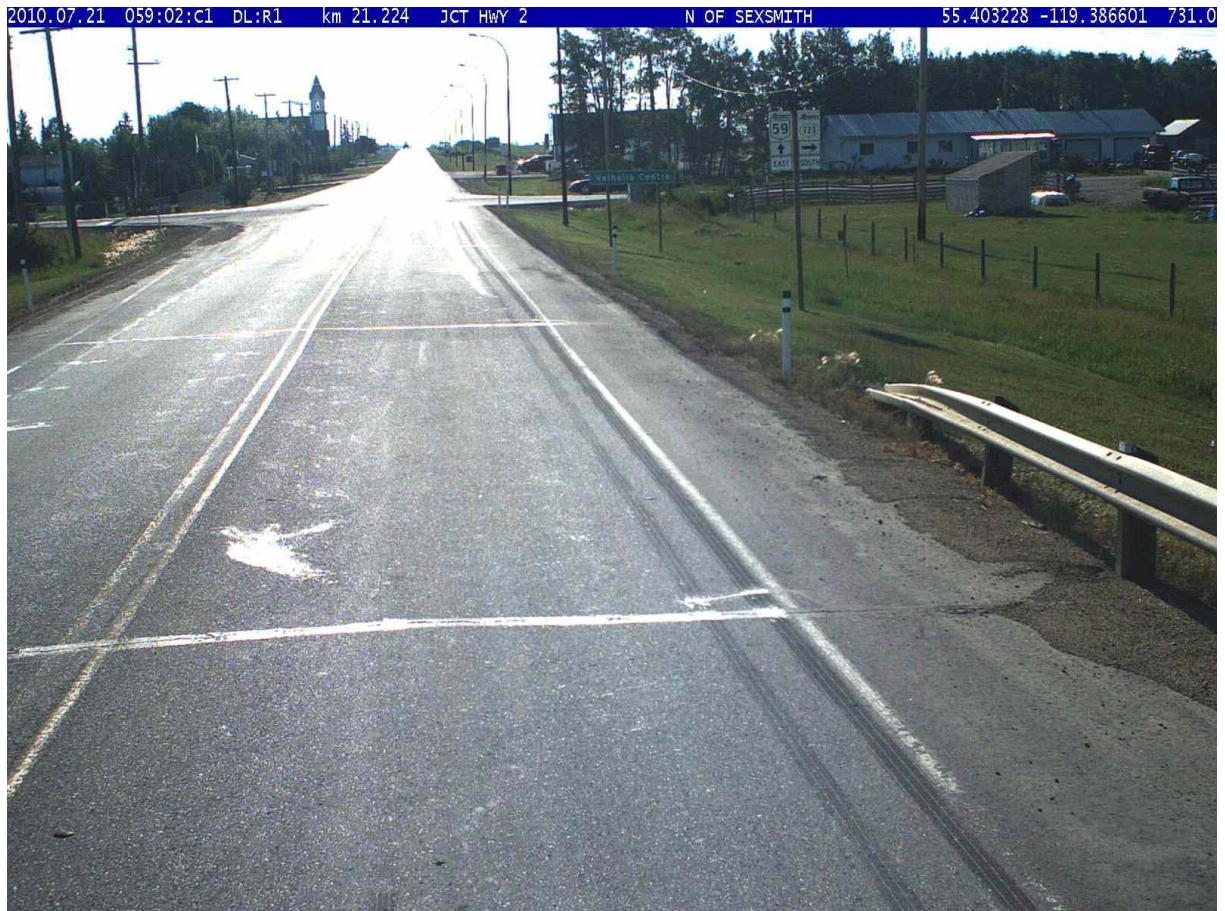
Photograph/Diagram (If Available)

Summary
Design exception request is for maintaining the existing modified Type 2/ Type 1 intersection treatment. Improving the existing intersection to the warranted treatment and service road concept would require additional R/W which would significantly impact the existing surrounding properties and accesses. Based on the HGDG (Updated 1999), Chapter D.7 Intersection Treatment – Two Lane Undivided Highways, a Type 2c intersection would typically be warranted

- The intersection is illuminated. Hwy 59 and both intersecting legs are posted at 50 km/h. Intersection sight distance is adequate for all design vehicles using the intersection on a daily basis.
- Low AADT in the design year. 1290 vpd on Hwy 59 and 760 vpd on Hwy 723.

Install 600 mm wide stop bar line which is typically used for rural intersection applications.
