PROJECT: SOUTHERN REGION GEOHAZARD ASSESSMENT

TITLE: S15 - CROWSNEST LAKE ROCKFALL BARRIER

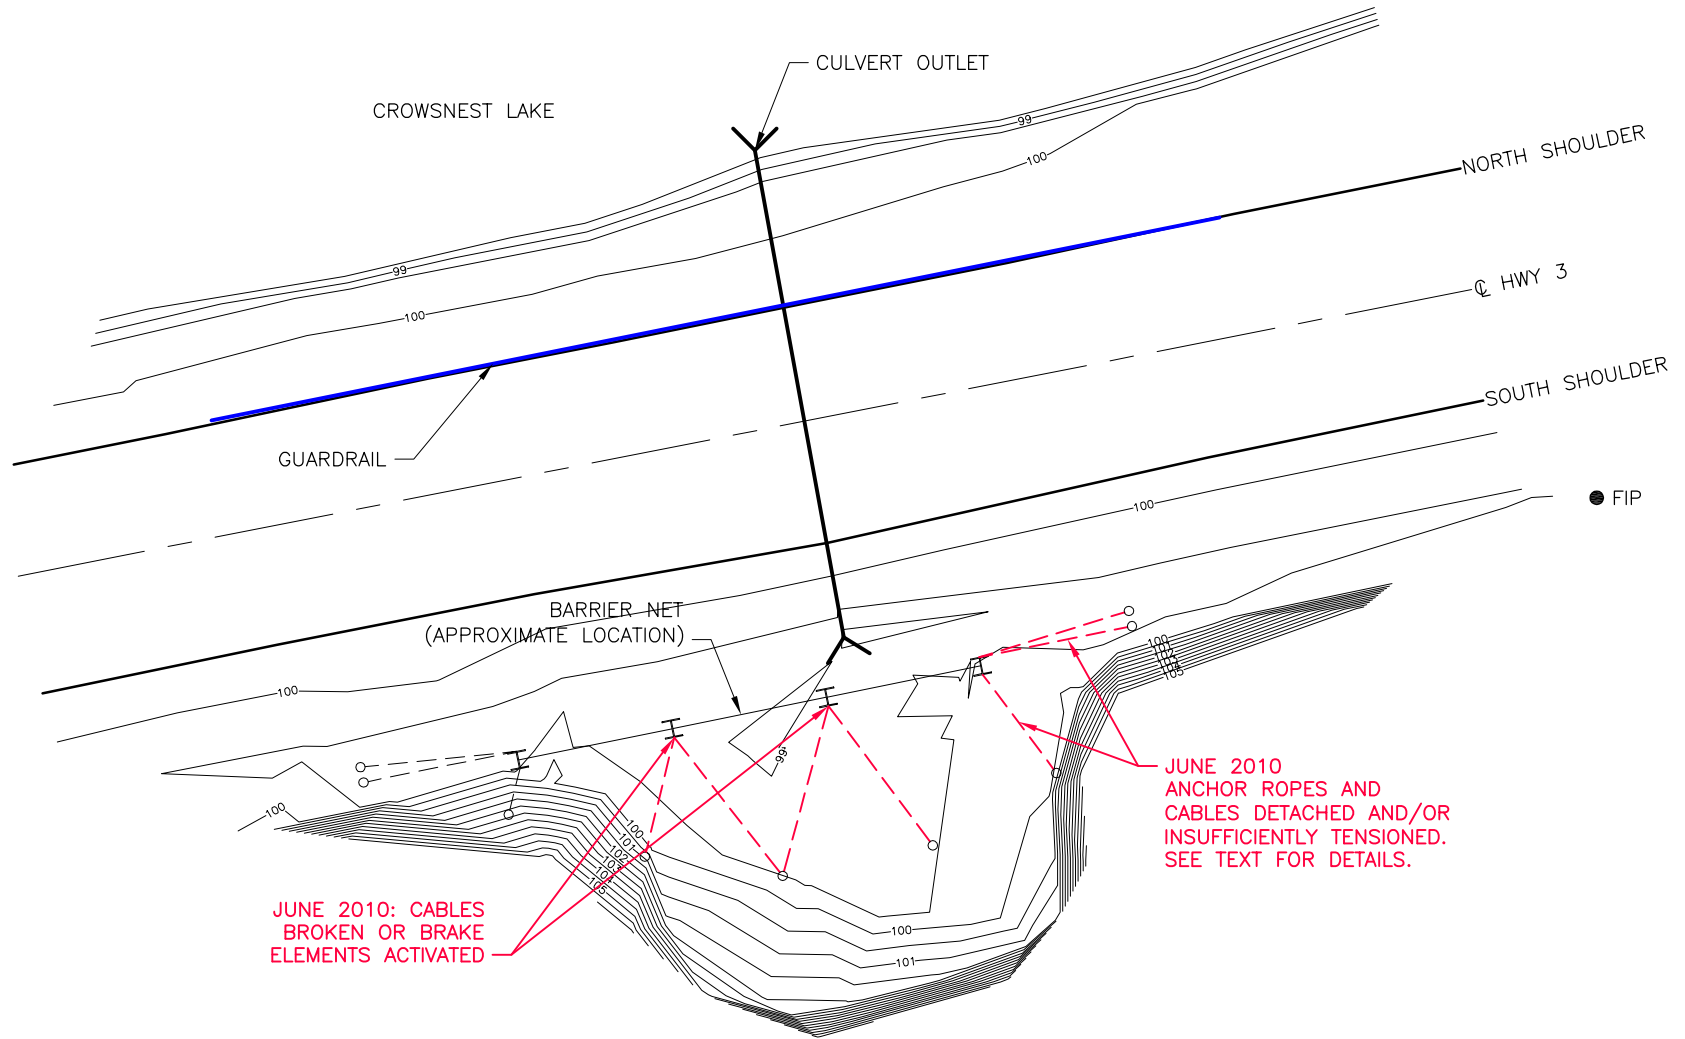
DATE: OCTOBER 2010	JOB No.: CG25332.200	CAD FILE: 25332B02.dwg	FIGURE No.: FIG S15-1	REV. A
-----------------------	-------------------------	---------------------------	--------------------------	-----------

JUNE 2010: CABLES
BROKEN OR BRAKE
ELEMENTS ACTIVATED

JUNE 2010
ANCHOR ROPES AND
CABLES DETACHED AND/OR
INSUFFICIENTLY TENSIONED.
SEE TEXT FOR DETAILS.
