Client	Alberta Transportation	<b>Figure S17-1</b>	
Project	Southern Region Geohazard Assessment	Date: Aug-08	Revision
<b>S17 - Mount Baldy Rock Cut Typical Cross-Section</b>		Job No. CG25277.B	
		File No.:

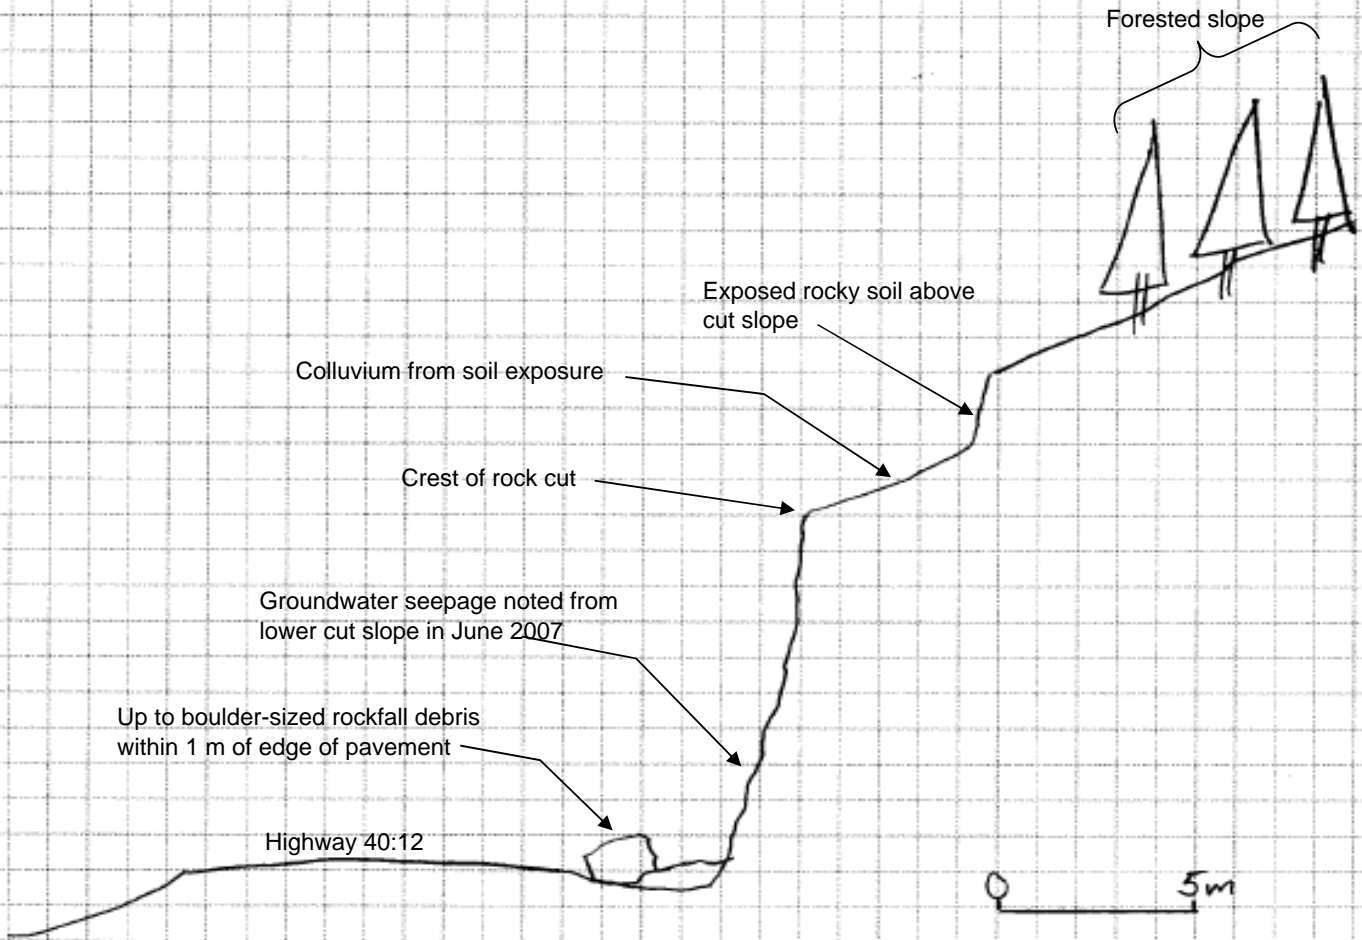
(Facing North)

- 1. Typical cross-section near maximum cut slope height.
- 2. All dimensions approximate.
