SOUTHERN REGION GEOHAZARD ASSESSMENT

"EAST END OF RUNDLE" AVALANCHE AREA **OBLIQUE VIEW SHOWING AVALANCHE PATHS**

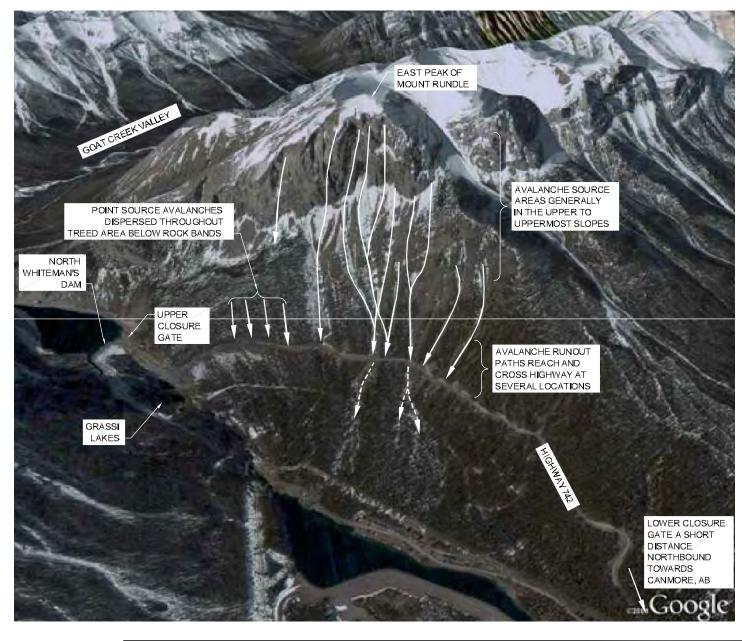
CG25309.B 25309N15.dwg FIGURE 2

- 1. IMAGE FROM GOOGLE EARTH.
- 2. FACING WEST.
- 3. AVALANCHE PATHS AS SHOWN ARE APPROXIMATE. ACTUAL LOCATIONS DEPEND ON SNOWPACK CONDITIONS THROUGHOUT EACH WINTER SEASON.

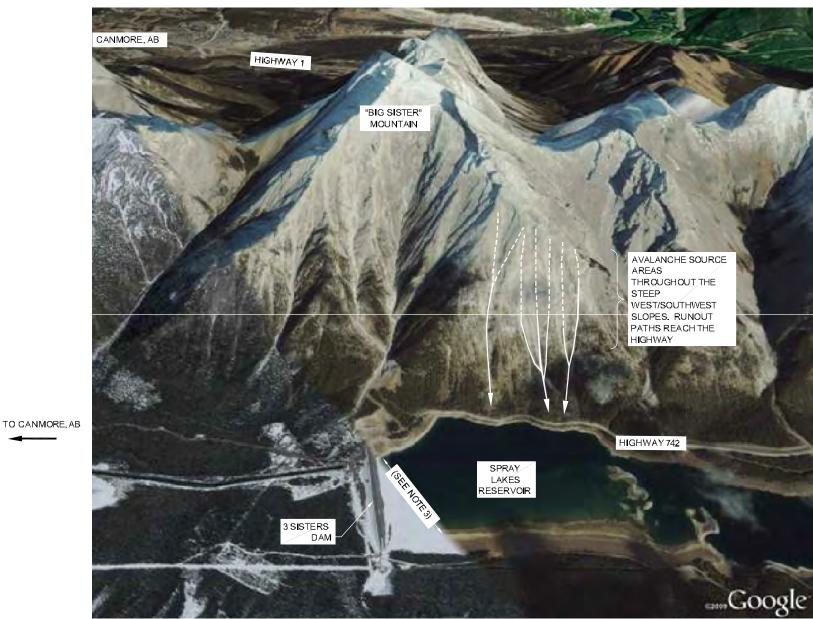
DATE: FIGURE No.: CG25309.B 25309N15.dwg FIGURE 3 JUNE 2009

2. FACING NORTHEAST.

APPARENT STRAIGHT BOUNDARY BETWEEN SNOW COVERED AND NON-SNOW COVERED AREAS DUE TO COMPILATION OF SATELLITE PHOTOS FROM DIFFERENT DATES.

AVALANCHE PATHS AS SHOWN ARE APPROXIMATE. ACTUAL LOCATIONS DEPEND CLIENT: ON SNOWPACK CONDITIONS THROUGHOUT EACH WINTER SEASON.

"BACK OF BIG SISTER" AVALANCHE AREA **OBLIQUE VIEW SHOWING AVALANCHE PATHS**

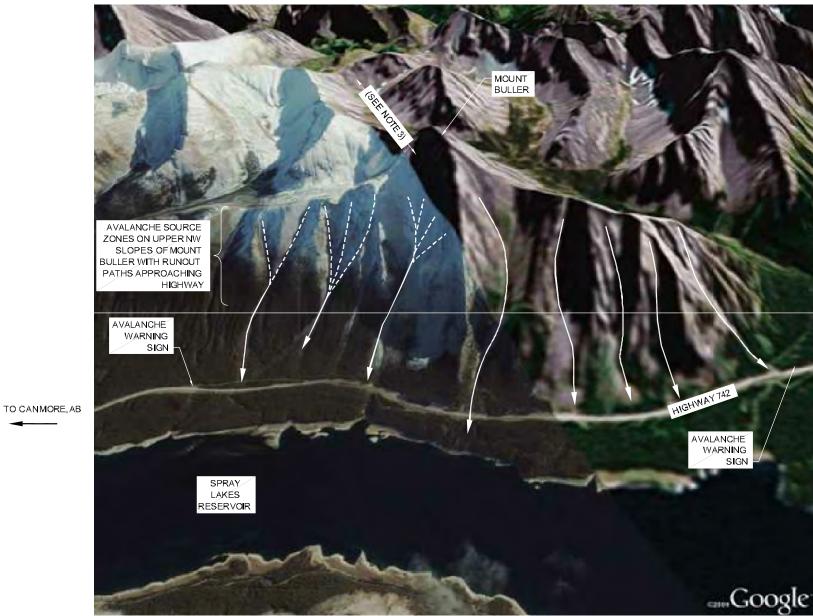
DATE:			JOB	No.:	CAD FILE:	FIGURE No.:		REV.
	JUNE	2009		CG25309.B	25309N15.dwg	FIGURE	4	Α

2. FACING EAST.

3. APPARENT STRAIGHT BOUNDARY BETWEEN SNOW COVERED AND NON-SNOW COVERED AREAS DUE TO COMPILATION OF SATELLITE PHOTOS FROM DIFFERENT DATES.

4. AVALANCHE PATHS AS SHOWN ARE APPROXIMATE. ACTUAL LOCATIONS DEPEND CLIENT: ON SNOWPACK CONDITIONS THROUGHOUT EACH WINTER SEASON.

TITLE: "BULLER CORNER" AVALANCHE AREA **OBLIQUE VIEW SHOWING AVALANCHE PATHS**
