# Repairs to Highway 40 and Forestry Trunk Road

Alberta Flood 2013

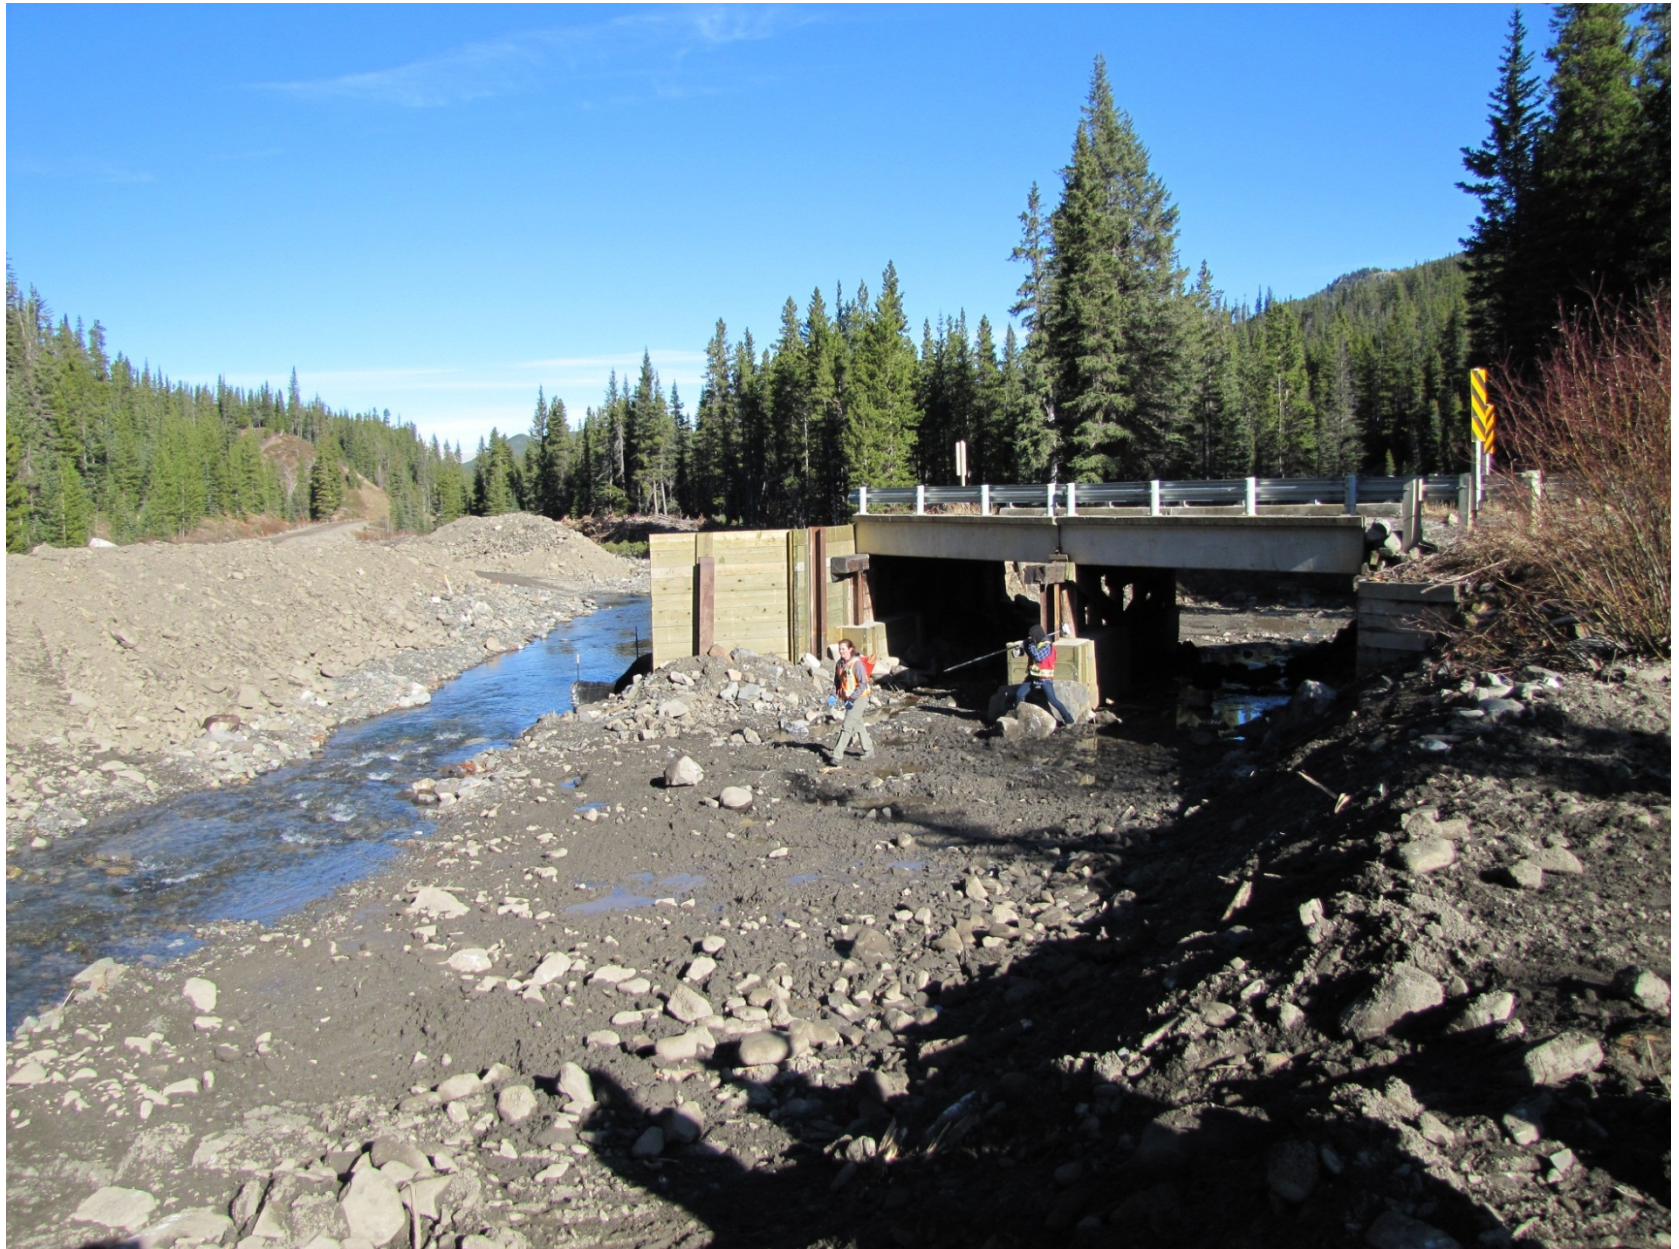
Forestry Trunk Road bridge approach washed out. Note creek has created a new channel which needs to be re-directed under the bridge.

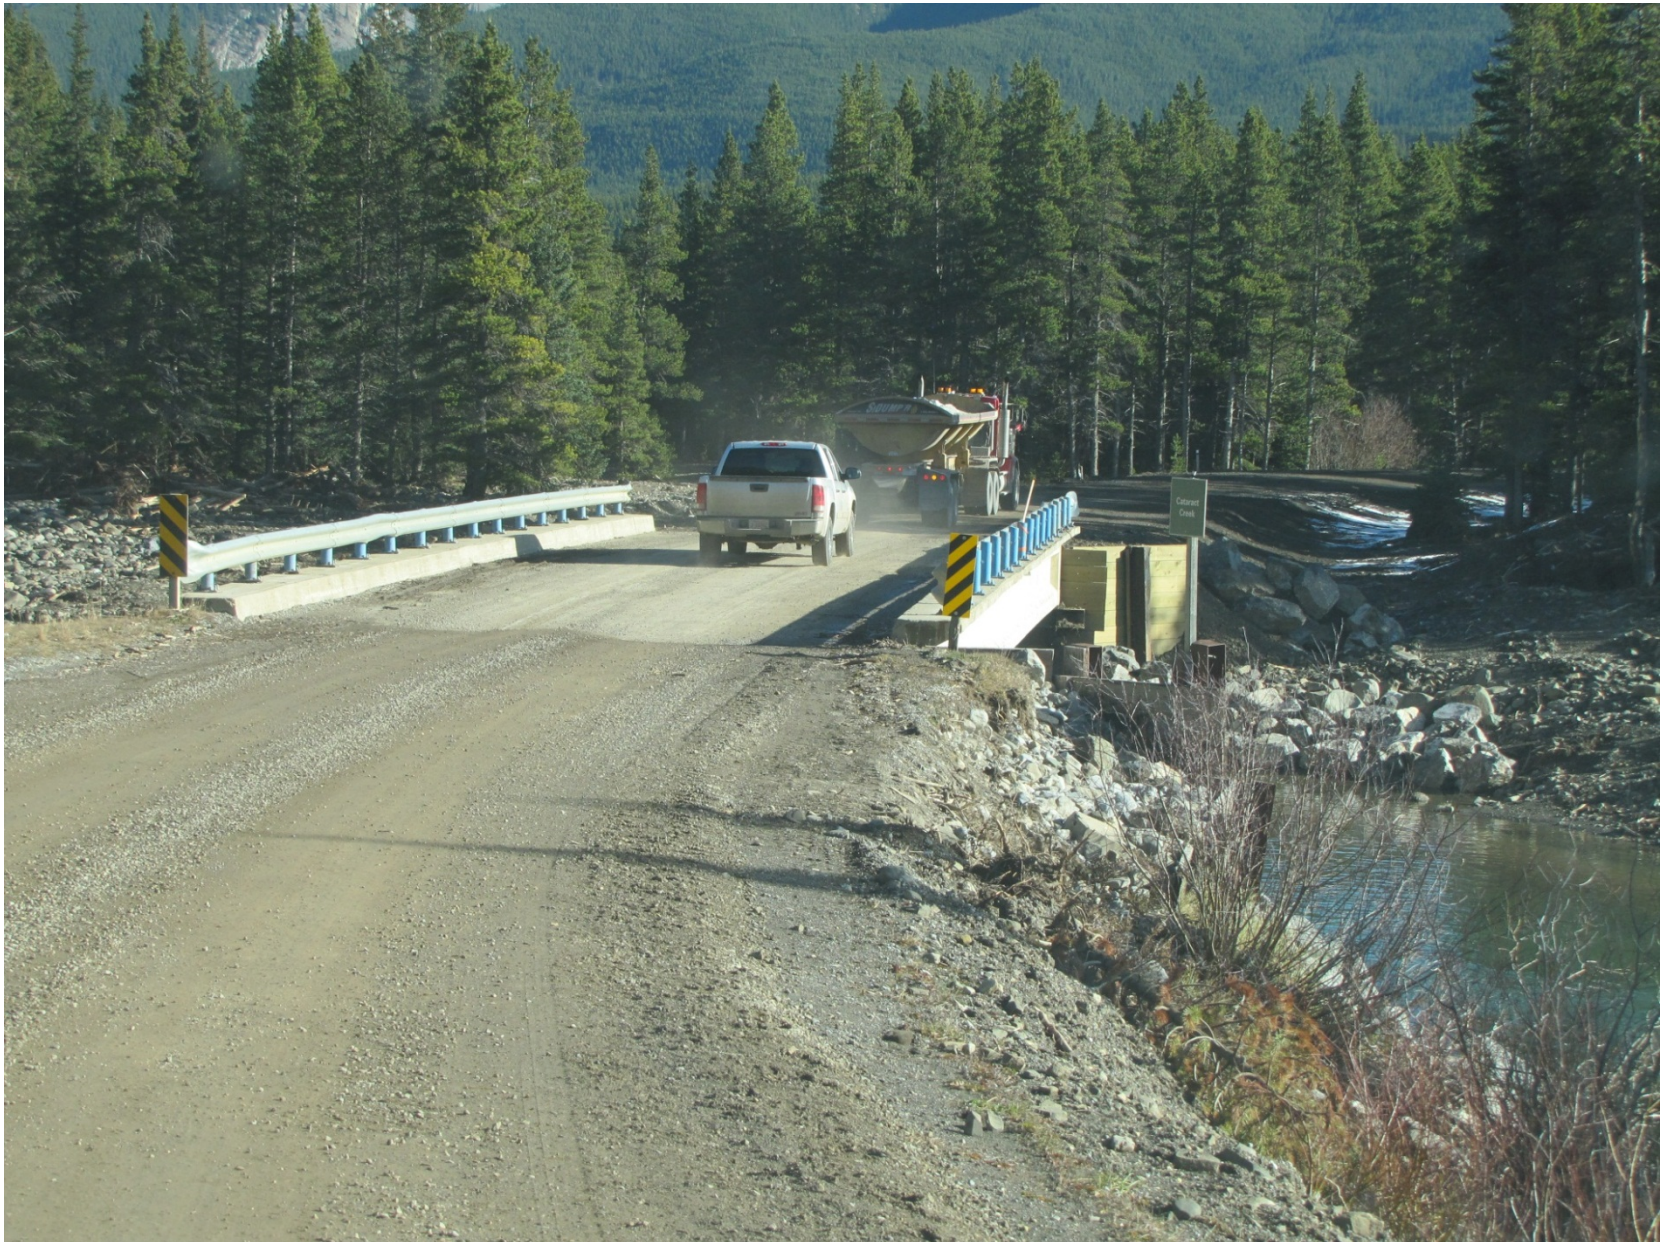
Forestry Trunk Road bridge approach back filled and repaired for traffic to drive on. Creek has been restored to its original course.

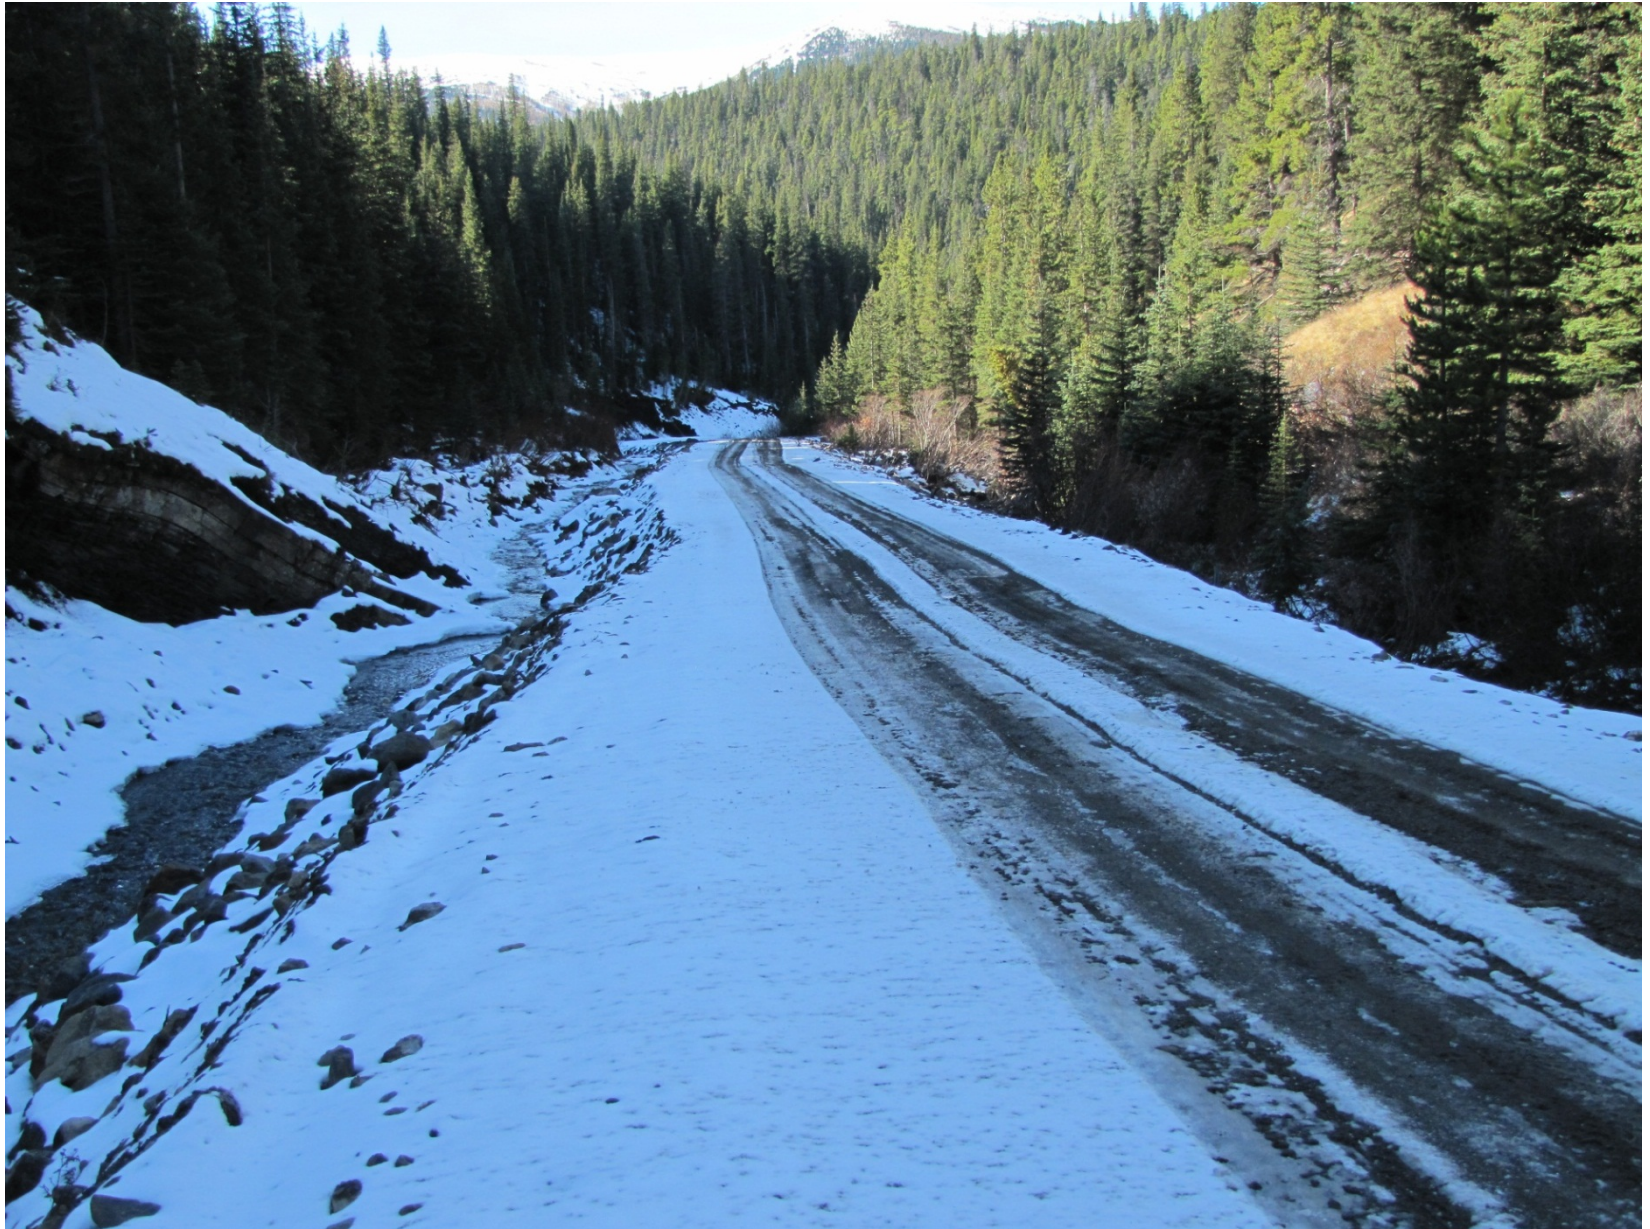
Forestry Trunk Road at bottom of the valley was rebuilt to allow traffic to drive on. Water is still flowing freely along both sides of roadway.

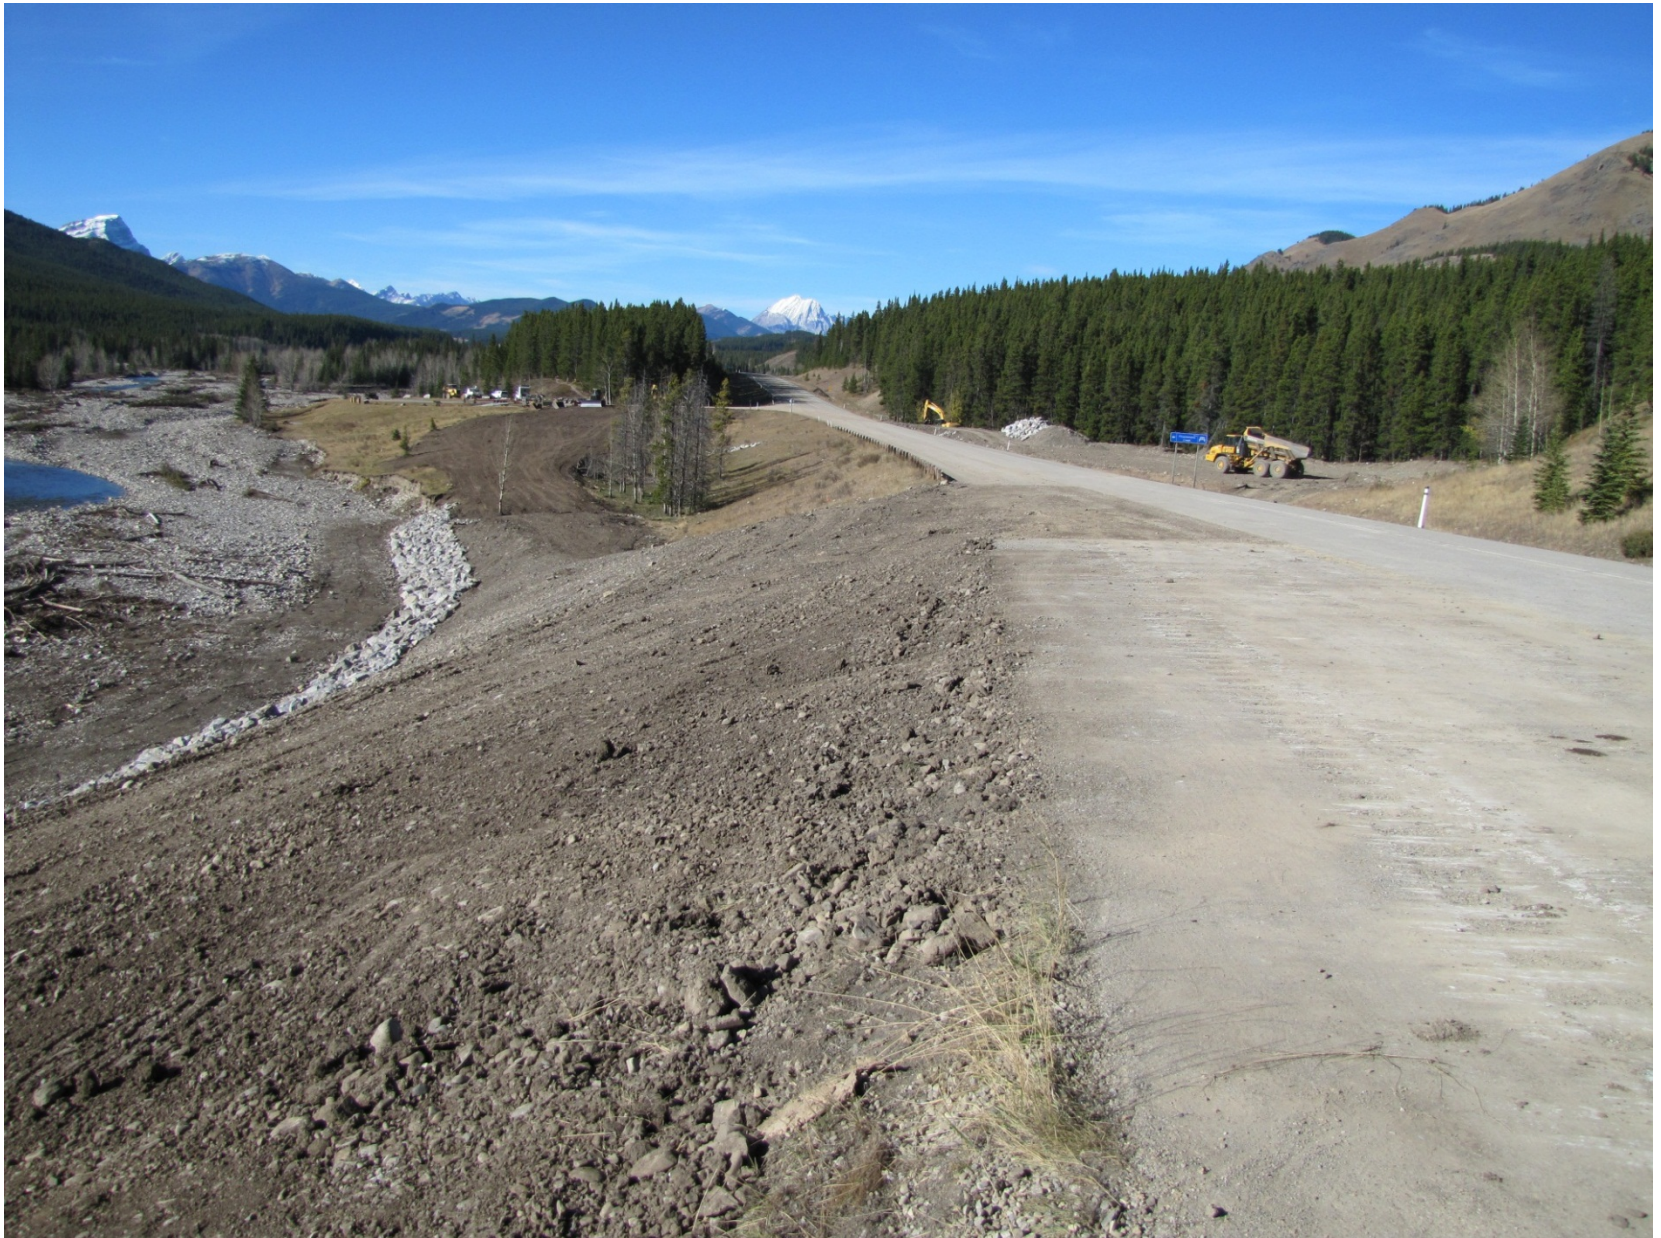
Highway 40 washout repair with a new gravel road surface and slideslope repaired.

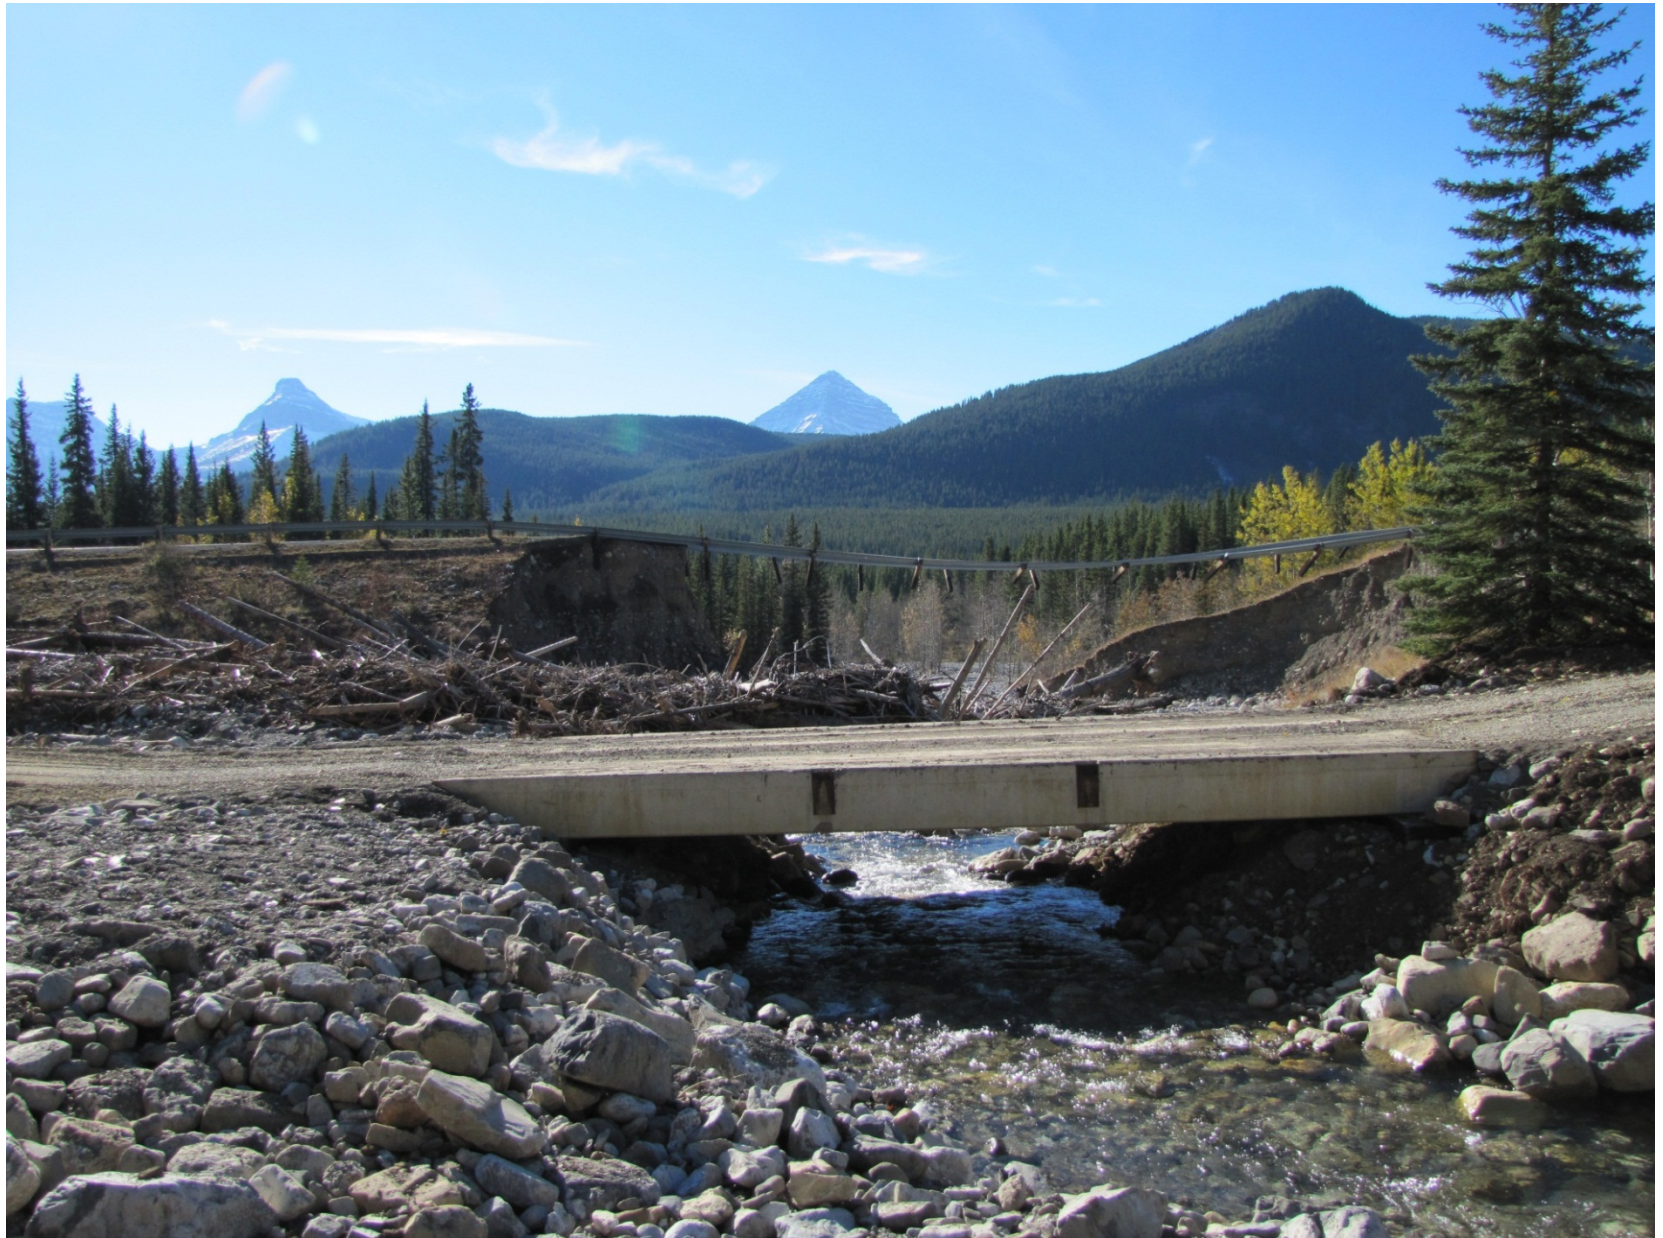
Highway 40, temporary bridge detour at Lineham Creek. Note damaged road and missing culvert location in background.

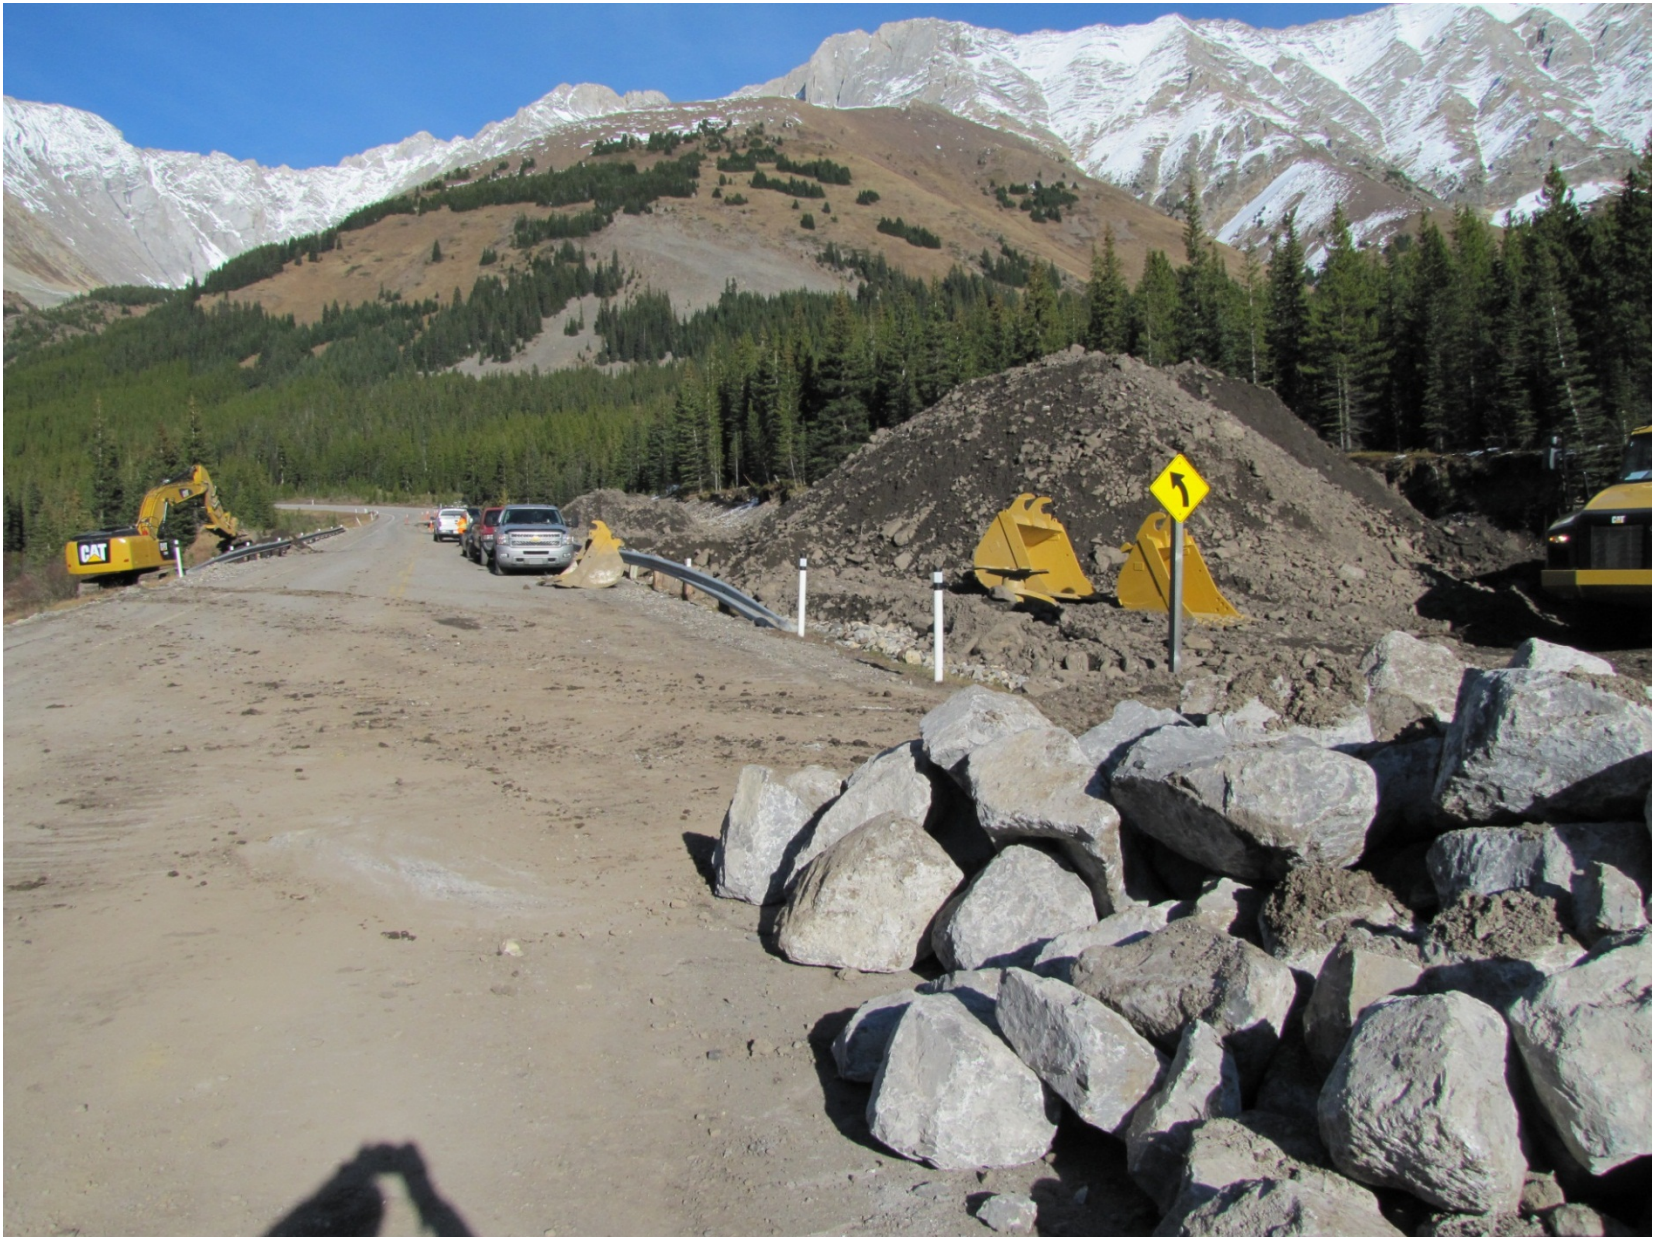
Highway 40, repair work at Storm Creek site where debris from mountain run off plugged culverts and washed road and ditches away.
