SITE NUMBER AND NAME C56 H836:02 Settlement Repair		HIGHWAY & KM km 9	PREVIOUS INSPECTION DATE May 18, 2010	INSPECTION DATE May 17, 2011
LEGAL DESCRIPTION 11-29-23-W4	NAD 83 COORDINATES N 5704031 E 351107	RISK ASSESMENT PF: 1 CF: 1 TOTAL: 1

LAST READING DATE:	
PRIMARY SITE ISSUE: Pavement Settlement – slide on shoulder.	
APPROXIMATE DIMENSIONS: 40 m long	
DATE OF ANY REMEDIAL ACTION: 160 (5 rows) launched soil nails installed in July 2010.

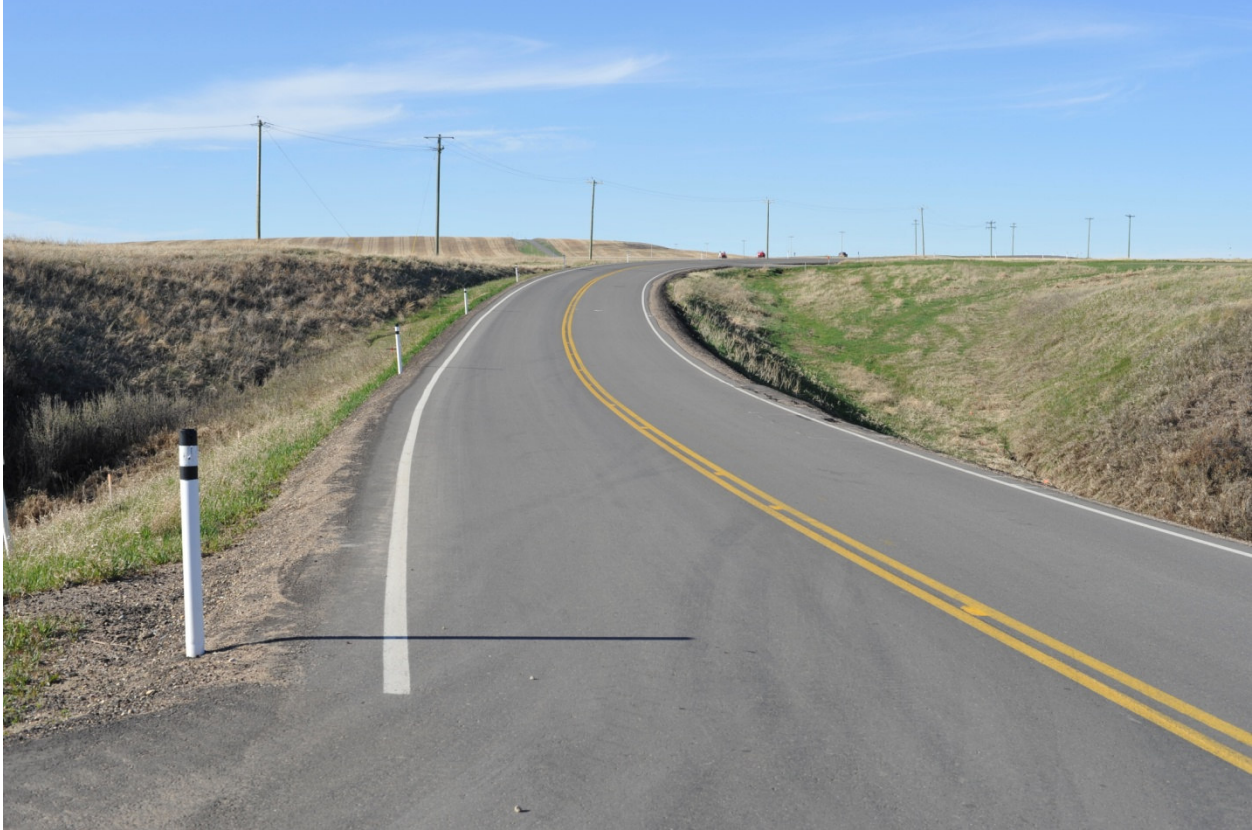
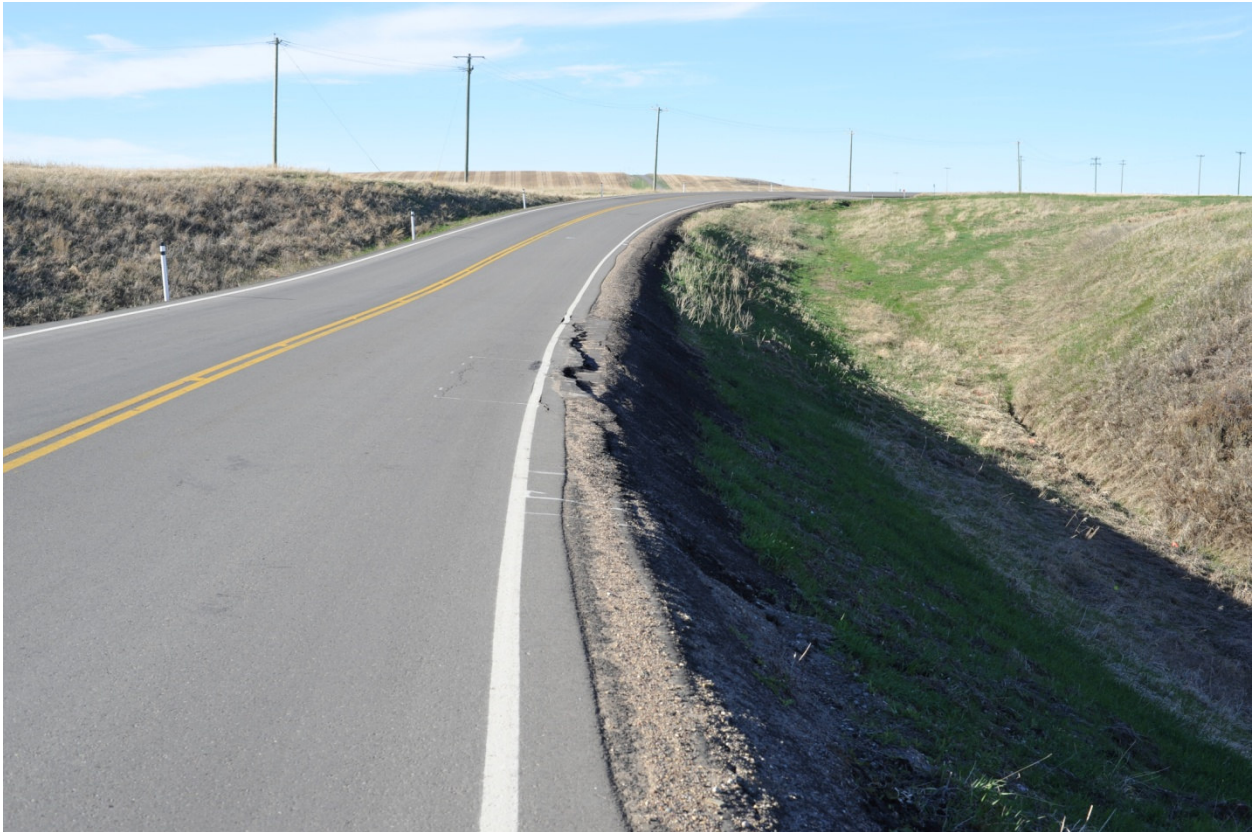
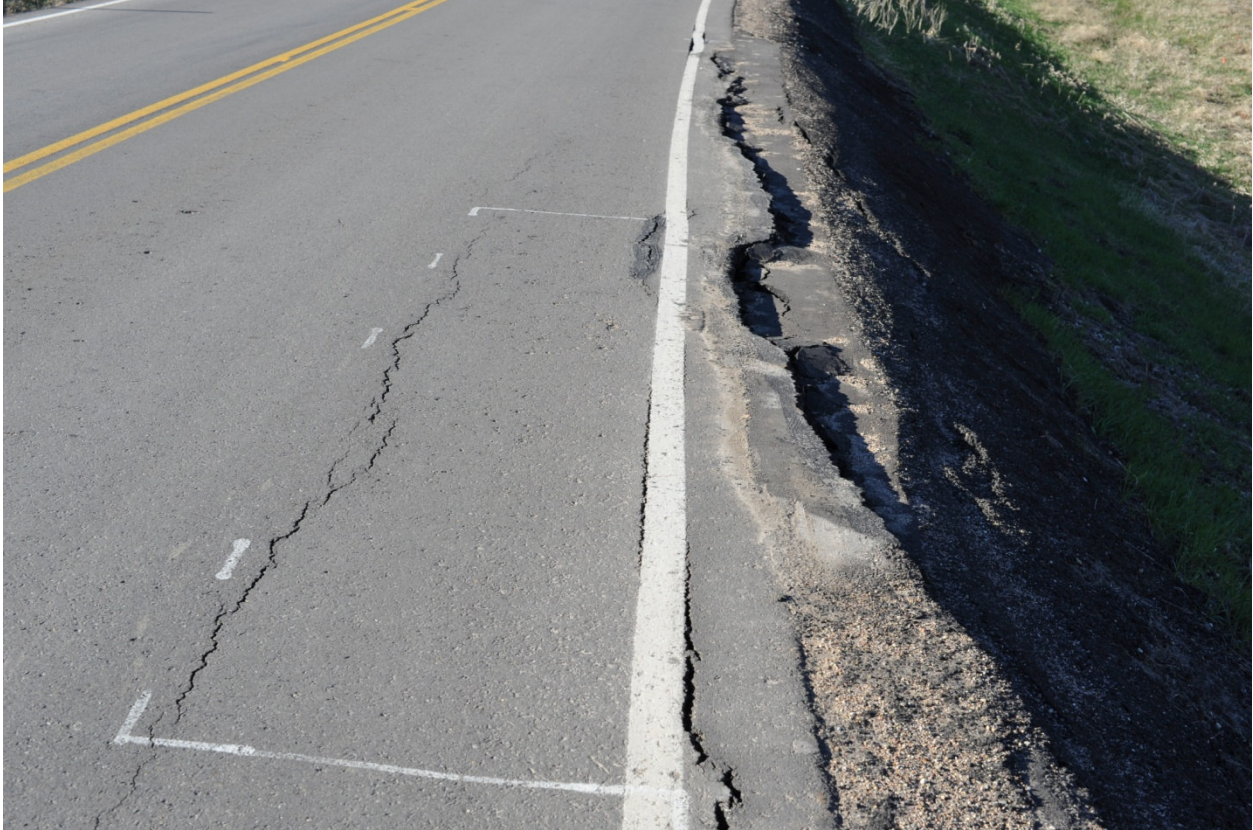
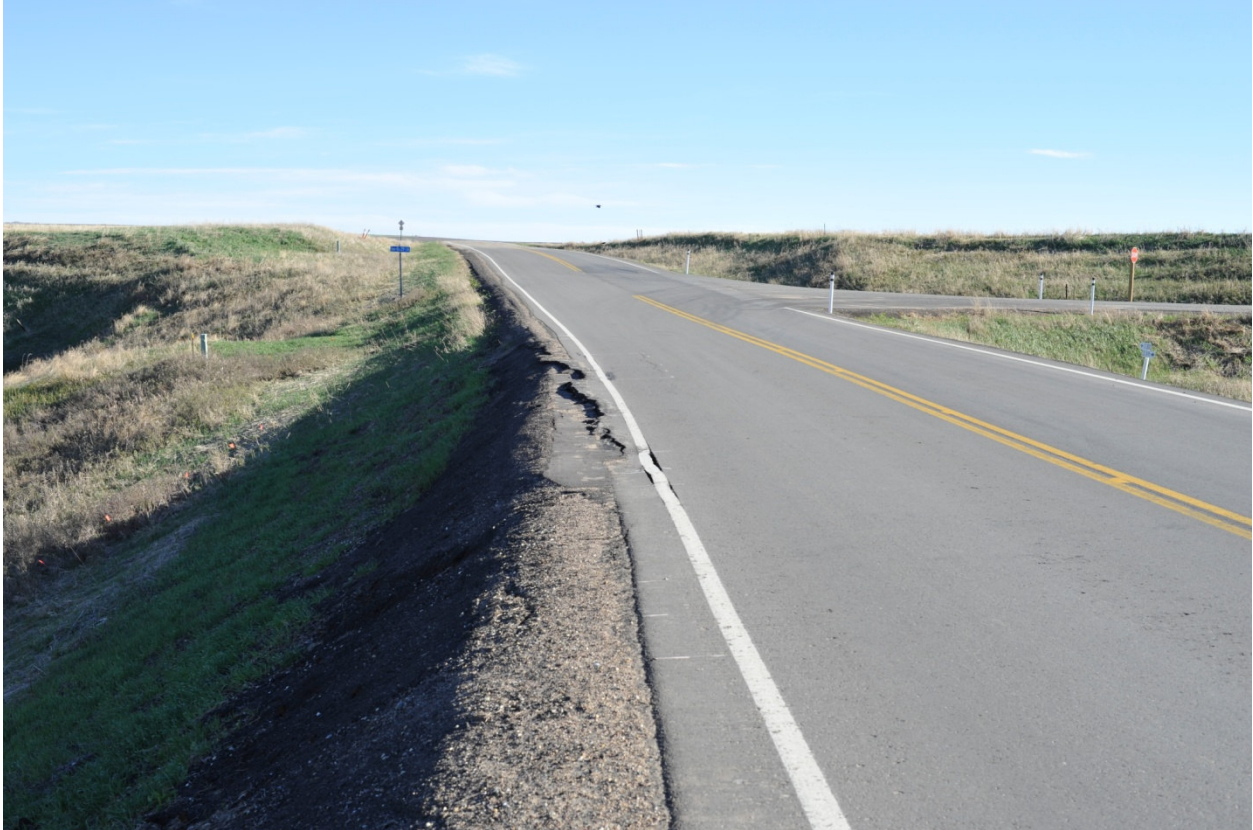
Site C56 H836:02 Settlement Repair (soil nail)
May 17, 2011

ITEM	CONDITION EXISTS		DESCRIPTION AND LOCATION	NOTICABLE CHANGE FROM LAST INSPECTION	
	YES	NO		YES	NO
Pavement Distress	X		Minor cracking at extreme edge of pavement.		
Slope Movement		X			
Erosion		X			
Seepage		X			
Culvert Distress		X

COMMENTS & RECOMMENDATIONS
See attached photos.
MCI to monitor – remove from Geohazard program
