**Reference: North Central Region, Edson/Stony Plain, Site NC081 – Highway 16A:08 Evansburg Slide, Fall 2025 Instrumentation Monitoring Report**

## 1.0 OBSERVATIONS

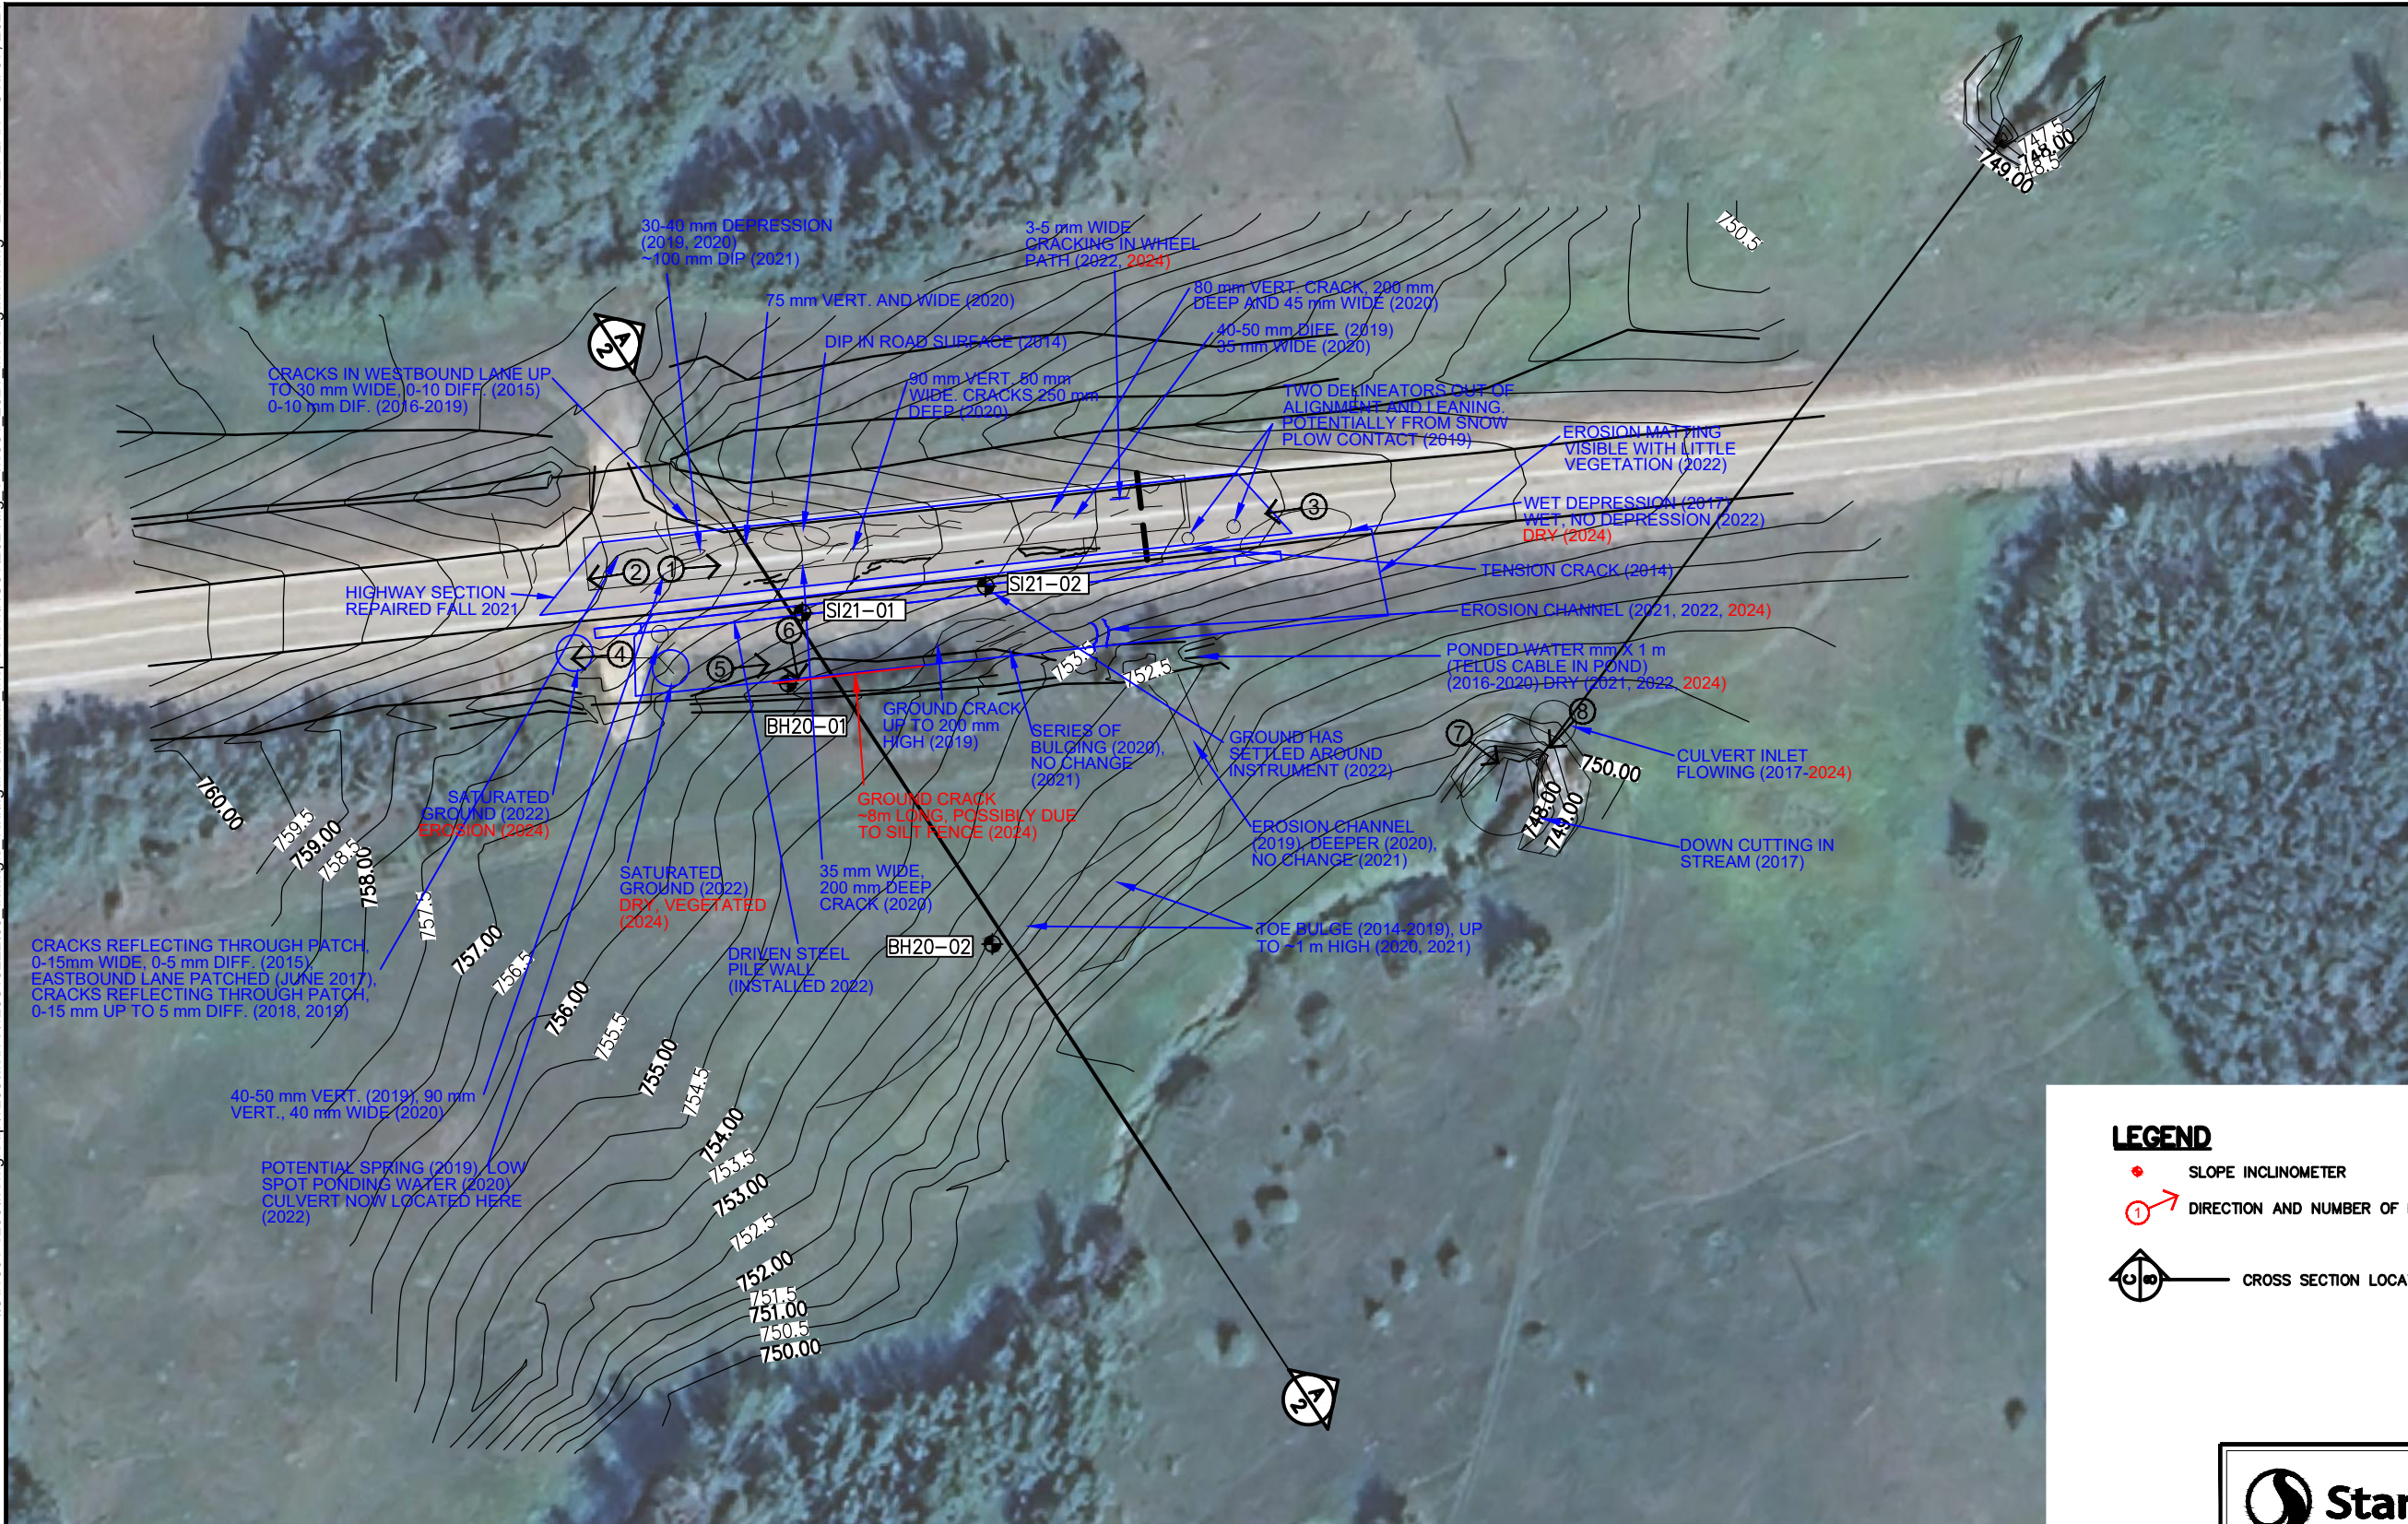
The Fall 2025 reading cycle consisted of instrument readings of two slope inclinometers (BH21-01 and BH21-02) and four standpipe piezometers (BH20-01A, BH20-01B, BH20-02A, and BH20-02B). BH20-01 and BH20-02 were found blocked at 3.0 m below ground surface in October 2021 and May 2025 respectively. **Figure 1** attached provides a schematic of the site. The instruments were read by Akintola Fakinlede, GIT and Adham Zahr, Geotechnical EIT on October 2, 2025.

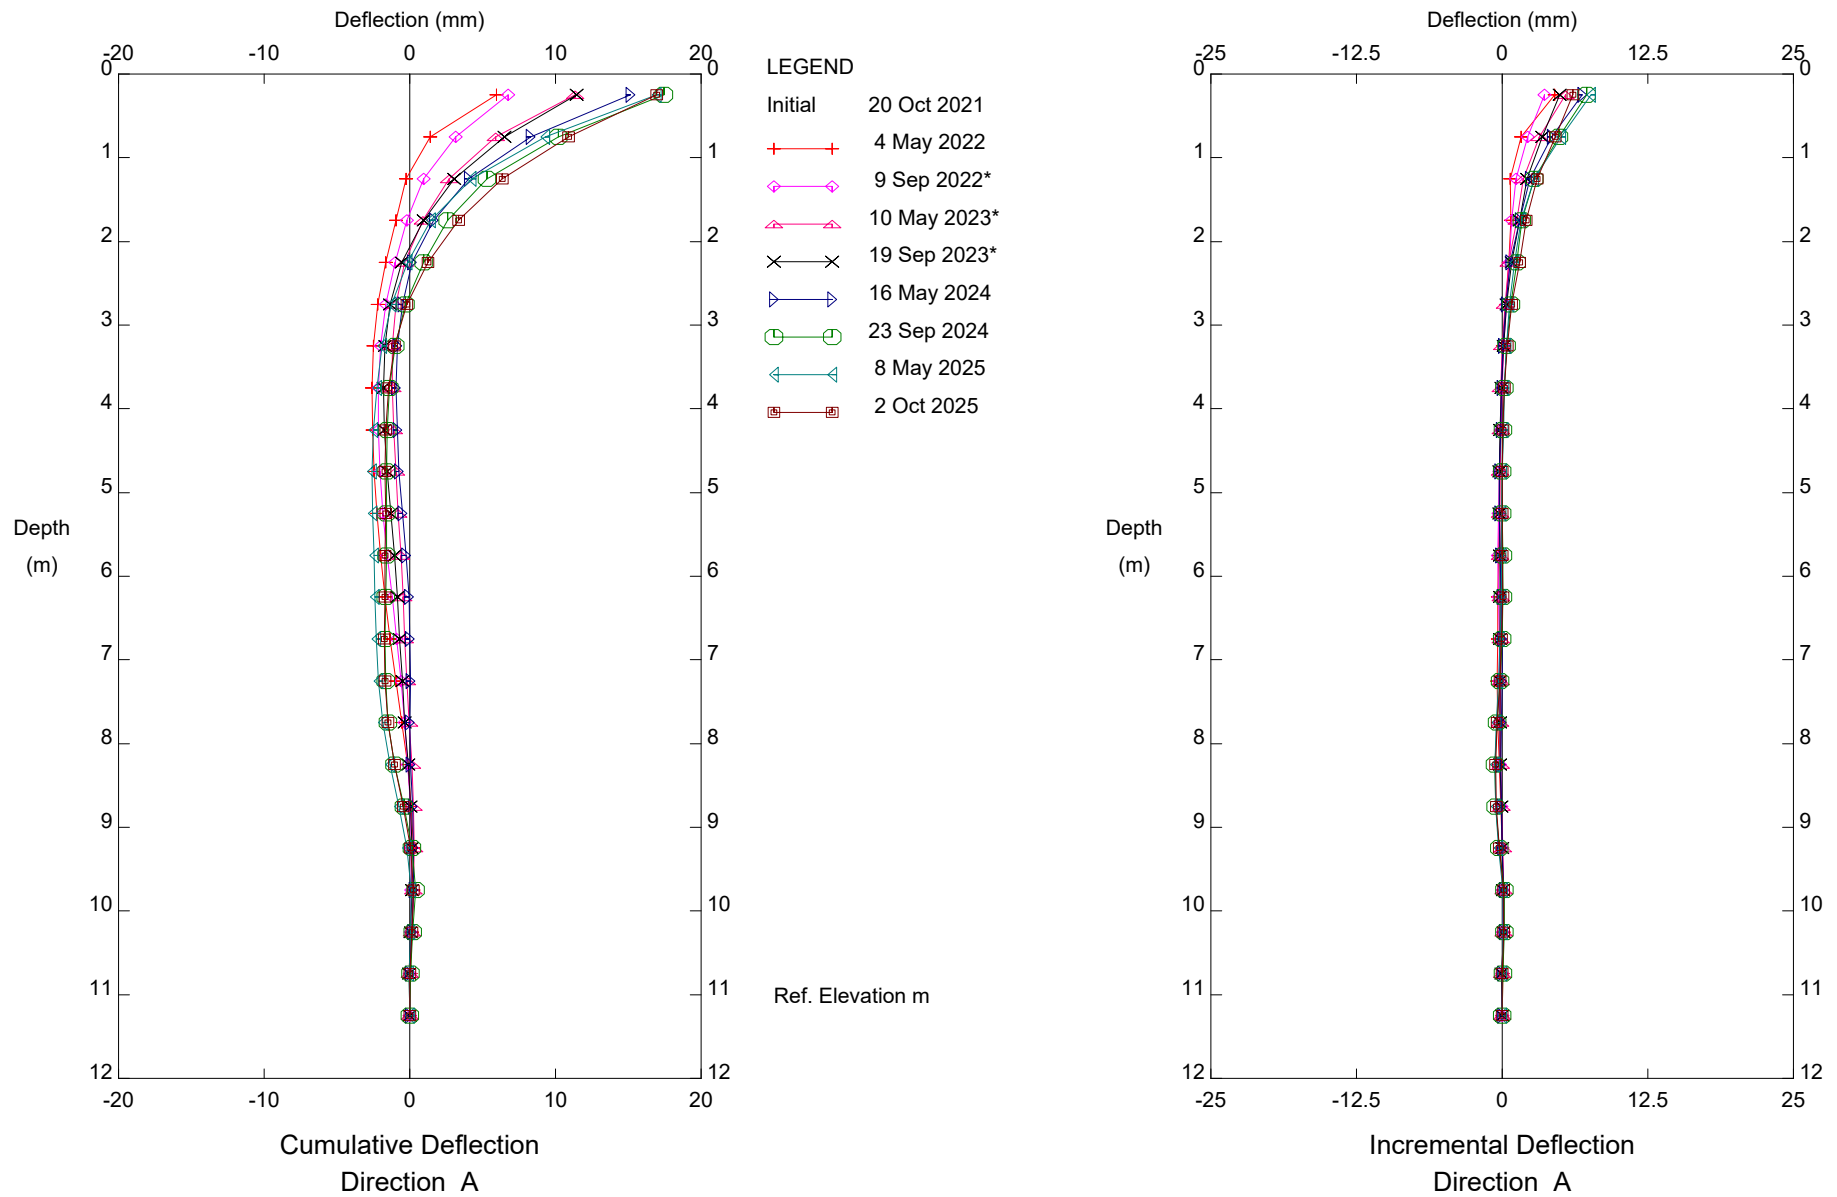
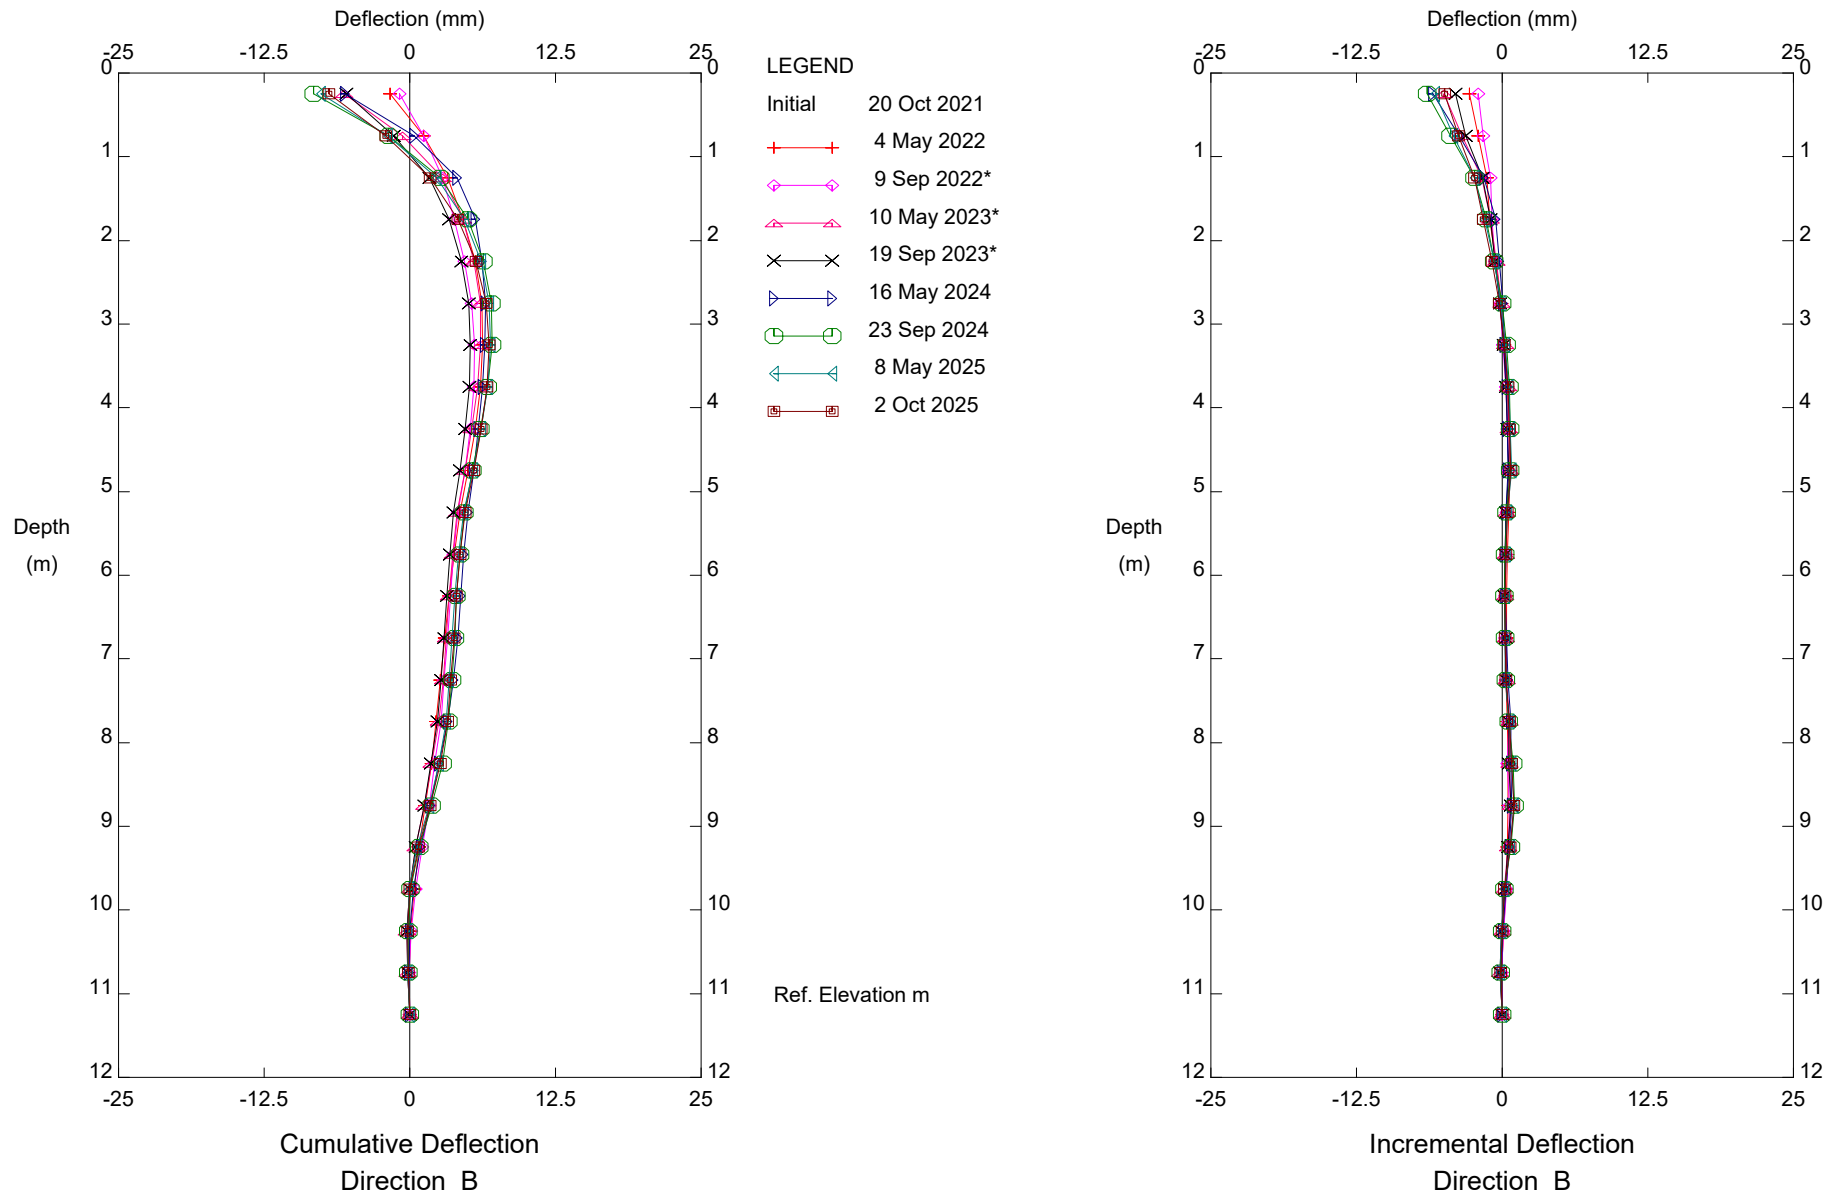
NC81 - 16A Evansburg, Inclinometer SI 21-01,P27

No discernable zone of movement was observed in SIs BH21-01 and BH21-02 which were installed in piles P27 and P57, respectively. However, small movements were observed at the pile tops. These movements may reflect deflection and loading of the pile wall.

BH21-01 and BH21-02 have no discernable movement zones.

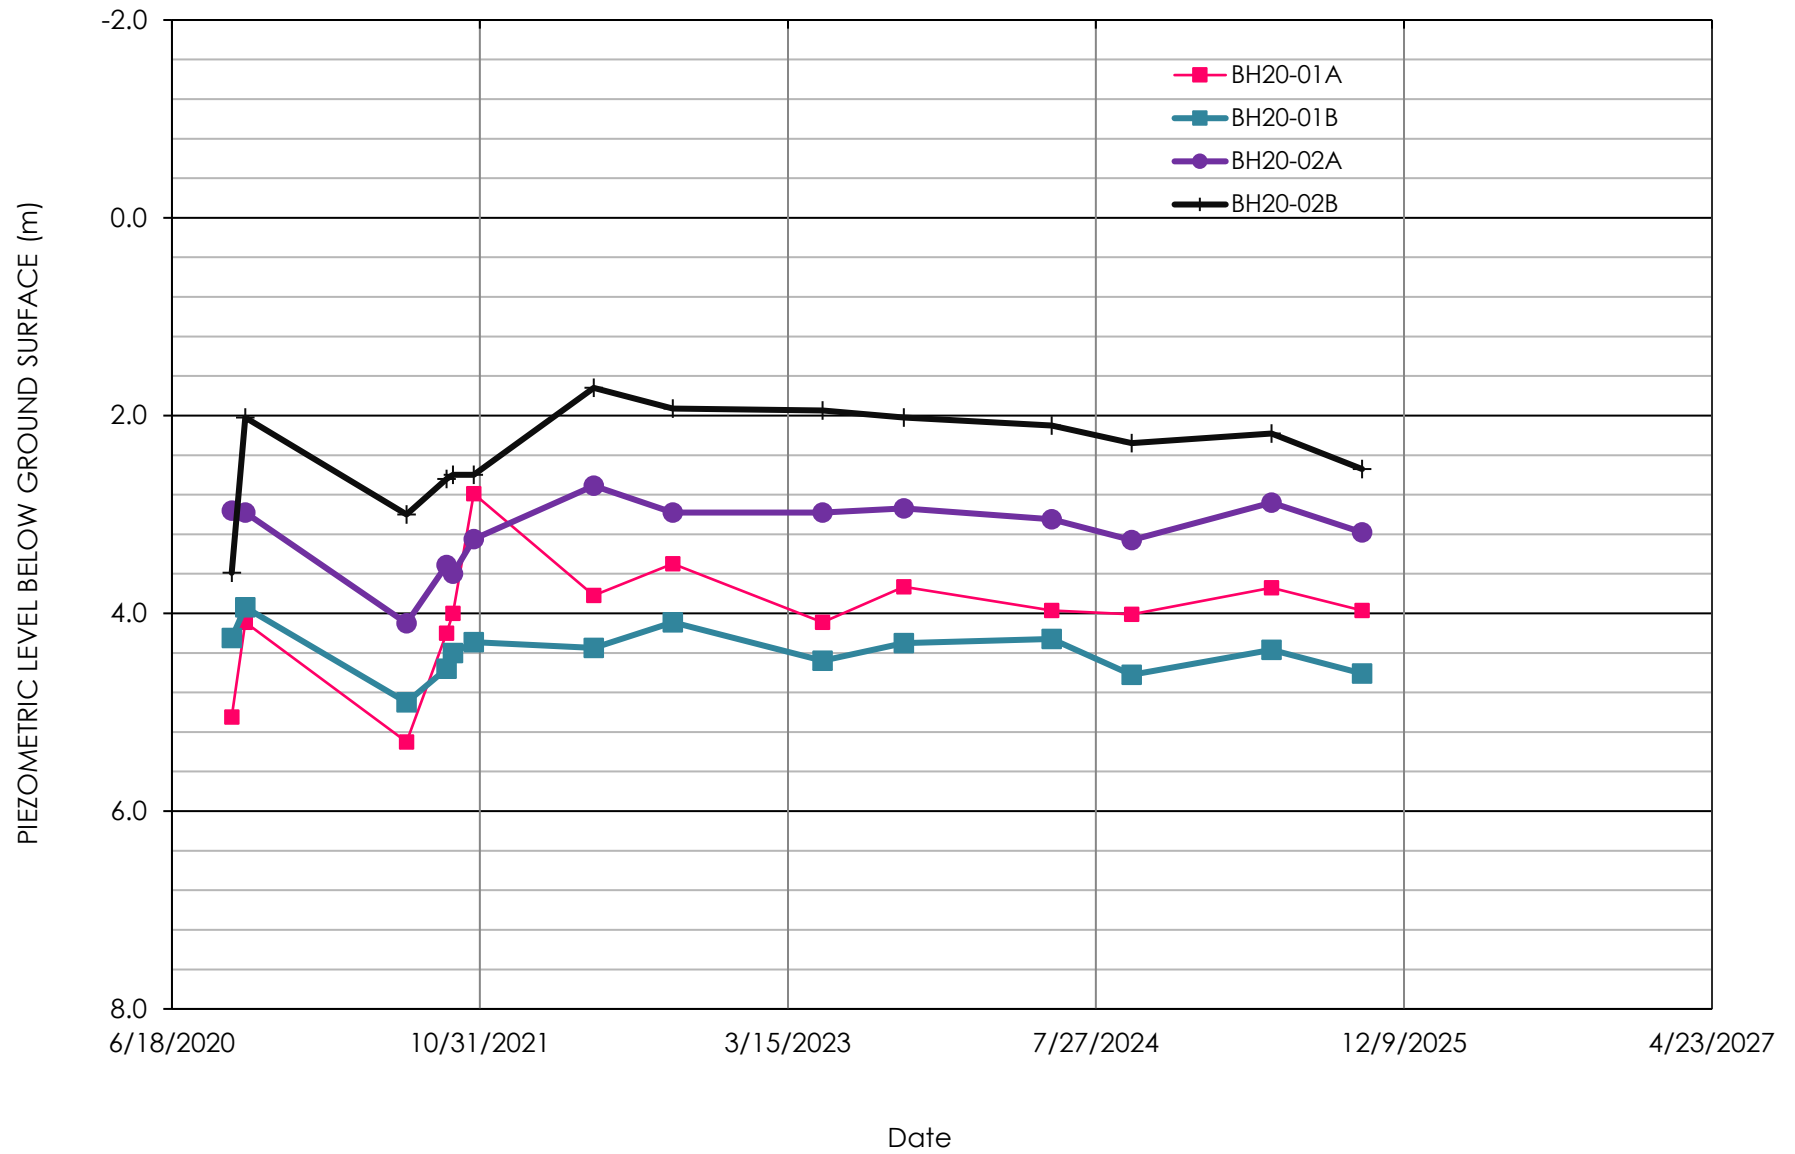
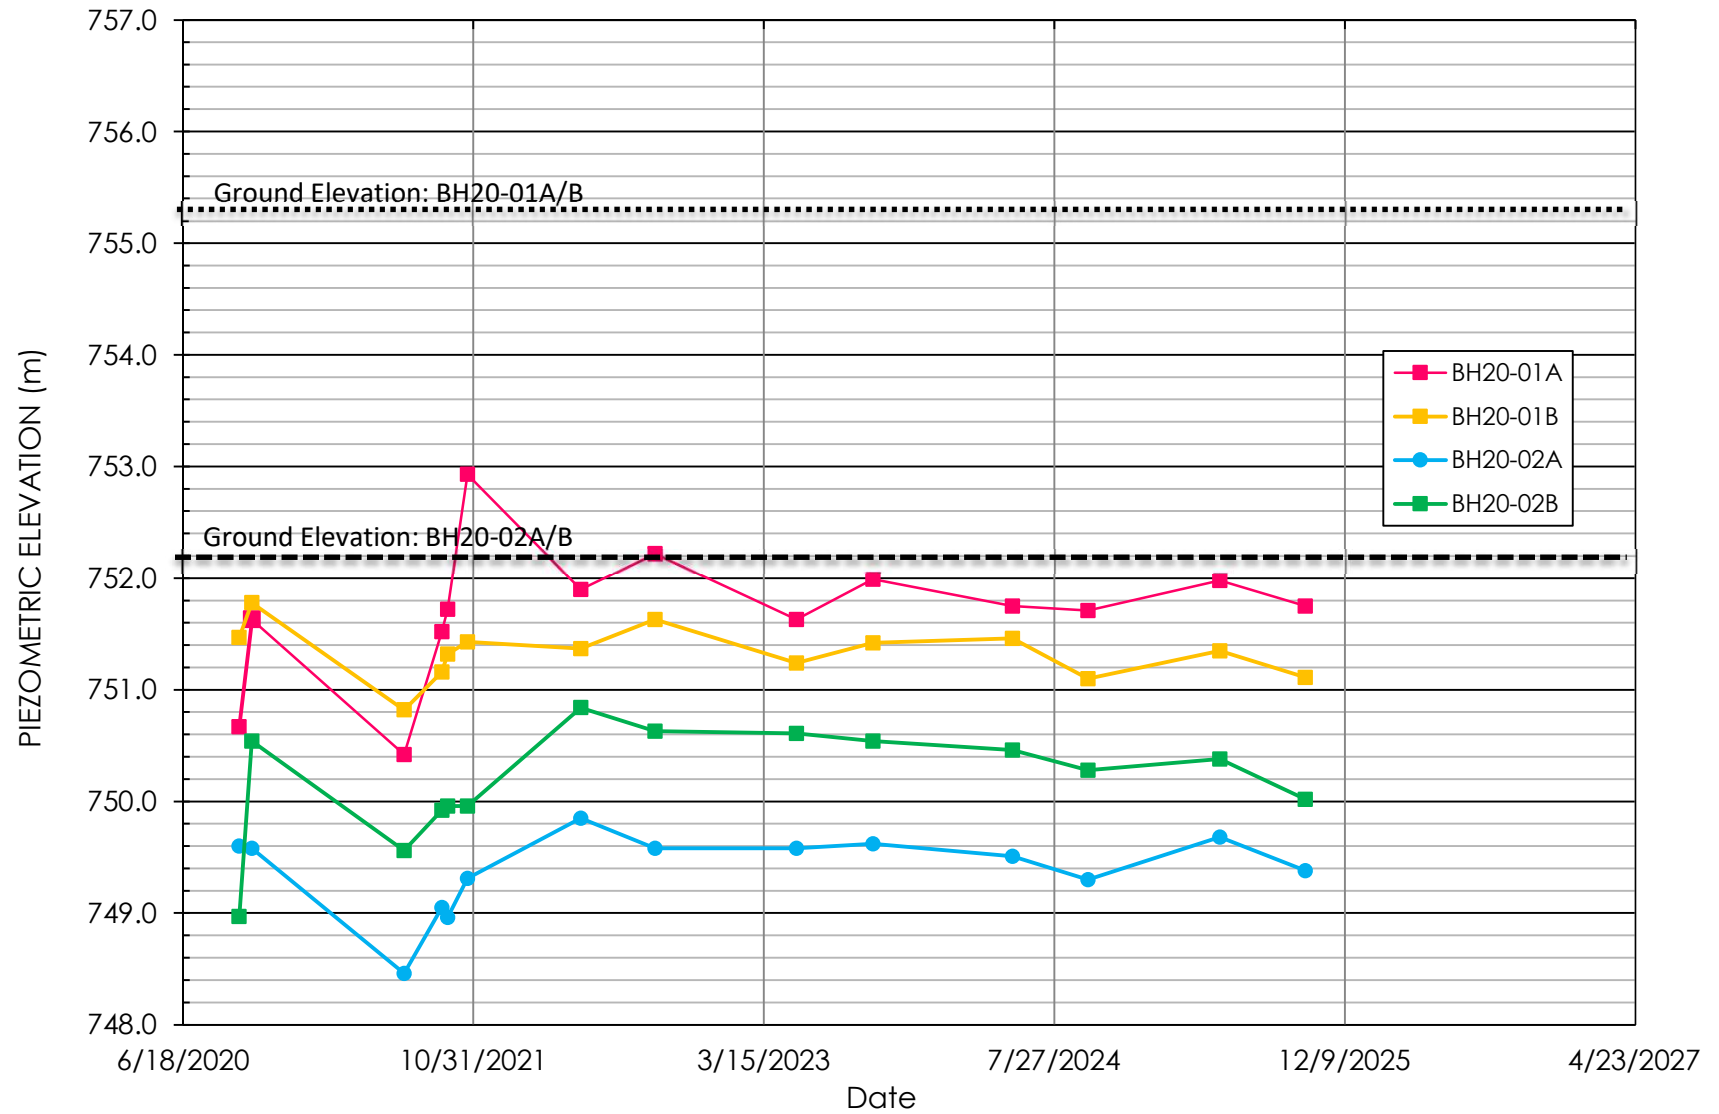
## PIEZOMETER DATA

Compared with water levels from the previous reading cycle, all piezometers show a decrease in water levels ranging from 0.2 m to 0.4 m. The water levels at the site ranged from 2.5 m to 4.6 m below ground surface (bgs), with elevations ranging from 749.4 m to 751.8 m. For reference, the creek elevation is approximately 750 m.
