To:	Amy Driessen	From:	Leslie Cho and Lawrence Onwude
	Transportation and Economic Corridors		Stantec Consulting Ltd.
File:	123315222	Date:	June 6, 2025

Reference: North Central Region, Edson/Stony Plain, Site NC081 – Highway 16A:08 Evansburg Slide, Spring 2025 Instrumentation Monitoring Report

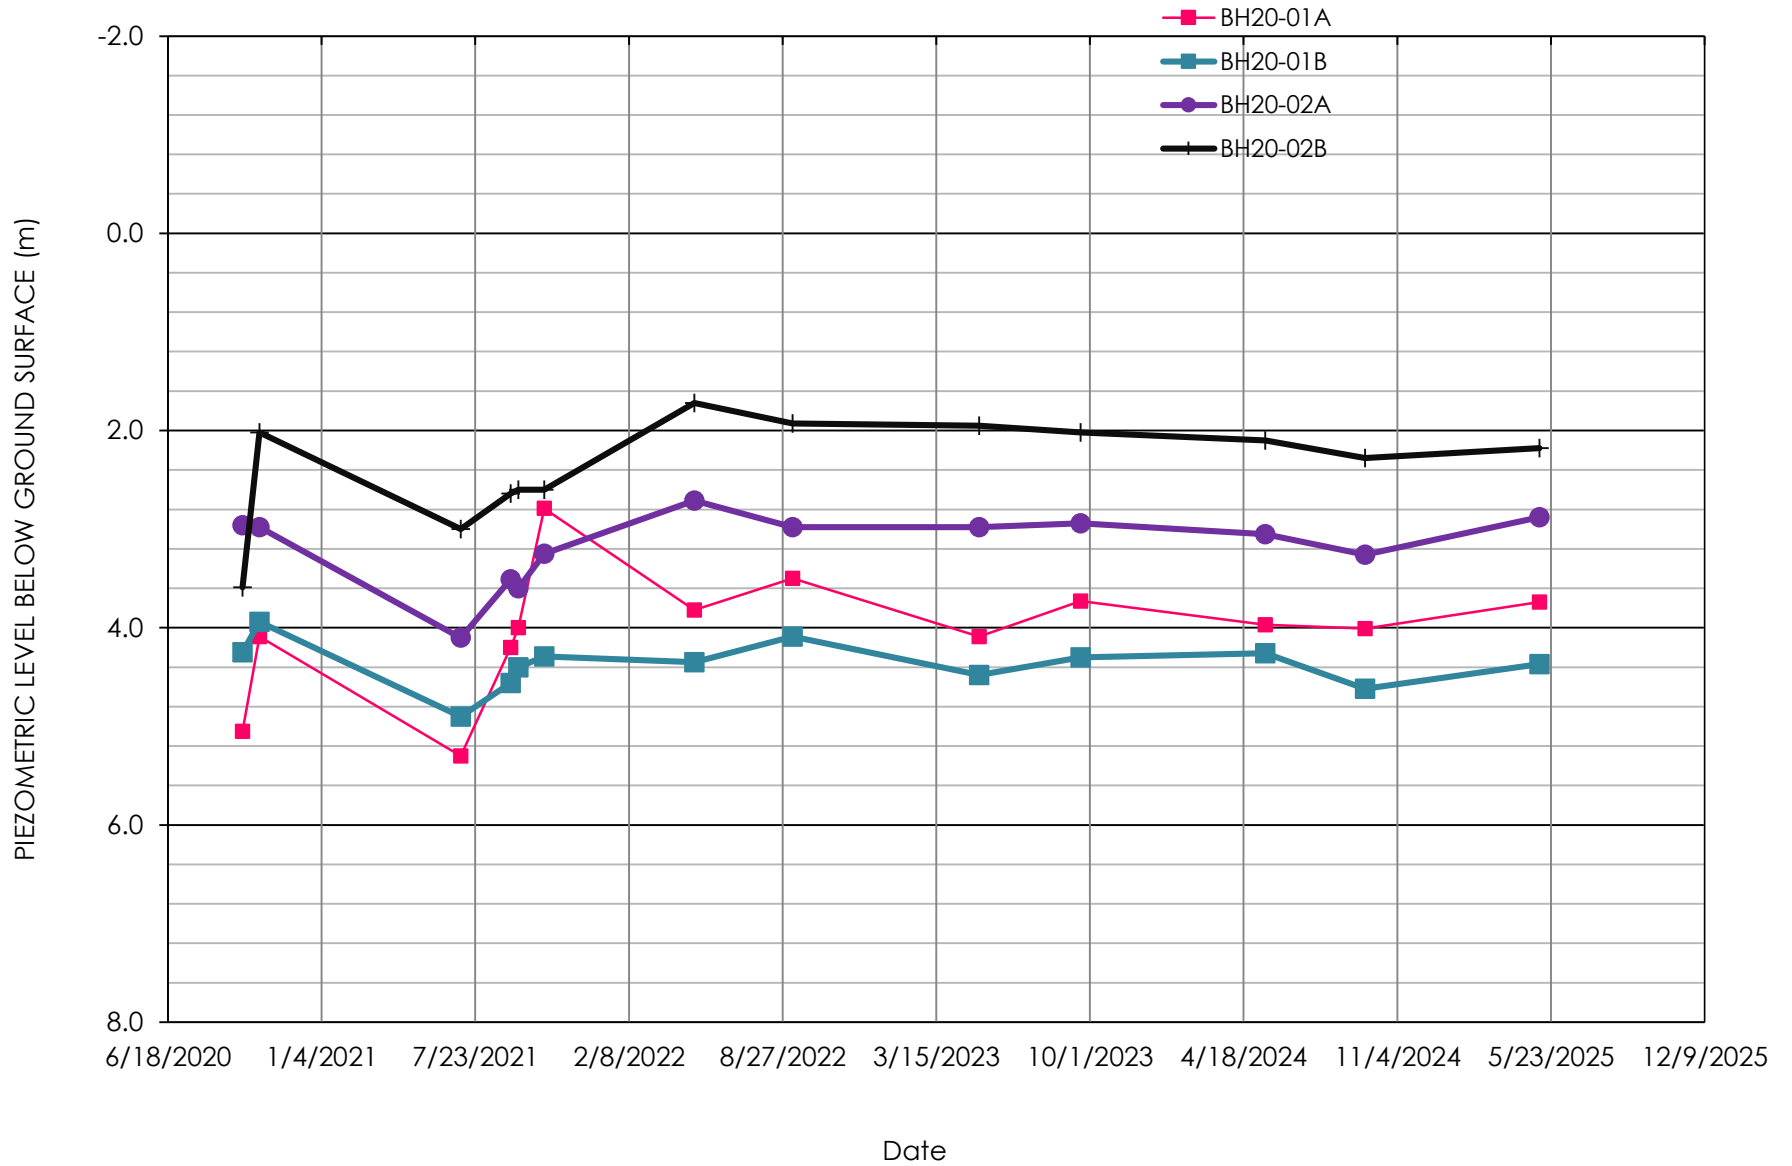
PIEZOMETER DATA

Compared with water levels from the previous reading cycle, all piezometers show an increase in water level ranging from 0.1 m to 0.4 m. The water levels at the site ranged from 2.2 m to 4.4 m below ground surface (bgs), with elevations ranging from 749.7 m to 752.0 m. For reference, the creek elevation is approximately 750 m.
