Pathfinder Marking System

File: 8190-3-19

Location: Highway 22:16 (Cochrane)
Applied: September 2008
Evaluated: July 9, 2009

3Km S. of Jct. Hwy. 567

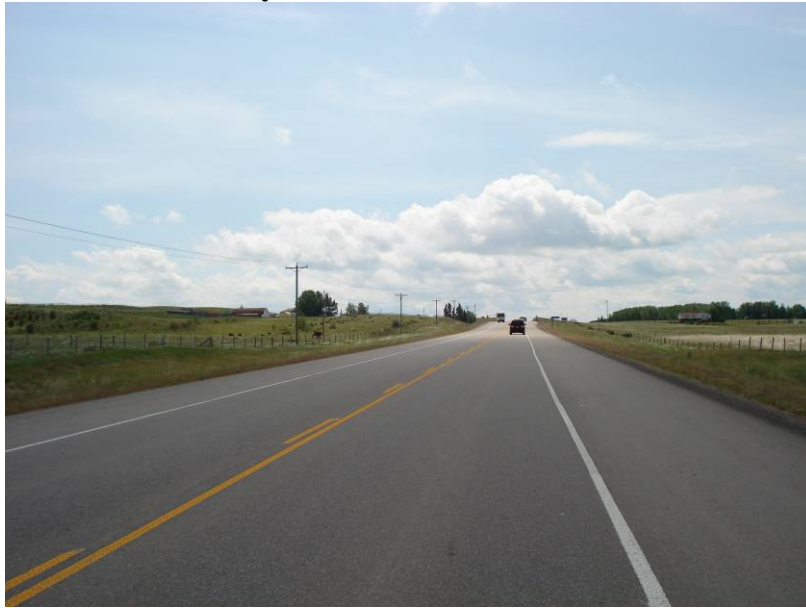
The Pathfinder markings are all intact, no evidence of debonding on this project.

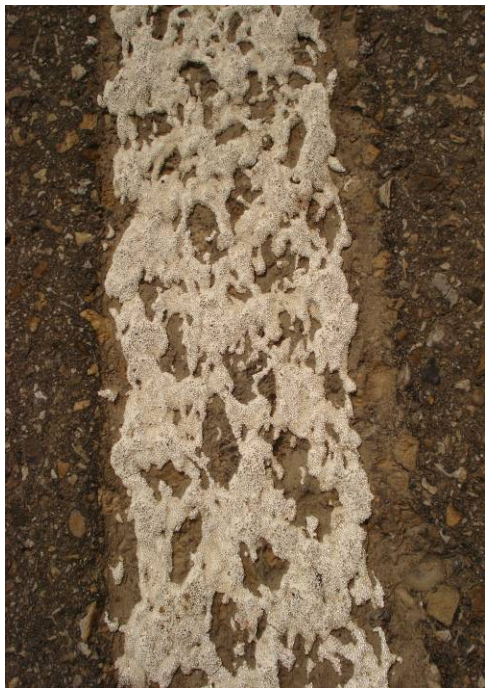
W. edge line

Retro readings west white edge line: 307, 270, 306, 324, 280, 289, 303, 297, 239, 297 – **Average: 291Mcd**

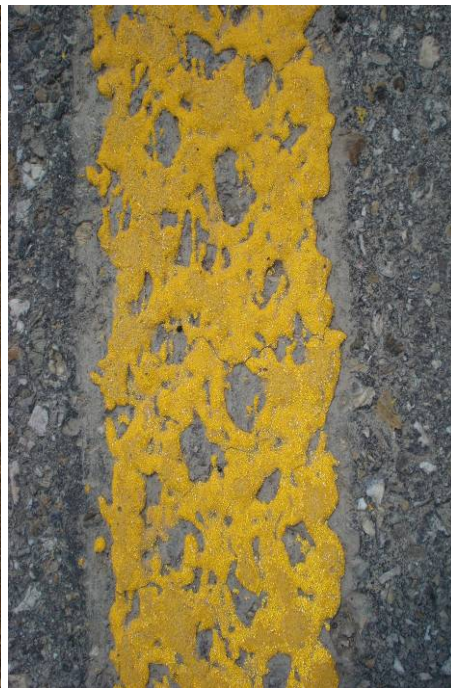
Skip line

Retro readings yellow skip line: 189, 171, 170, 171, 169, 174 – **Average: 174 Mcd**

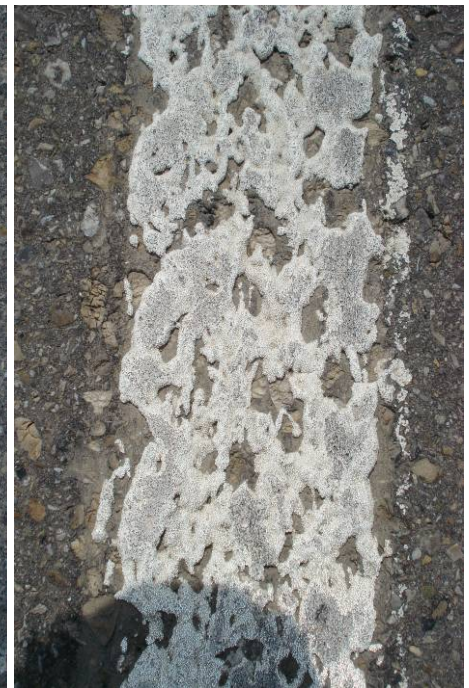
E. edge line

Retro readings east white edge line: 311, 296, 325, 312, 336, 358, 327, 272, 272, 344 – **Average: 315Mcd**

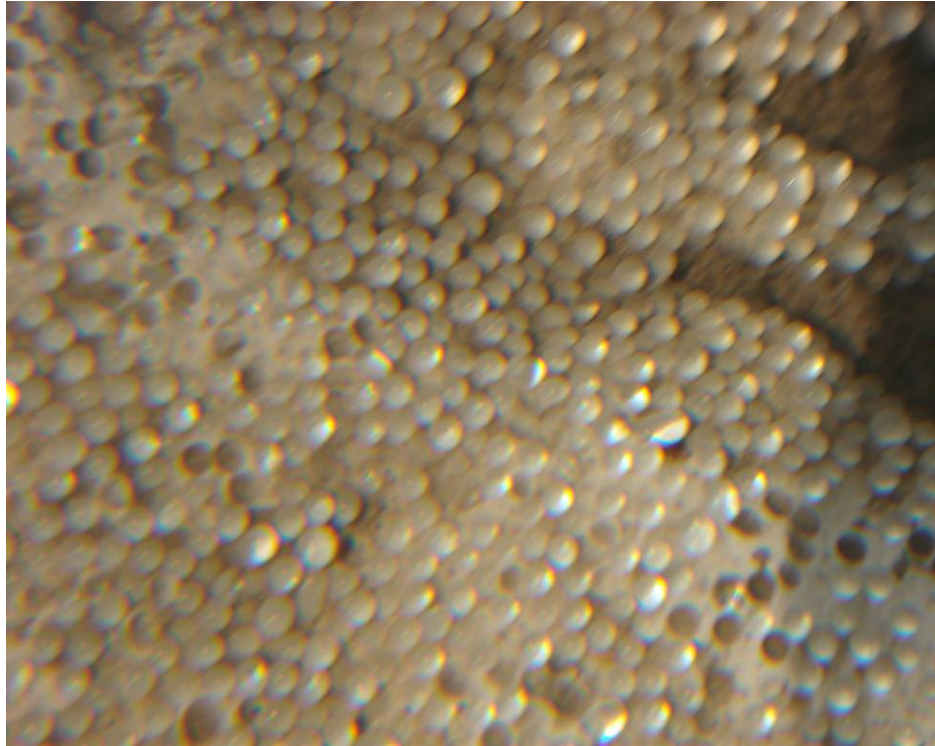
Magnification of Pathfinder marking – excellent glass bead retention

The Pathfinder markings look very good and are providing excellent delineation at this time. The retro-reflective readings are excellent after one winter. Glass bead retention is excellent as can be seen in the magnified photograph above.
